Importance of Substructure Evaluation

Wiss, Janney, Elstner Associates, Inc.

Inspection Case Studies and Techniques

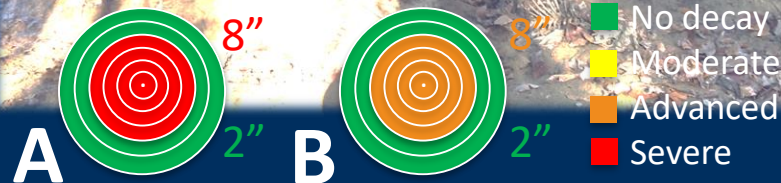
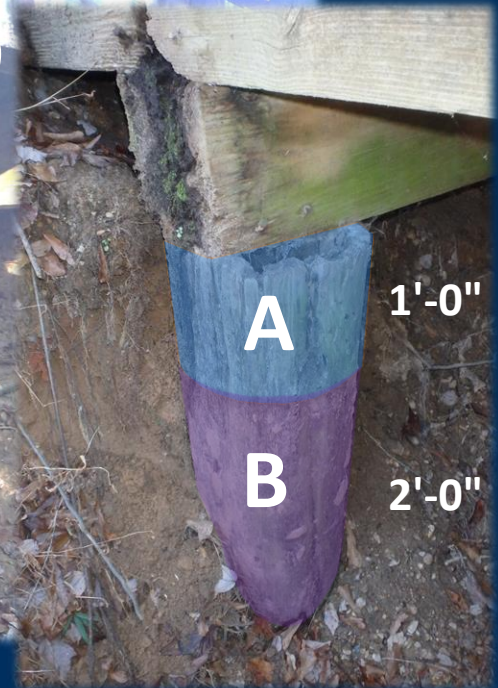
■ Bent 3-Pile 1 (12"φ x 3' Long)

Visual	✗
Sounding	✗
Probing	N/A
Drilling	✗

→ 45% loss in capacity

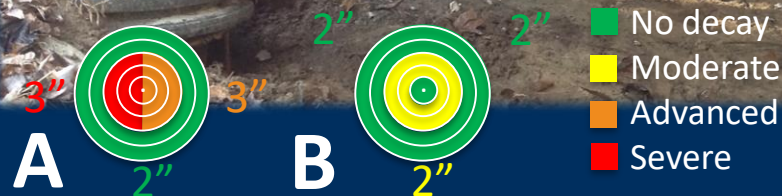
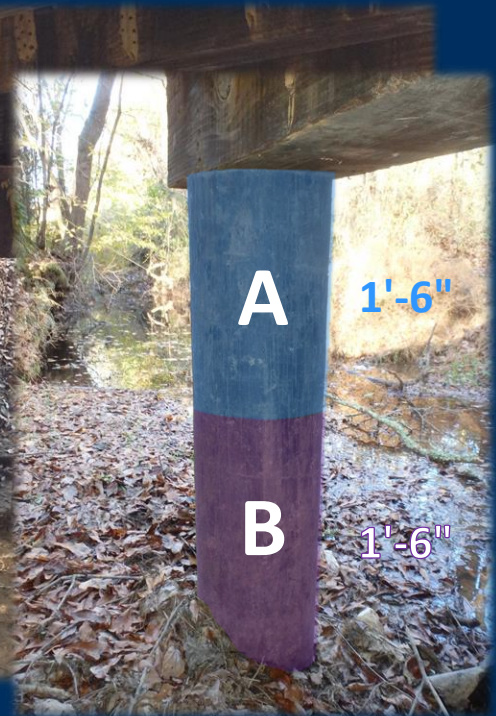
■ Bent 2-Pile 1 (10"φ x 3' Long)

Visual	✓
Sounding	✗
Probing	N/A
Drilling	✗

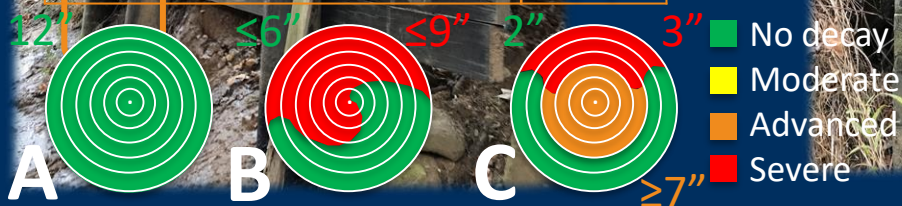
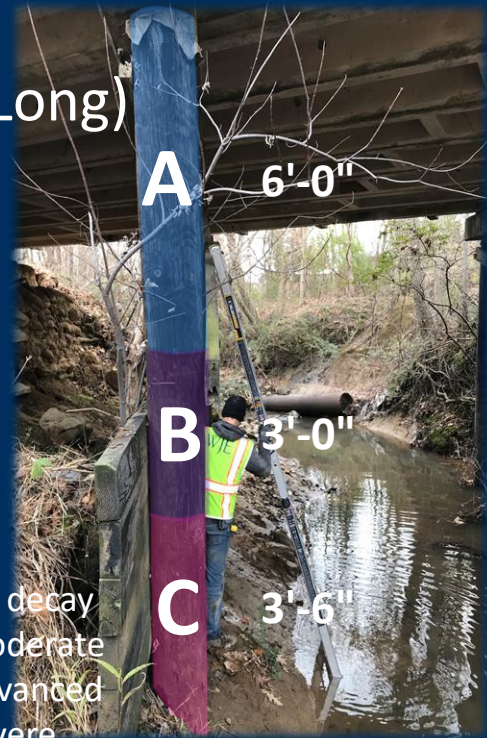
- Bent 3-Pile 6 (12" ϕ x 12'-6" Long)

Visual	✓
Sound	✗
Probing	N/A
Drilling	✗

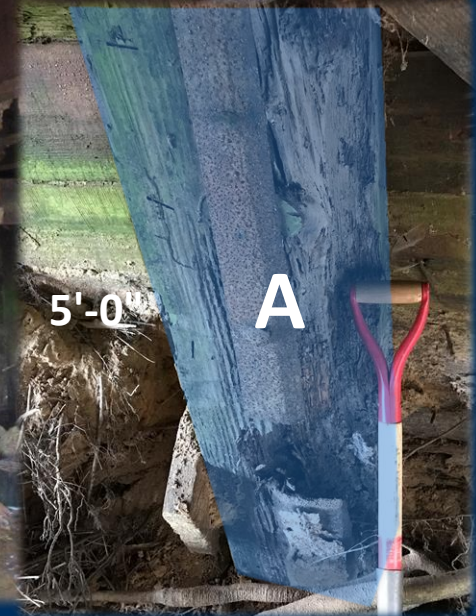
■ Bent 2-Pile 3 (12" SQ x 5' Long)

✗
Binding	✗
	N/A
Drilling	✗

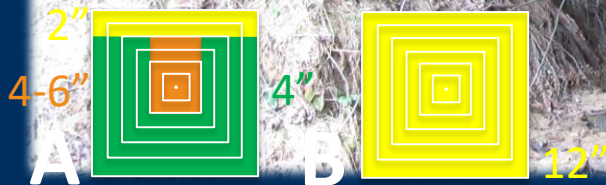
■ Bent 2-Pile 5 (12" SQ x 5'-6" Long)

✓
Binding	✗
	N/A
Drilling	✗

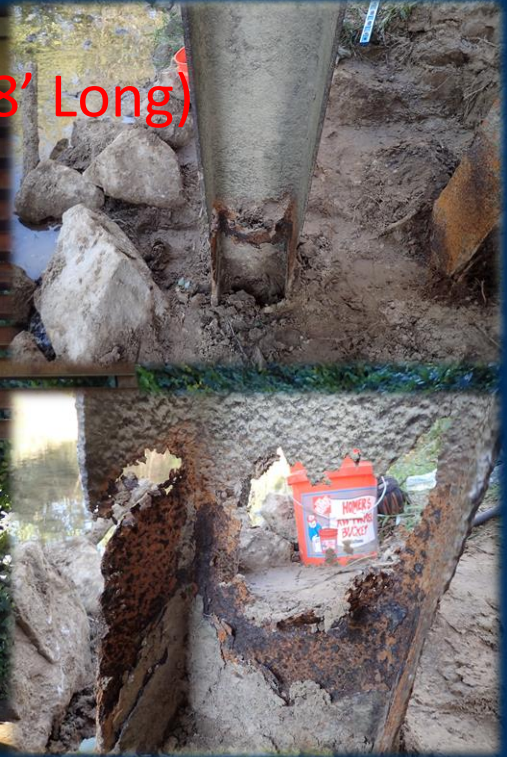
■ Bent 2-Pile 4N (HP10x42 x 18' Long)

Visual	✗
Corrosion product removal	✗
Section loss measurement	✗

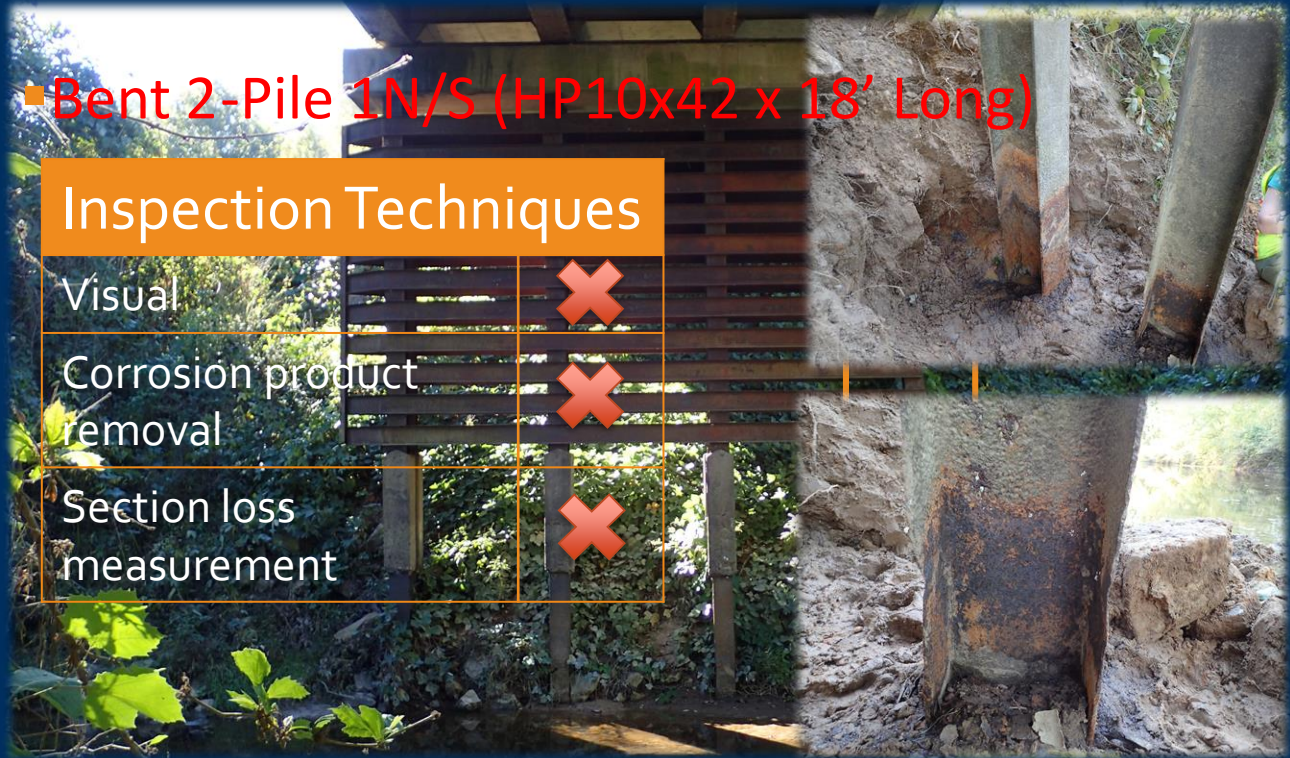
■ Bent 2-Pile 1N/S (HP10x42 x 18' Long)

Visual	✗
Corrosion product removal	✗
Section loss measurement	✗
