Culvert Inspection Program and Replacement Projects Case Studies

Washtenaw County Road Commission Presenters

Halbert Road Culvert Replacement

2021 COUNTY ENGINEERS WORKSHOP

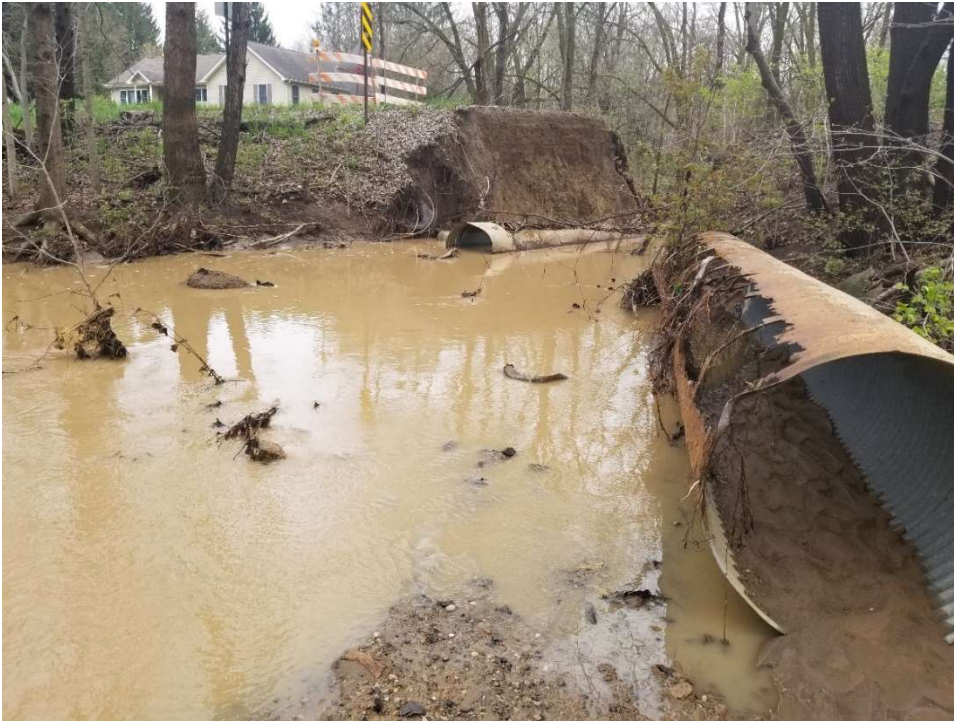
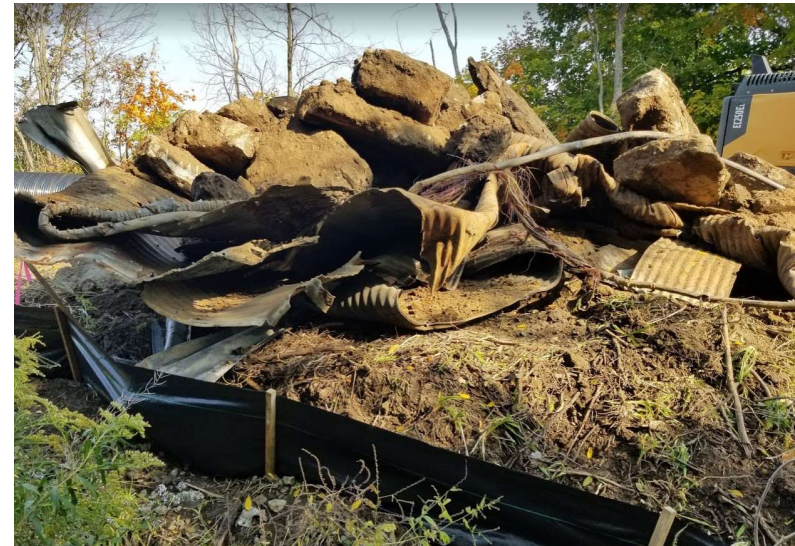
Braun Road – May 2019

Over 12 regional media outlets covered the Braun Road failure.

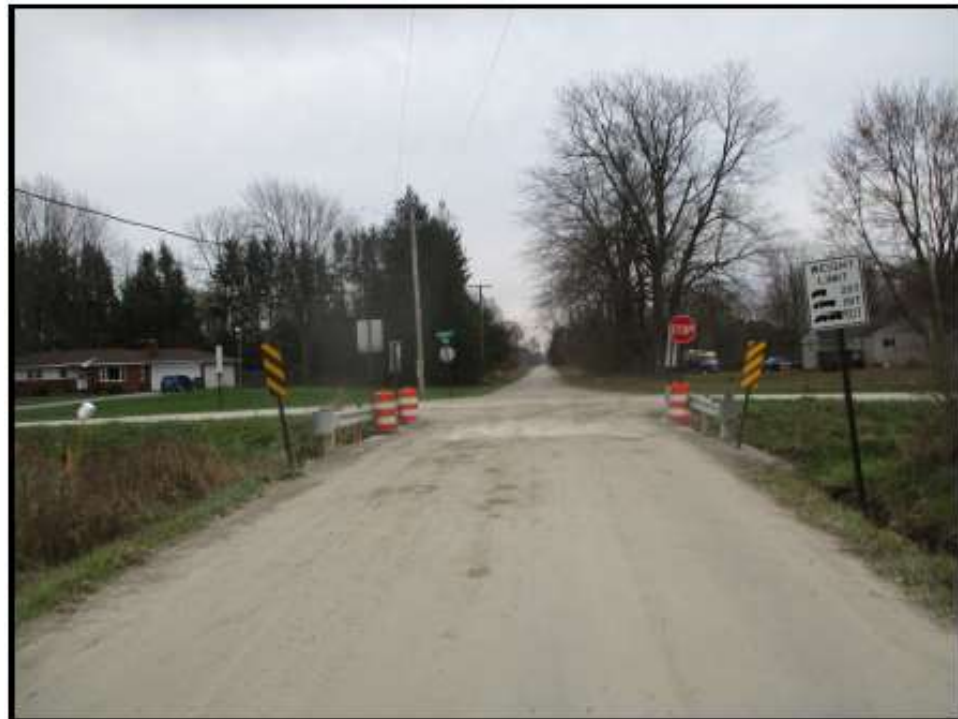
Hitchingham Road Culvert

- Culvert ID: C2017006
- Size: 17' Span x 24' Length
- Type: Jack Arch over Concrete Abutments
- Condition: Closed

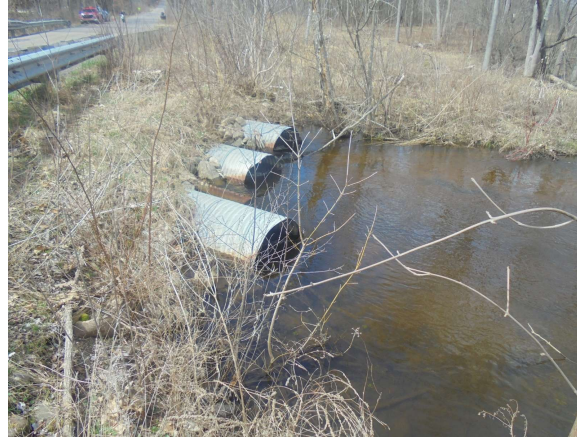
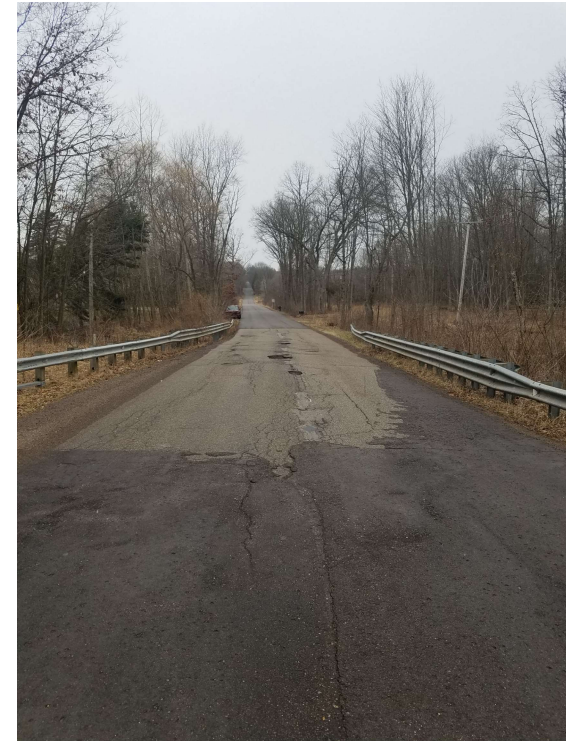
ORIGINAL CROSSING

- + THREE 36-INCH CMP CULVERTS
- + TWO 12-INCH CMP CULVERTS
- + ± 62 FEET IN LENGTH
- + ORIGINAL CULVERTS WERE ALIGNED DOWNSTREAM, HOWEVER, WERE ± 30 -DEGREES MISALIGNED UPSTREAM
- + ROADWAY HAD A SLIGHT BEND AT THE LOCATION OF THE CROSSING

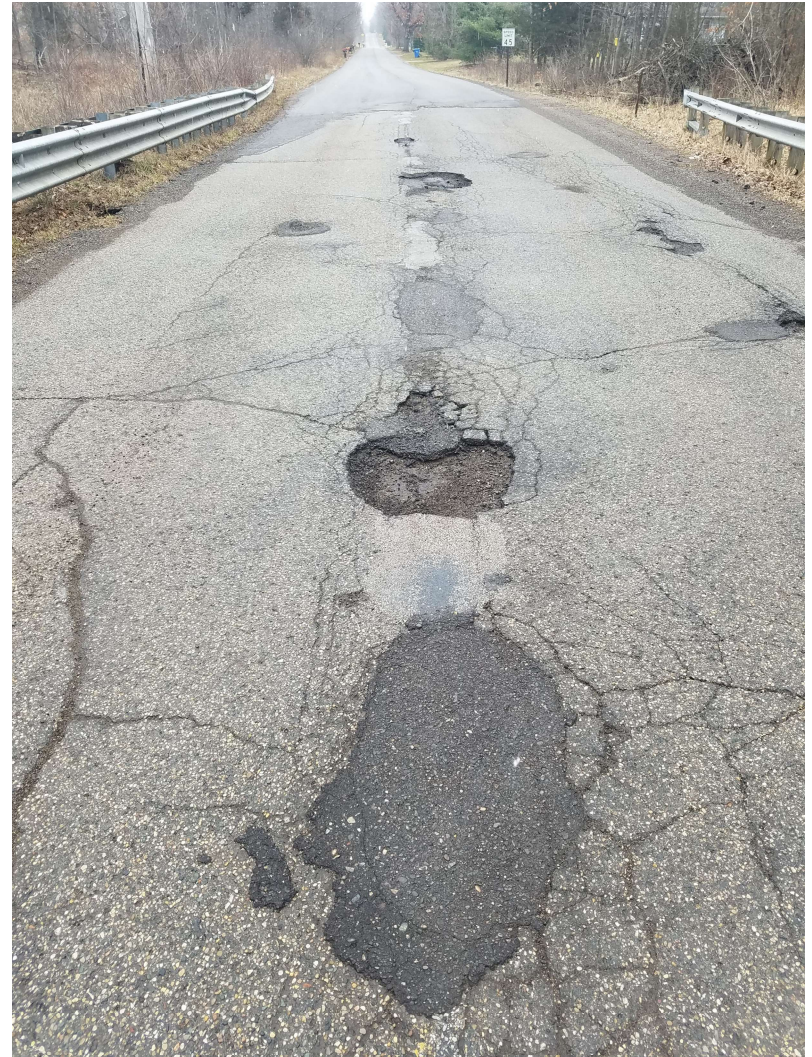
PROJECT NEED

- + ONE OF THE CULVERTS HAD FAILED
- + BACKFILL WAS CONTINUOUSLY FALLING INTO THE CULVERT CAUSING PAVEMENT FAILURE
- + REQUIRED ROUTINE HMA PATCHING
- + EROSION UPSTREAM OF CULVERTS
