Concrete Overlay Lessons Learned

County Engineers' Workshop February 10, 2022

ANN ARBOR-SALINE RD PROJECT

Getting out of a sticky situation A fog seal story

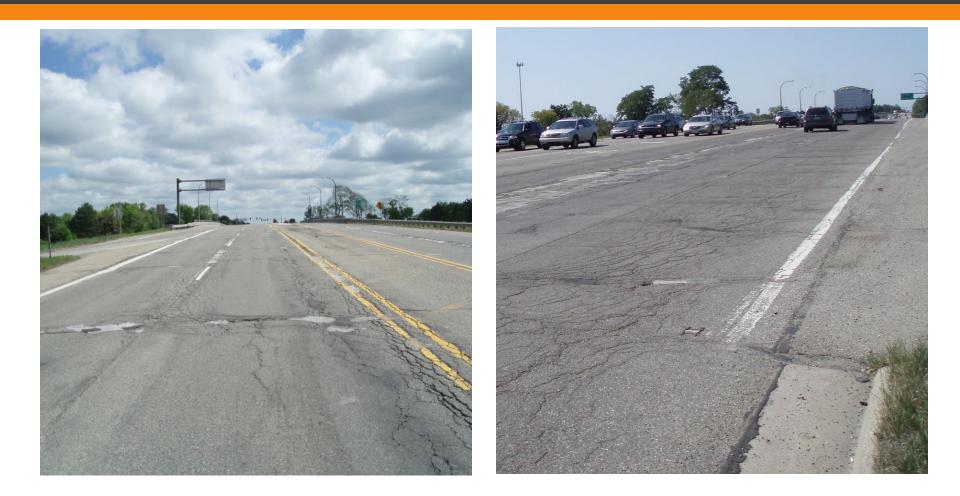
Existing Conditions for Full Depth Conc Pavement

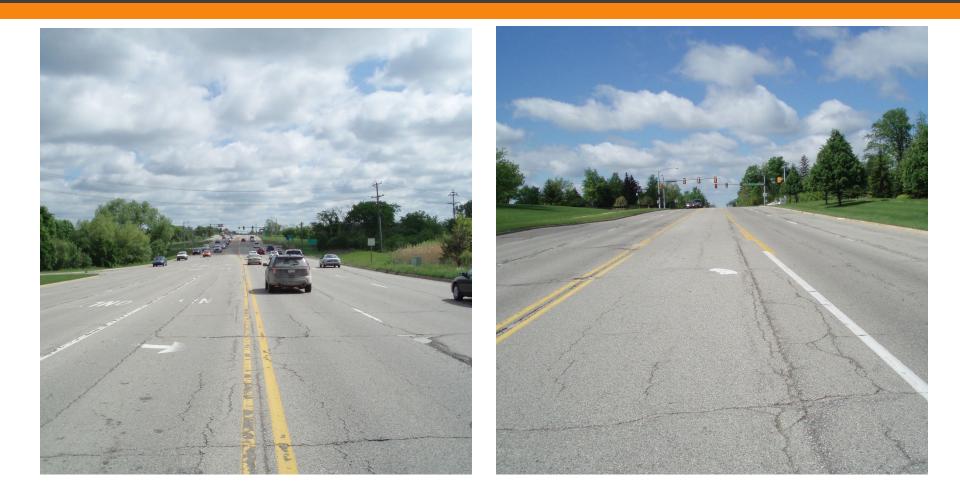
Existing Conditions for Conc Overlay

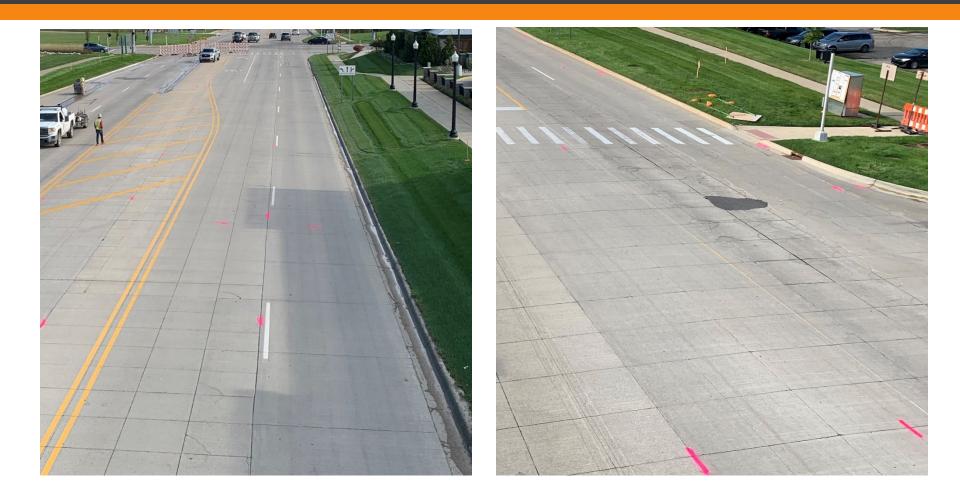
By 2019, thinned concrete overlay failed in traveled lanes.

Failed Thinned Conc Overlay

• Determination made to replace with full depth concrete pavement.

- Conc Pavt, Nonreinf, 9 inch
 - -4,490 SYD at \$51.50 per SYD
 - Approximately \$400,000 fix for a 20-year pavement

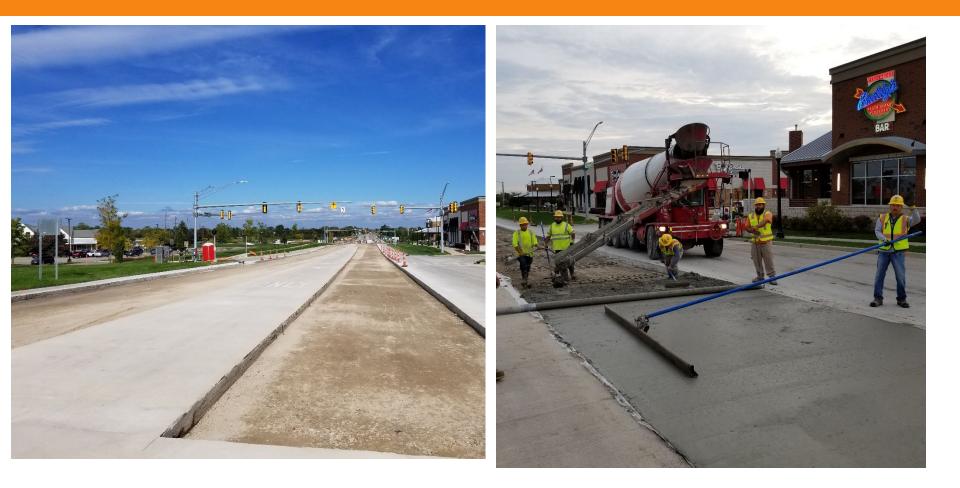
Full Depth Conc Repair

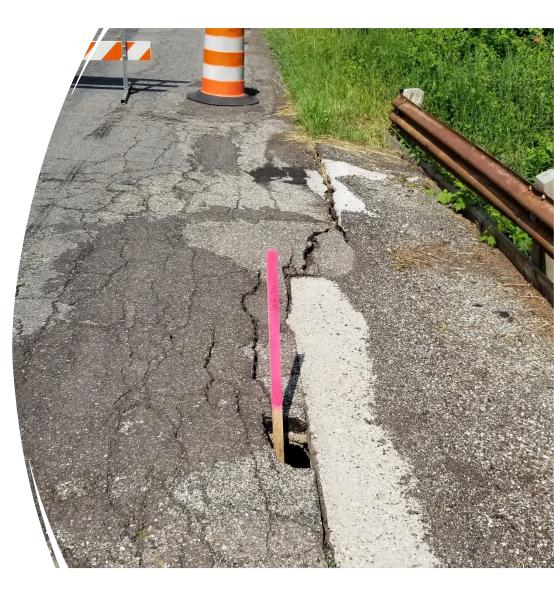
- Original series of culverts
 - 1 x 48" CMP & 2 x 36" RCP
- Approximately 100 years old
- Open holes in pavement led to road closure in 2017

- Not a bridge, but would be replaced with one
- No inspection required
- County did not regularly inspect culverts

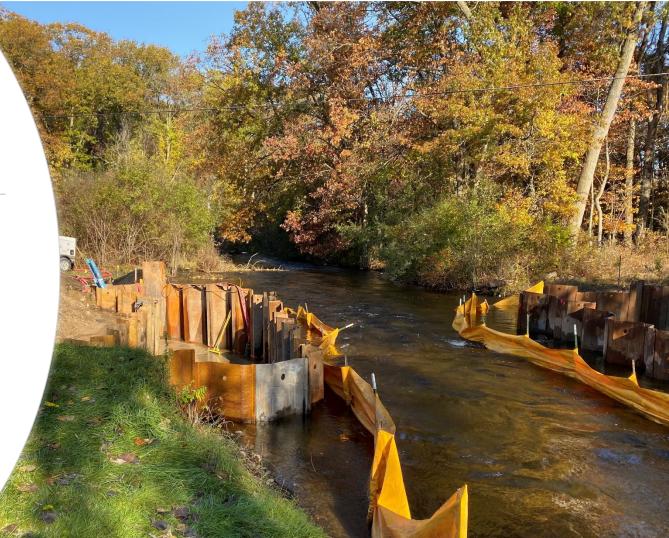
- Consultant surveyed utilities, including power poles
- Power lines were not included on plans
- While poles had enough clearance, lines were too close to the crane, creating a risk of arcing

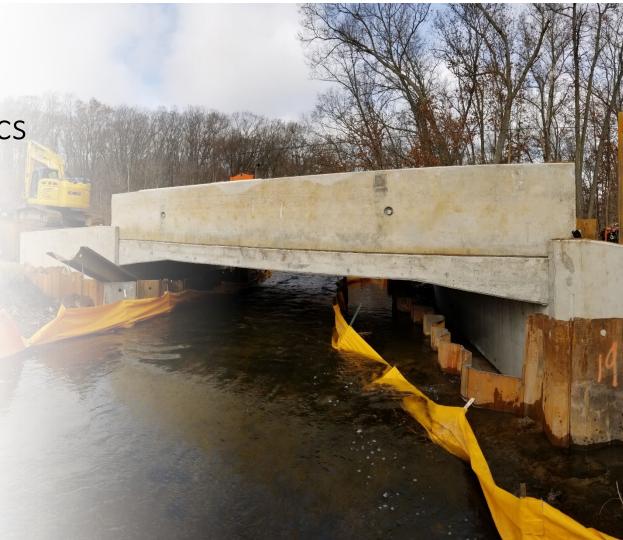
- Sheet piling had to be cut down to ground level
- At the time, water levels were high, so ground level was 18" underwater
- Had to hire a diver to cut sheets underwater (in December!)

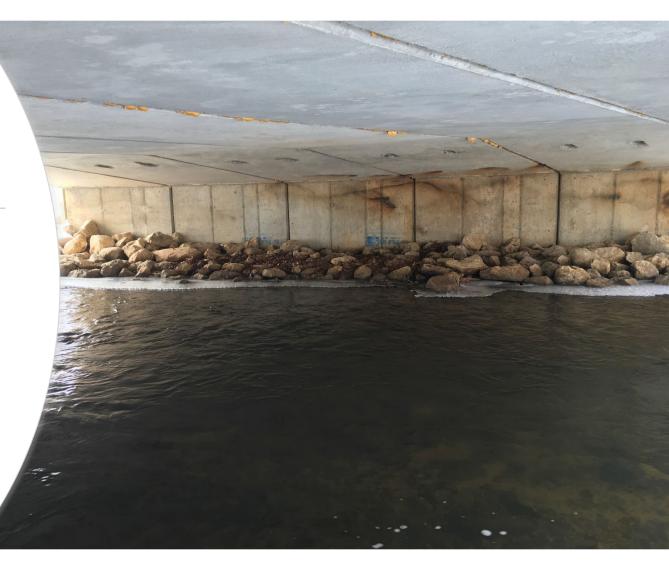
- Three-sided box culvert required lots of heavy riprap
- Riprap was placed after sheet piling was cut and bridge was nearly completed
- Because of the low clearance between the deck & the water, all 125 SYD of riprap had to be hand placed

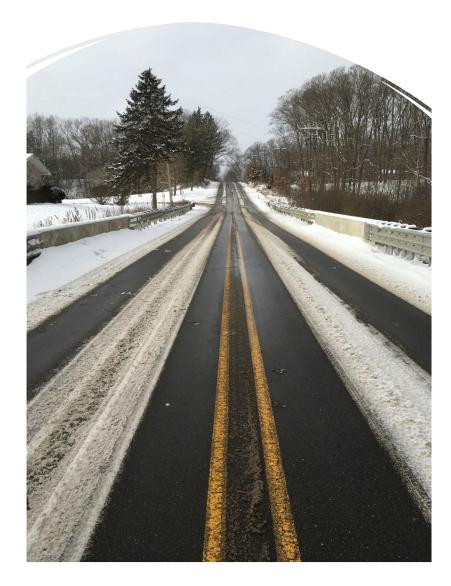
- West end of existing crossing involves short, steep approach slope
- Intense rains in summer 2021 led to major washouts and undermining of new pavement & guardrail
- While slopes were riprapped, there were no spillways, which had to be paved in when repairs were made

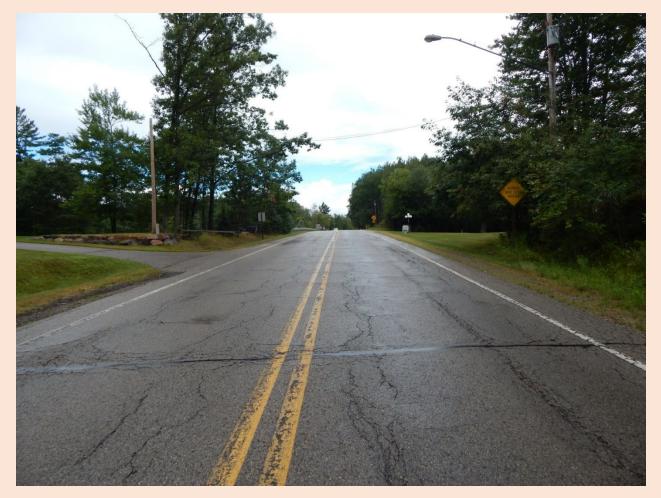
TYPICAL EXISTING CONDITIONS

- Its 2013. Pine Mountain Road has failed, cracking, rutting, pothole patches everywhere.
- It the Board's number 1 priority to rebuild this main truck route.

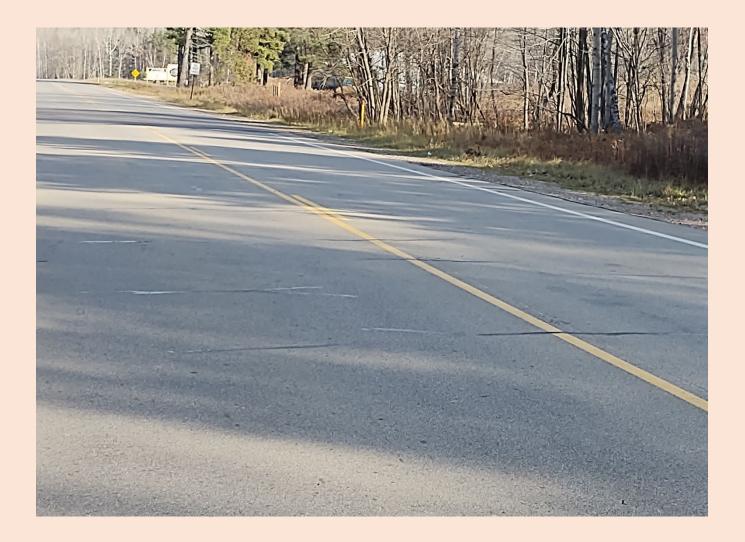
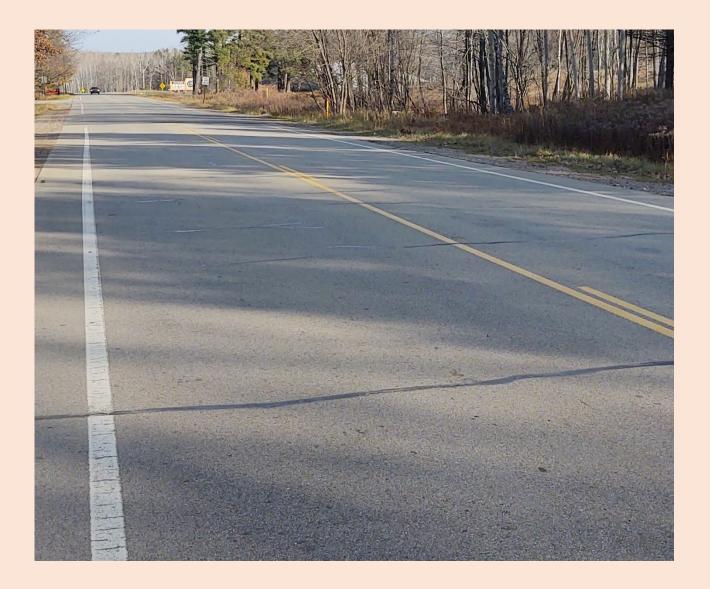
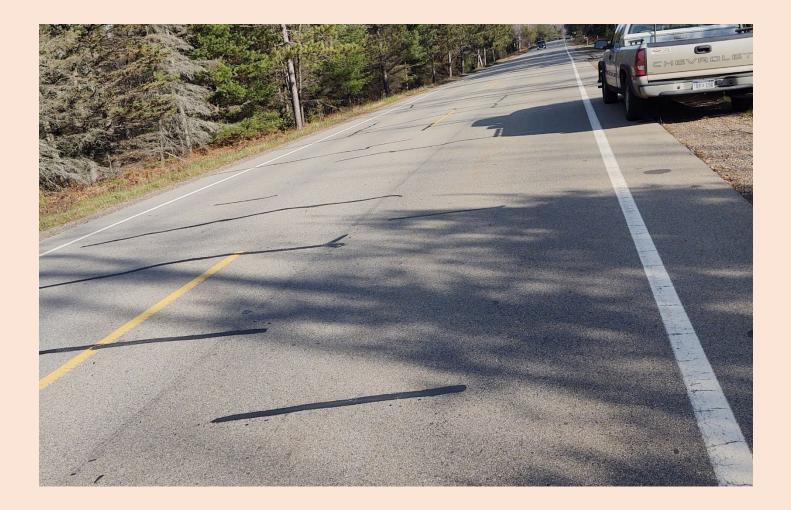
- Road not breaking up. Actually it was pretty good.
- No heaving or rutting
- Crowns and super elevations true
- Uniform spaced transverse cracks in areas.
 - ► Most road at about 110-120 ft
 - but 40-50 ft spacing in some areas
- Other random transverse cracks elsewhere in the project.

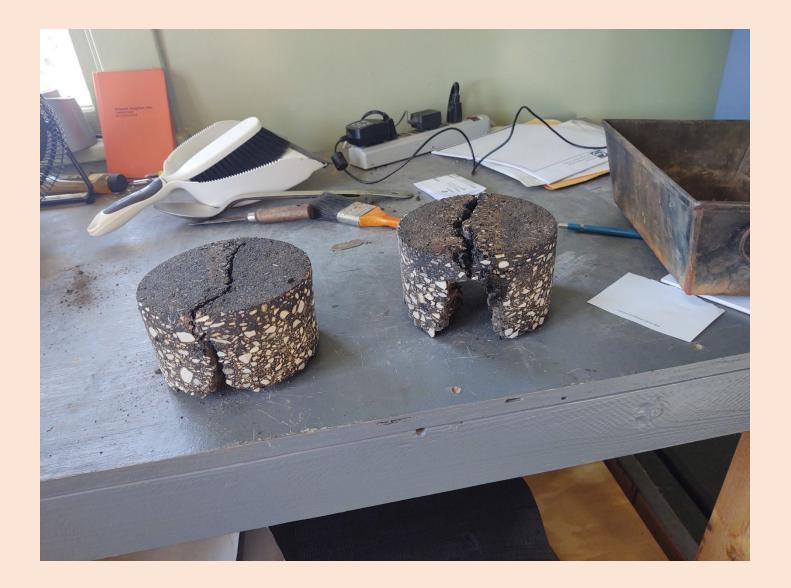
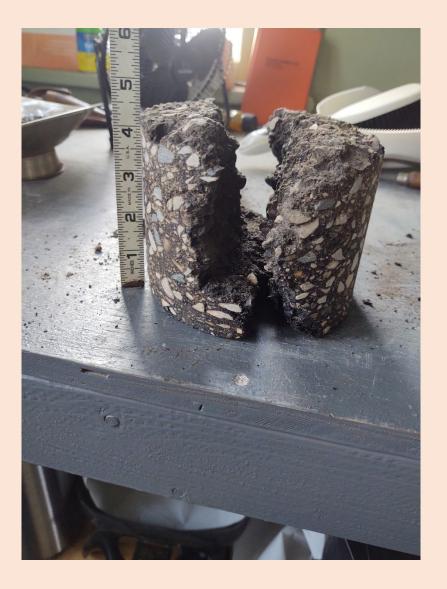
> Conducted pavement cores and soil boring in the affected areas

• Original soil borings showed 3 inch existing HMA, but really was much thicker in areas between some of the borings

- Closer soil borings
- Emulsions don't have PG. Use proper penetration / viscosity.
- Interview maintenance workers & old people who were there
