Raymond Road Bridge Rehabilitation

Calhoun County Road Department

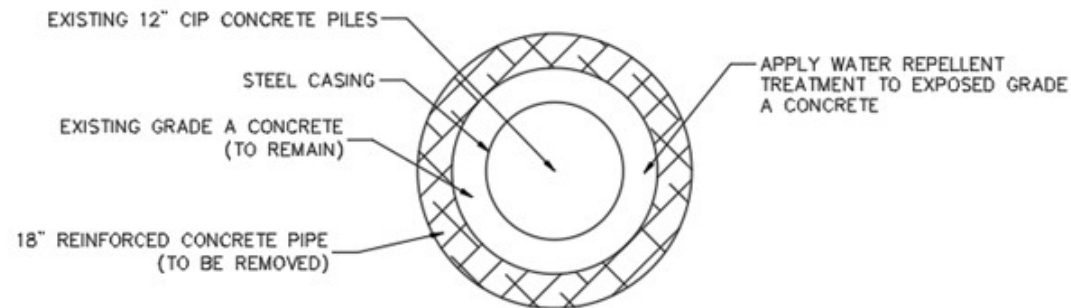
Assumed Column Design

- It was assumed that the columns were concrete piles, surrounded by steel casing, and Grade A concrete, and that the columns were enclosed in reinforced concrete pipe.
- The plans were to remove the concrete pipe, exposing the Grade A concrete.
- The Grade A concrete would then be finished with a water repellent treatment.

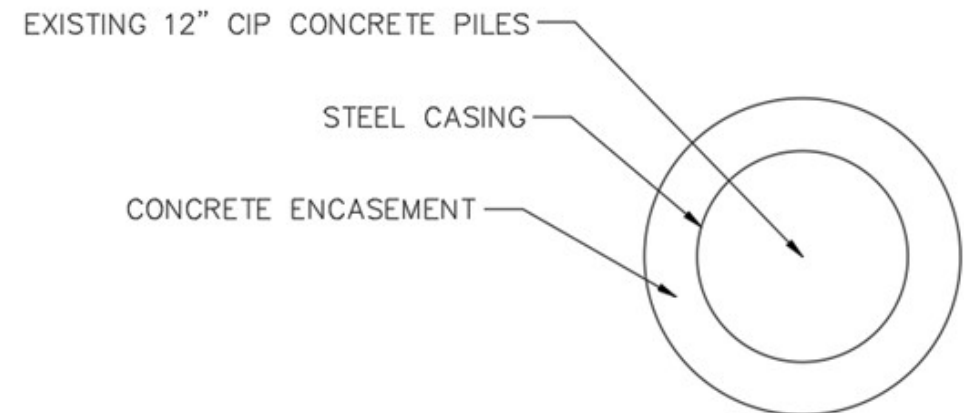
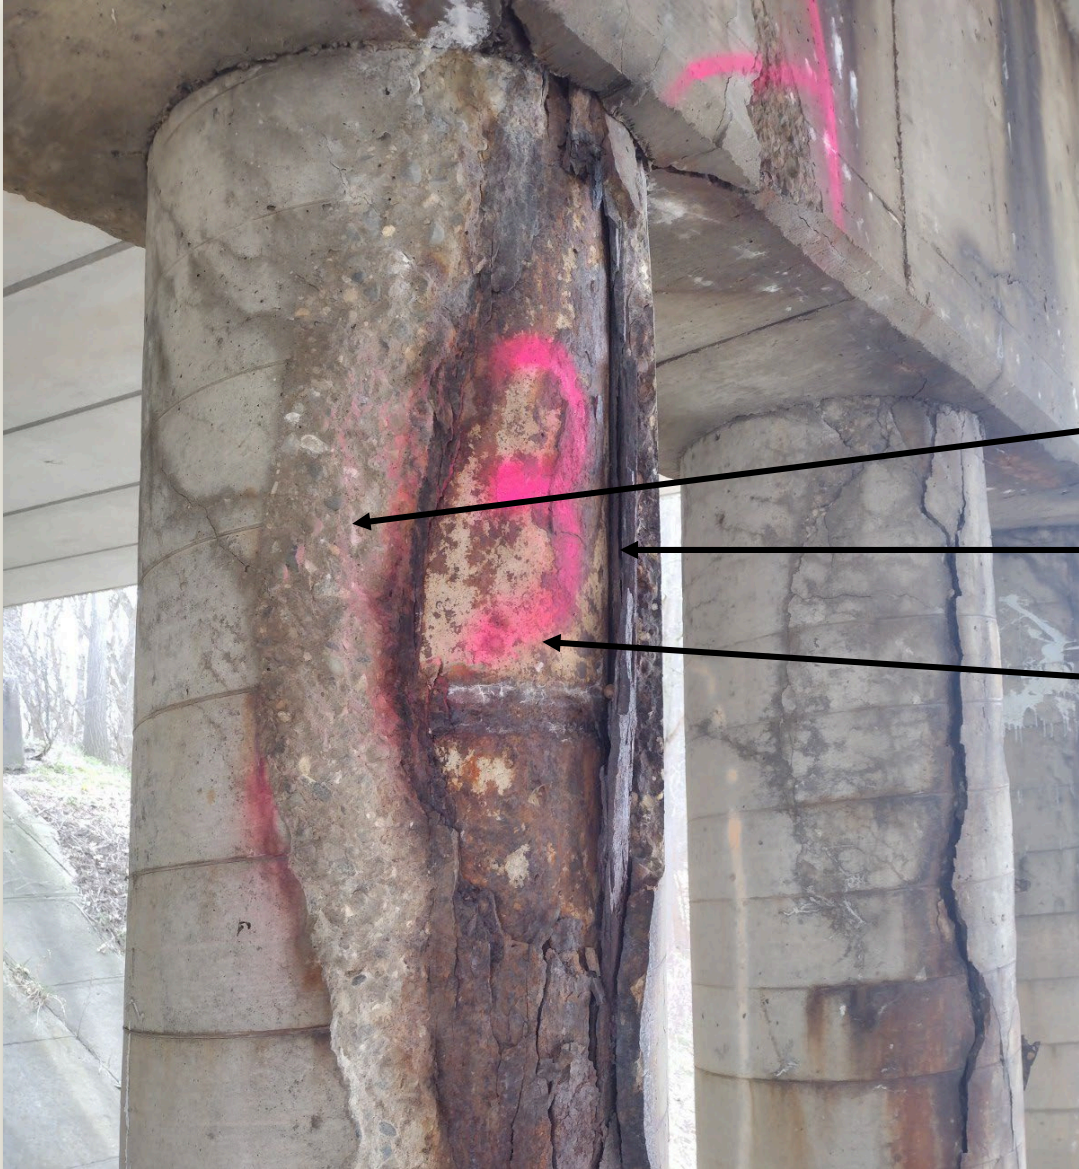
Actual Column Design

- Upon starting construction, it was discovered that design assumptions were incorrect.
- Failed exterior concrete was not RCP and there was only one layer of concrete outside of the steel casing.
- Some of the columns were too deteriorated to be rehabilitated and would need to be replaced.
- Forced to develop an alternative design

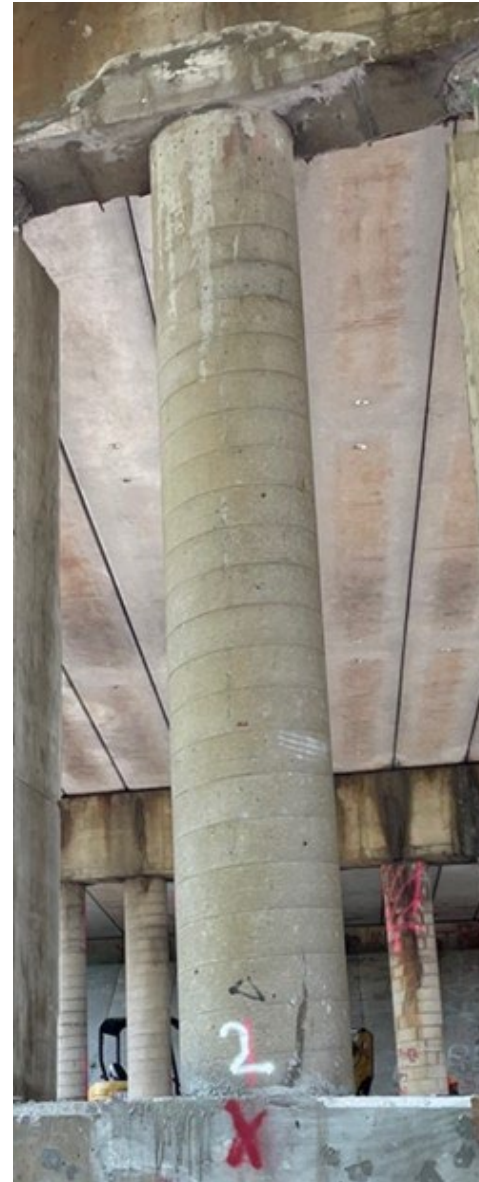
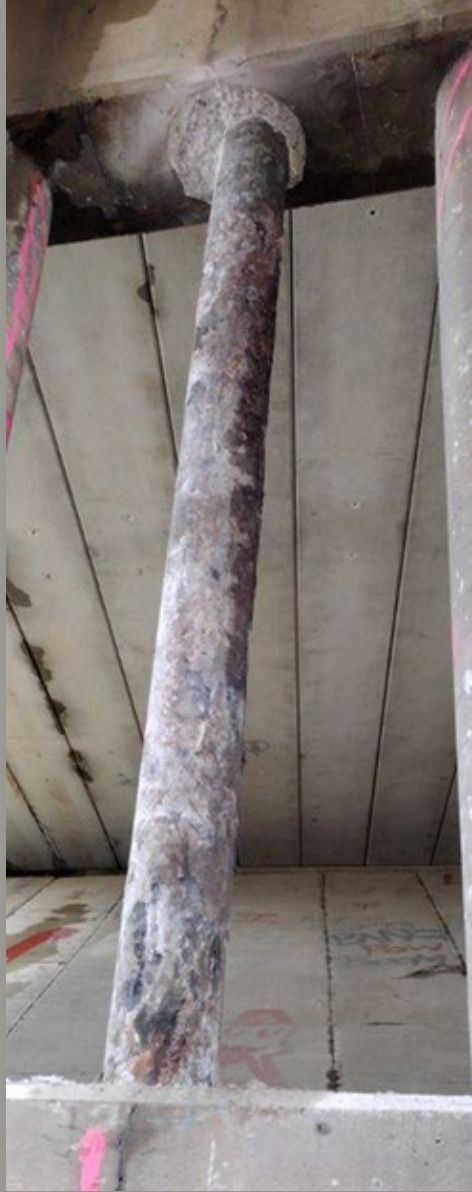
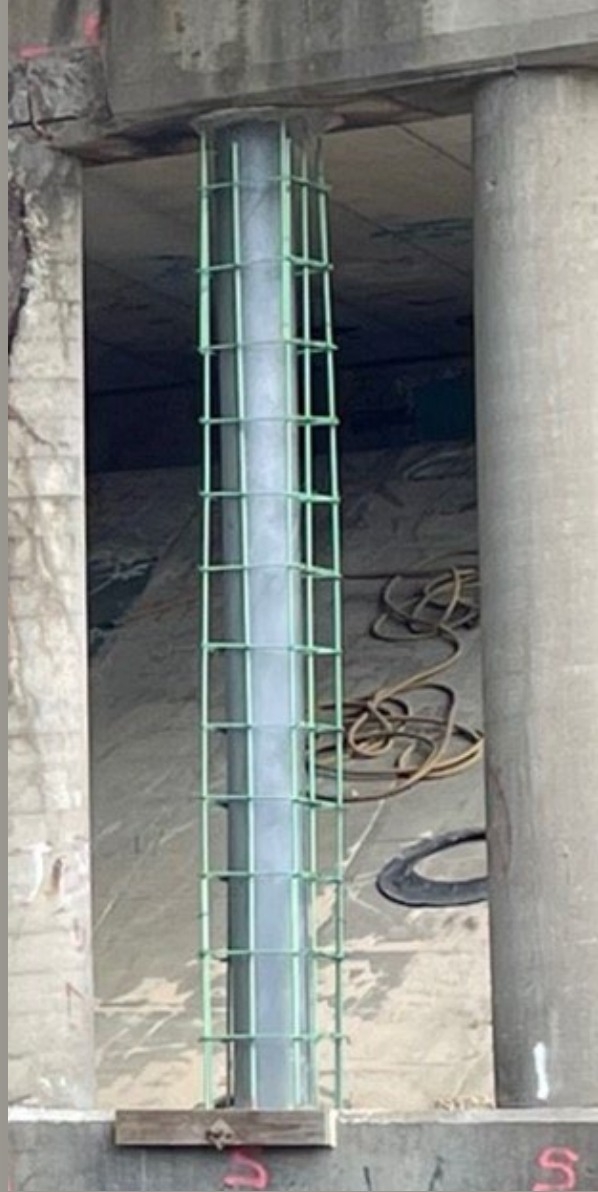
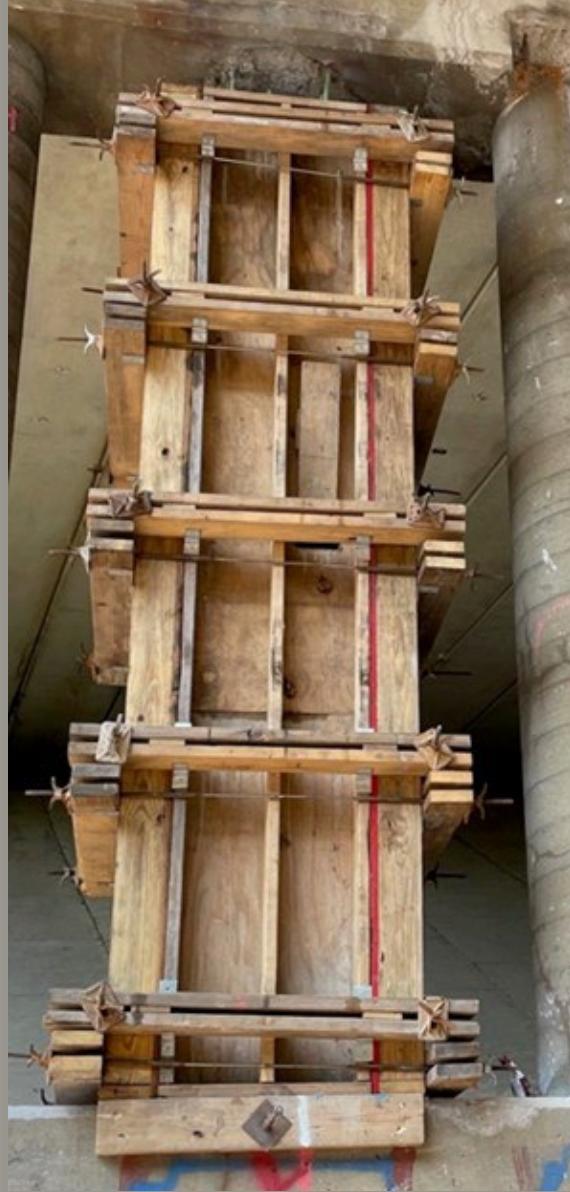
Substructure Redesign Case 1 – Rehab

Used for cases where the interior steel casing and concrete pile was sound enough to be rehabilitated

28 of 48 columns were rehabilitated

- Exterior concrete was removed
- Steel was blasted, cleaned, and coated
- Anchors installed in pier cap and crash wall
- Rebar cage tied to the anchors
- Form placed around rebar and concrete was poured

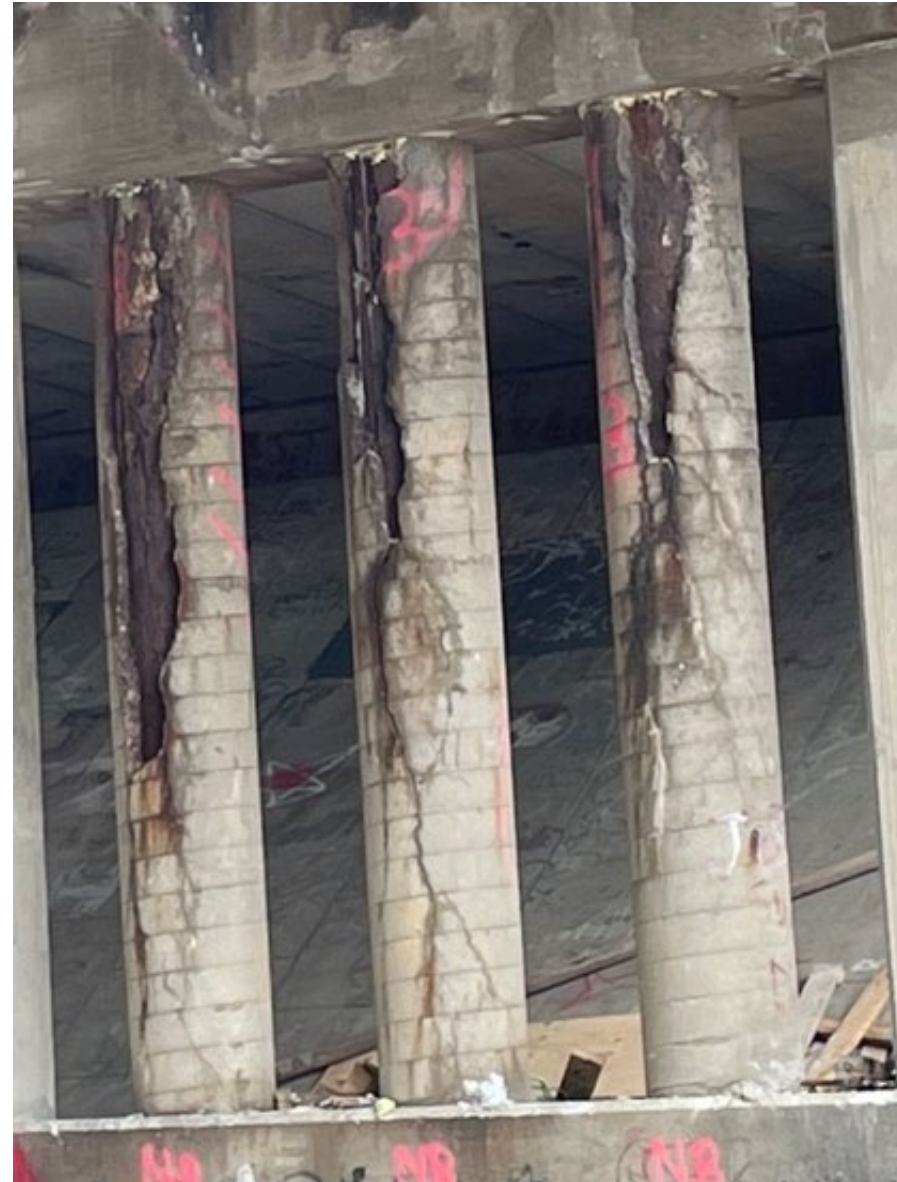
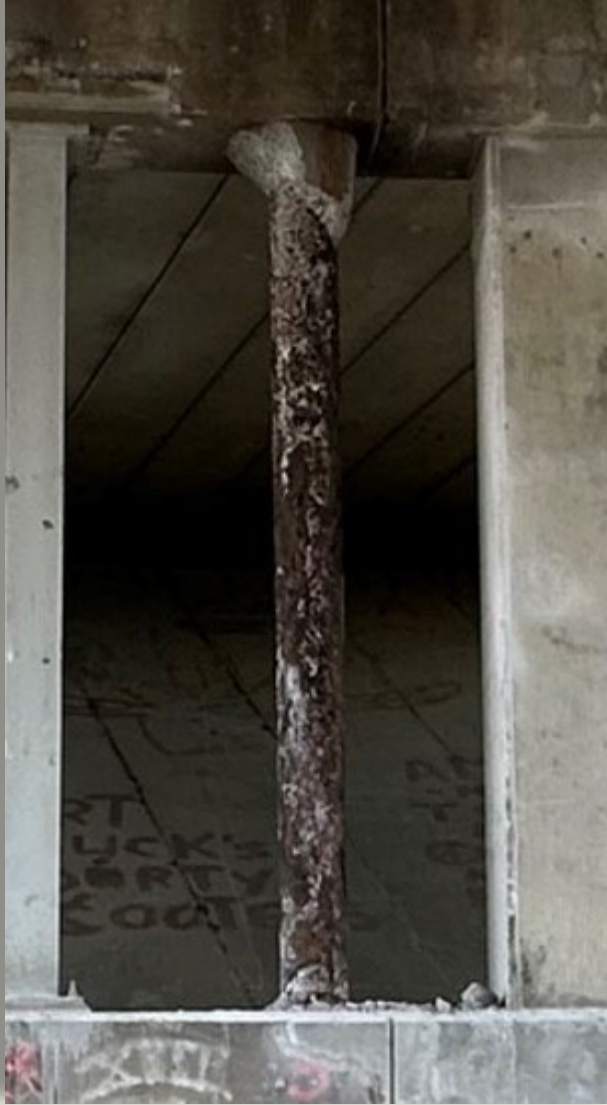
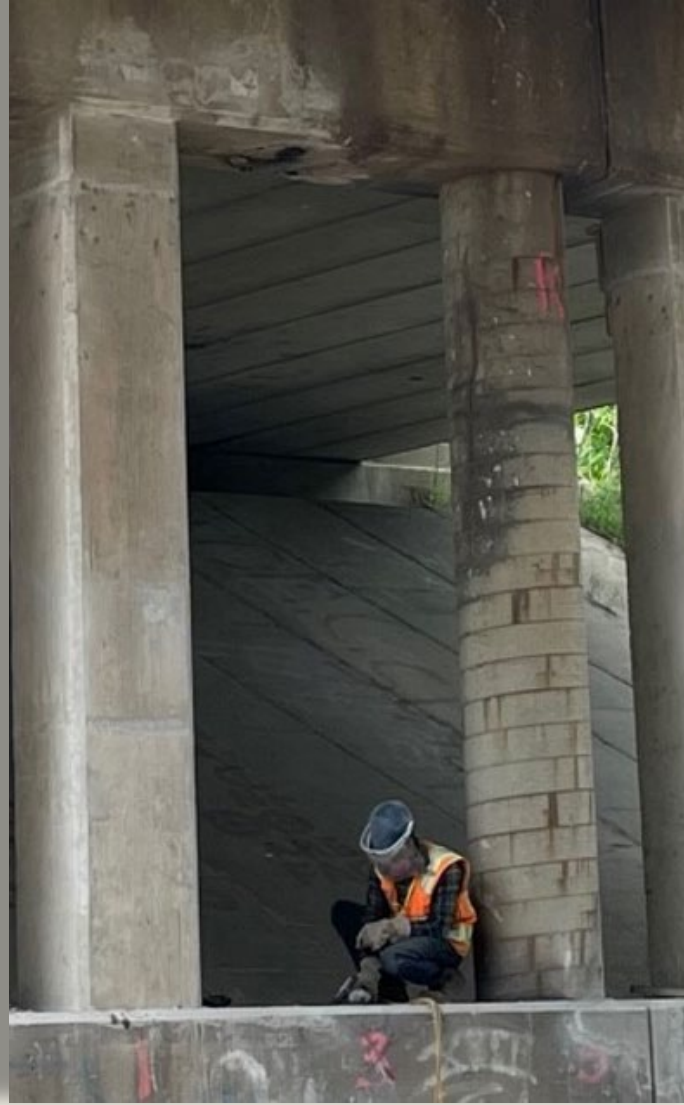
Substructure Redesign Case 2 – Replacement

Steel casing was too deteriorated to be cleaned and coated.

20 of 48 columns were replaced.

- Exterior concrete was chipped away
- Steel casing was cut, and the pile was removed
