# Culvert Assessment Program

Clinton County Road Commission  
County Engineers Workshop 2026

**Date:** May 30, 2025  
**To:** Marc Trotter – Clinton County Road Commission (CCRC)  
**From:** Kyle Patrick P.E. – Land & Resource Engineering (LRE)  
**Re:** Clinton County Culvert Assessments – Bengal Township

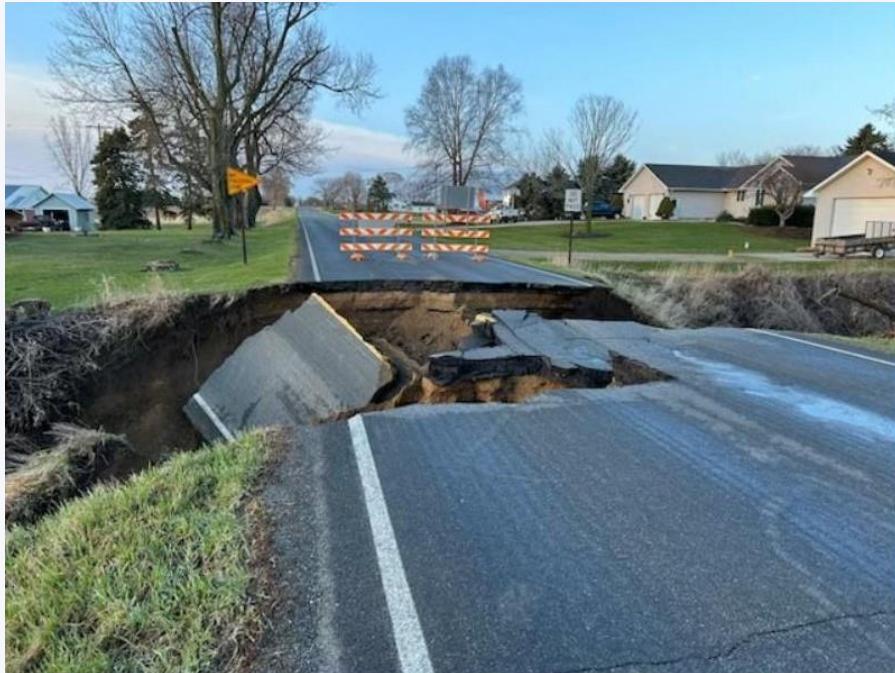
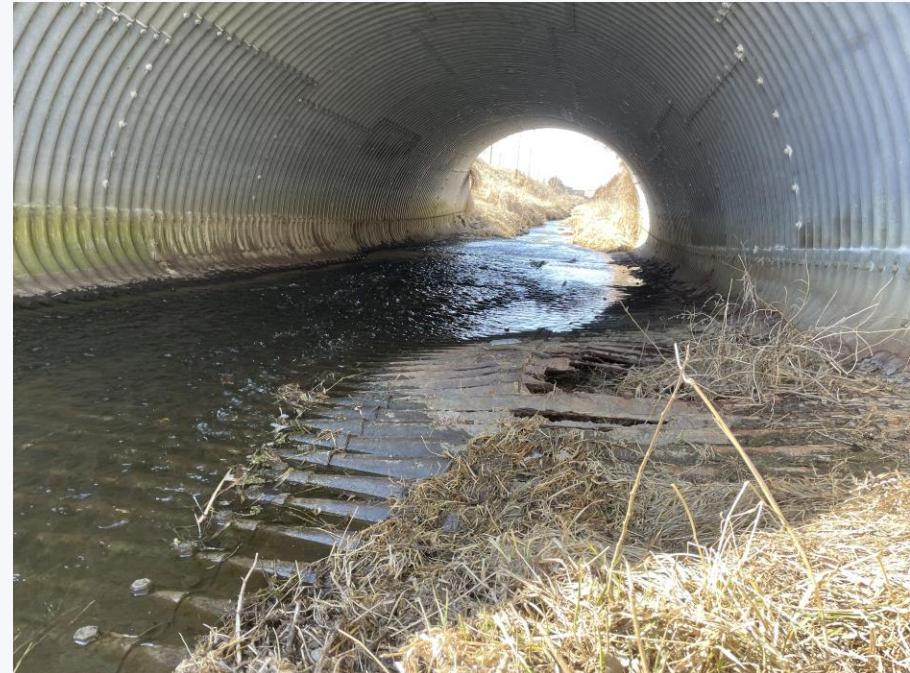
# Unexpected culvert failures exposed a gap in planning

- Three large CMP culverts closed in 2023
- No warning to townships; no time to budget
- Questions raised:
  - What else is approaching failure?
  - How can we avoid reactive closures?

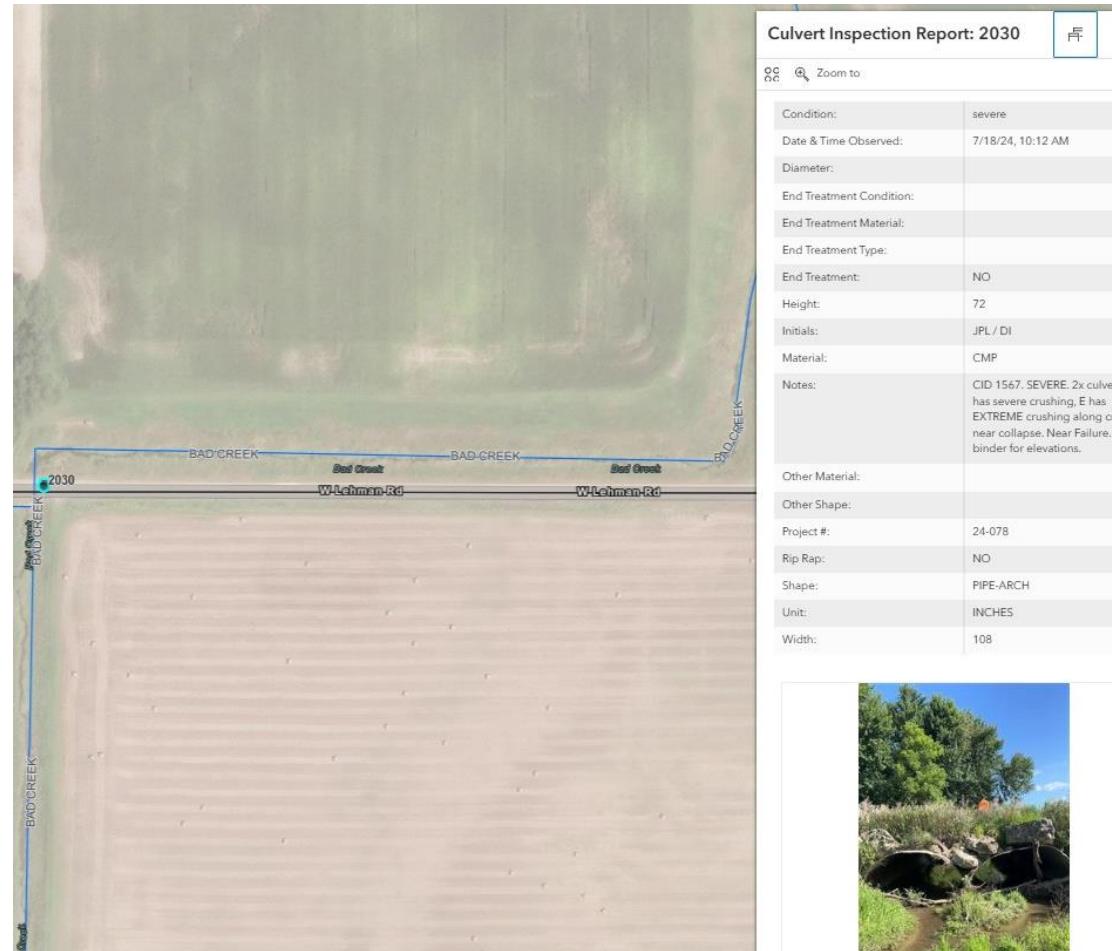
# Inventory data prevented unnecessary closure on Lehman Road

- Historical photos confirmed stability
- Reduced load; road remained open
- Decision support using inventory

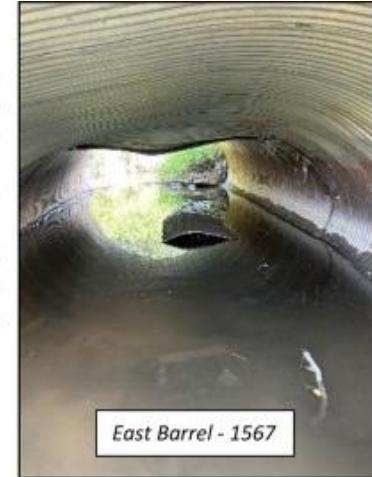
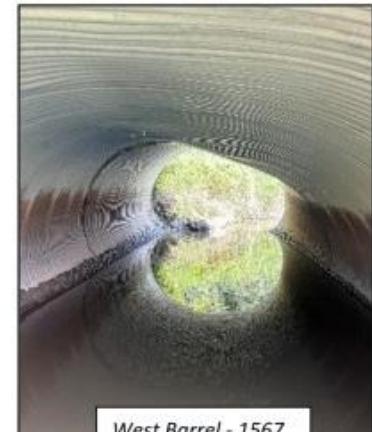
## (1567) Bad Creek and W. Lehman Road Crossing

The Bad Creek flows from south to north before crossing W. Lehman Road via a double culvert with heights of 72 inches and widths of 108 inches. Both culverts are in poor condition due to the severe joint separation and deflection upwards of 2 feet. The east barrel is experiencing crushing from the top and buckling along the invert. This failure is causing large amounts of infiltration and base material exposed, resulting in a culvert rating of severe. The west barrel also has severe crushing with high stress on joints and a small amount of separation in the middle. There is little corrosion, some localized pitting and general rust. Both culverts are near failure and should be replaced.

- Full-Replacement

- \$275,000 (see attached)

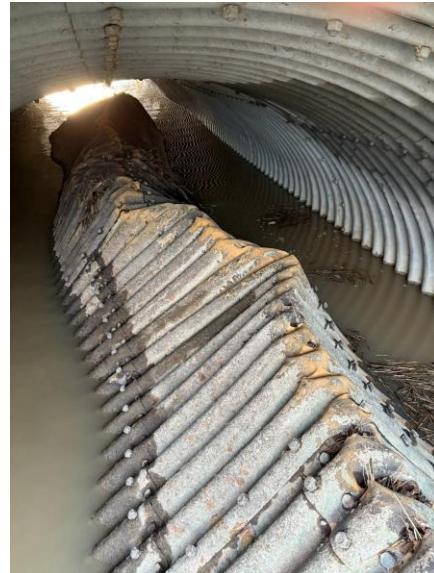
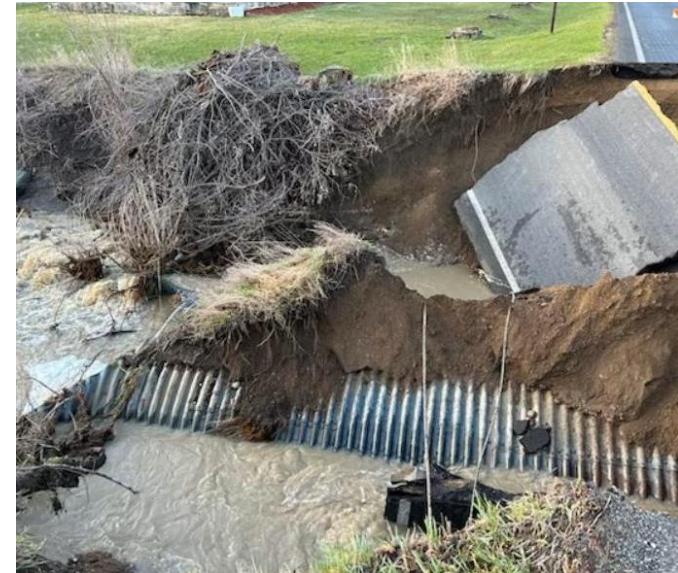
# Grange Road responded faster because inventory data already existed

- Emergency washout; replaced in 60 days
- Inventory enabled immediate design basis

4/3/25 – Culvert washed out during rainstorm

4/5/25 – Sizing confirmed & requested material quotes

5/12/25 – CMP replacement delivered

6/1/25 – Road open to traffic
