A TALE OF TWO BRIDGES

Au Train Bridge

**PROPOSED AU TRAIN
BRIDGE REHABILITATION**
MDNR - DTMB
ALGER COUNTY, MICHIGAN

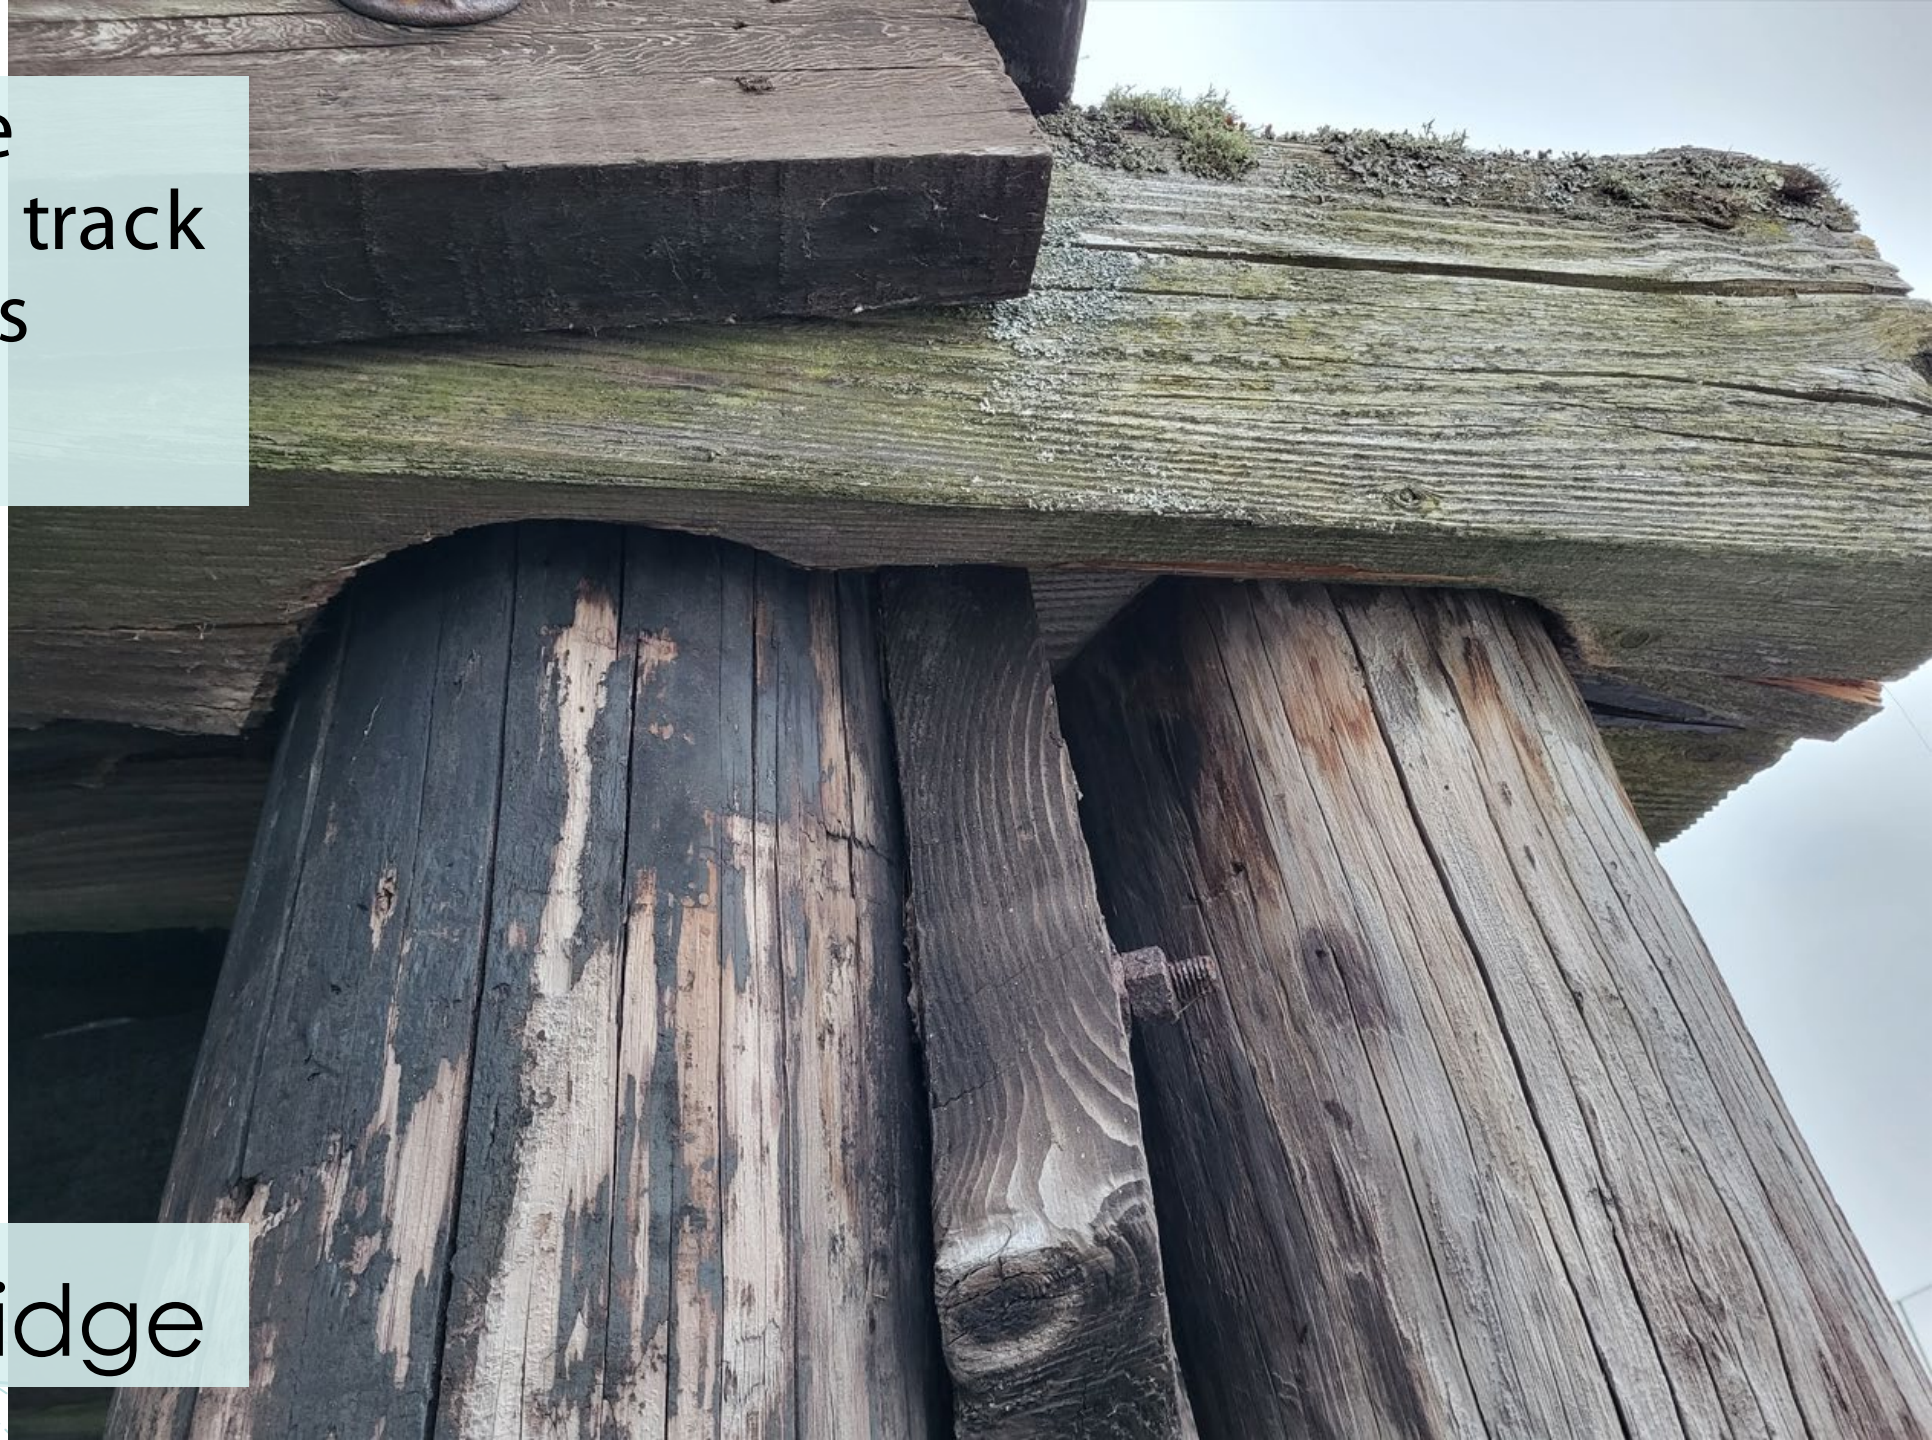
Au Train Bridge

No noticeable distress at the track level up to this point.

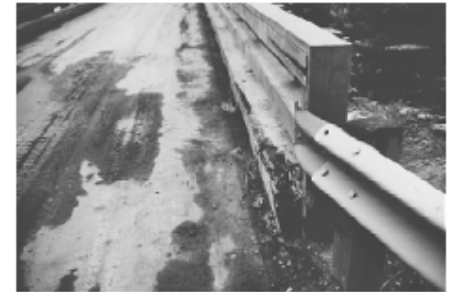
Figure 27—Vehicle damage to curb and rail system observed during a site visit near the end of the monitoring period.

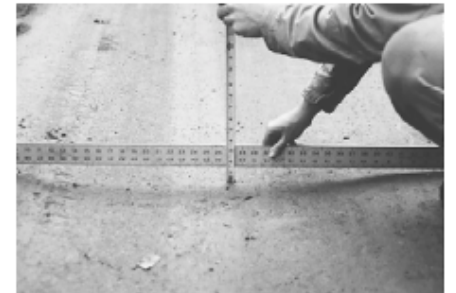
Figure 28—Rutting of asphalt wearing surface measured at the center span during a site visit for load test 2.

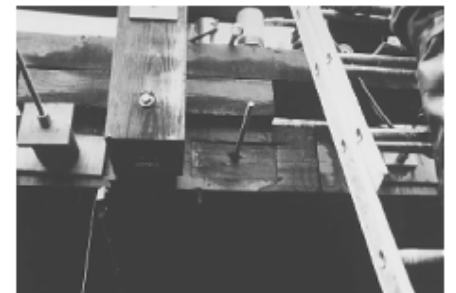
Figure 29—Visible crushing of approach span, Eastern Hemlock lumber lamination, observed after the removal of the bearing plate at the final site visit.
