Using UAV Collected Bridge Condition Data for a Rating Exercise

Intro to UAV-enabled methods to collect & process bridge condition data

Michigan Bridge Conference, 3/21/2017

Routine Surface Visual Inspection of a Bridge Deck Exercise

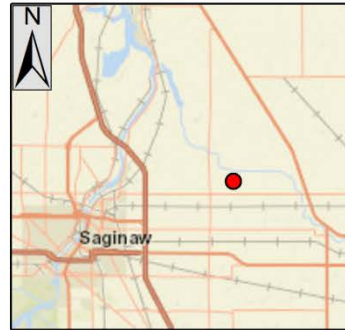
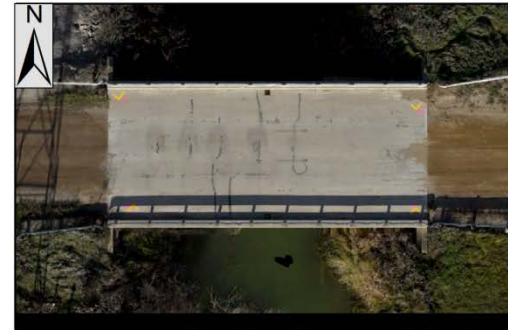
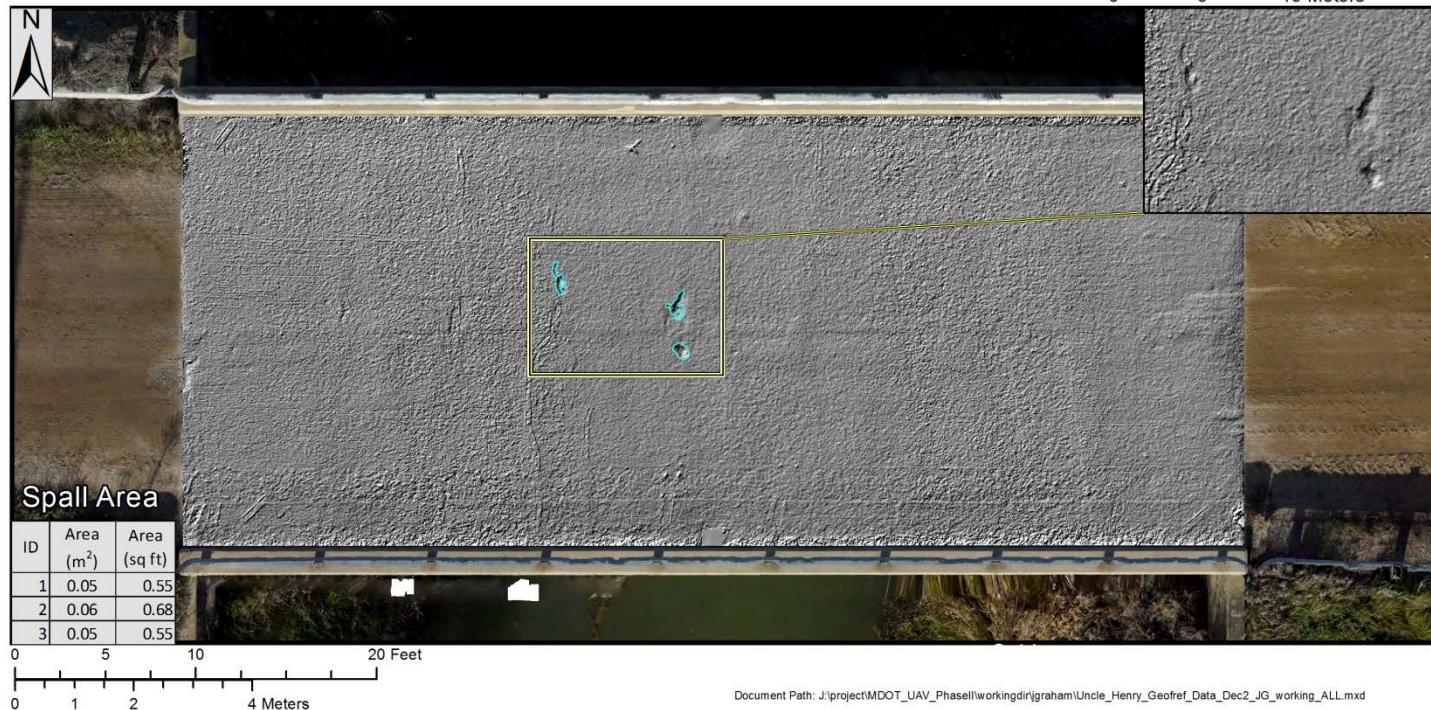
UAV Data
Uncle Henry Rd Bridge
Hillshade Relief
Application Detected Spalls
STR#9289 Saginaw, MI

Uncle Henry Rd Detected Spalls

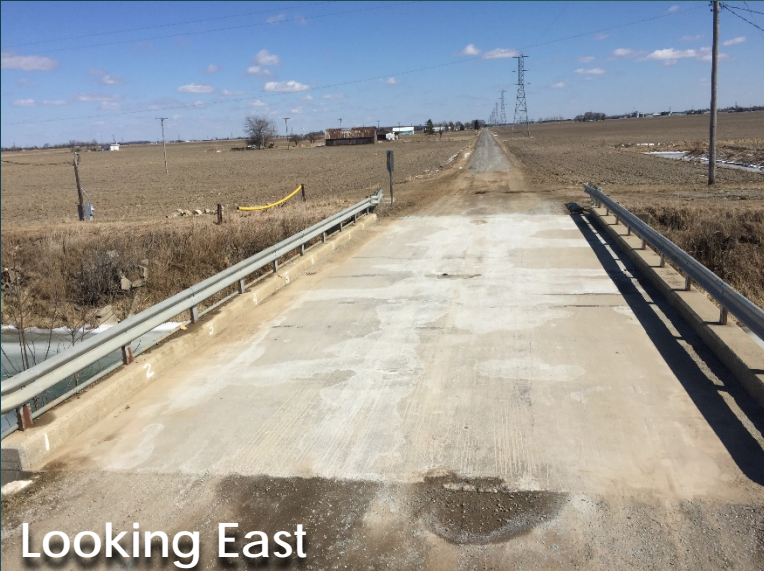
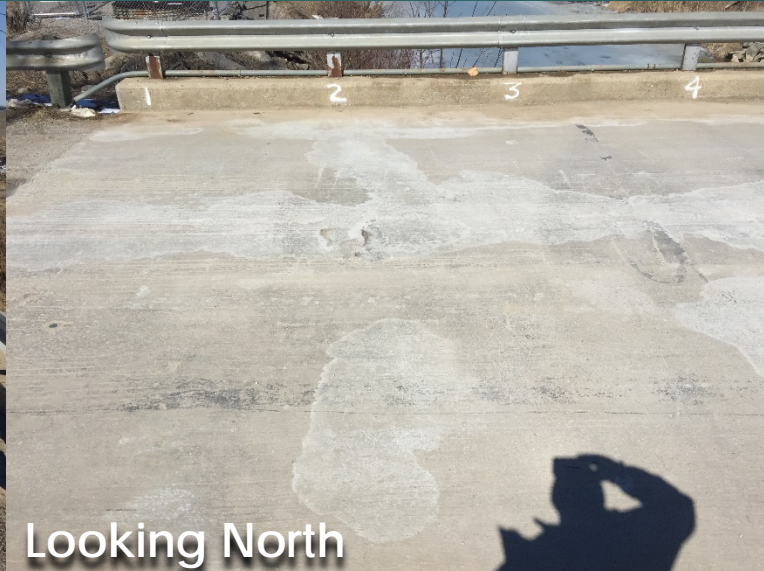
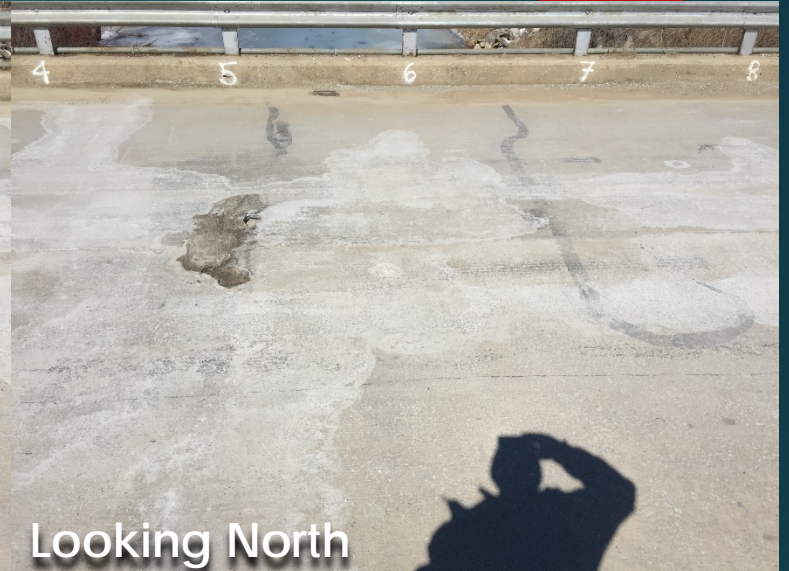
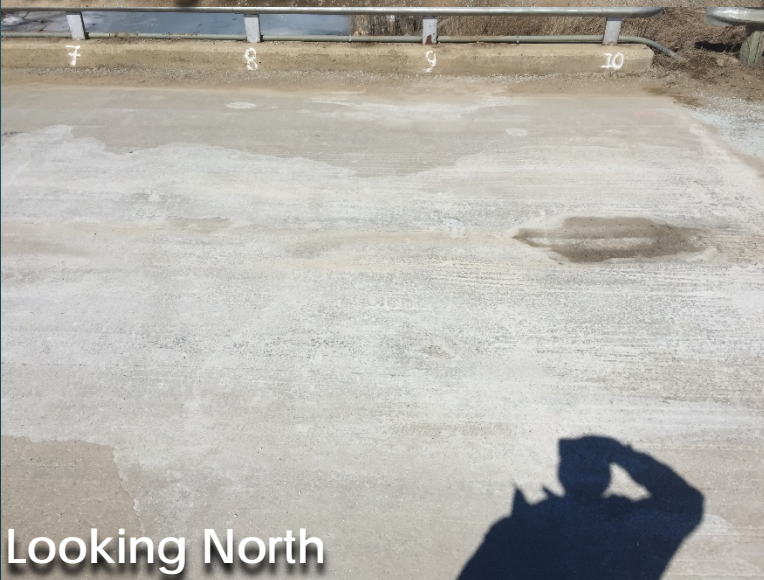
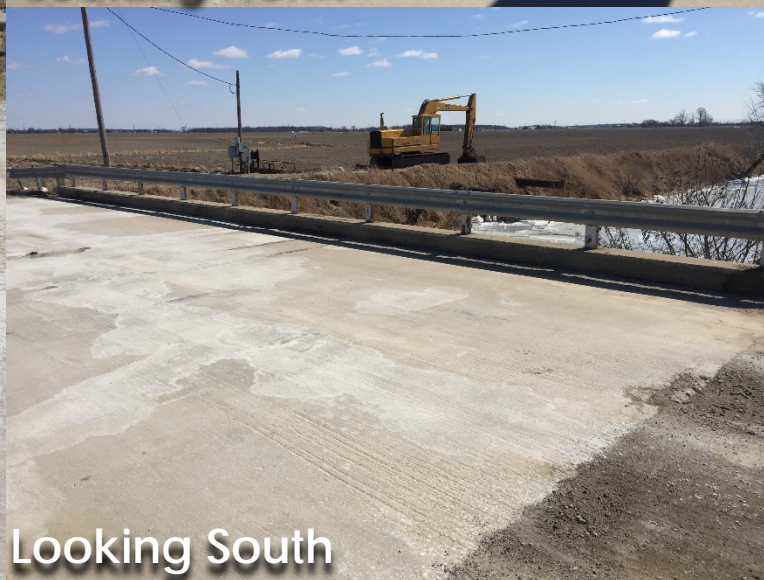
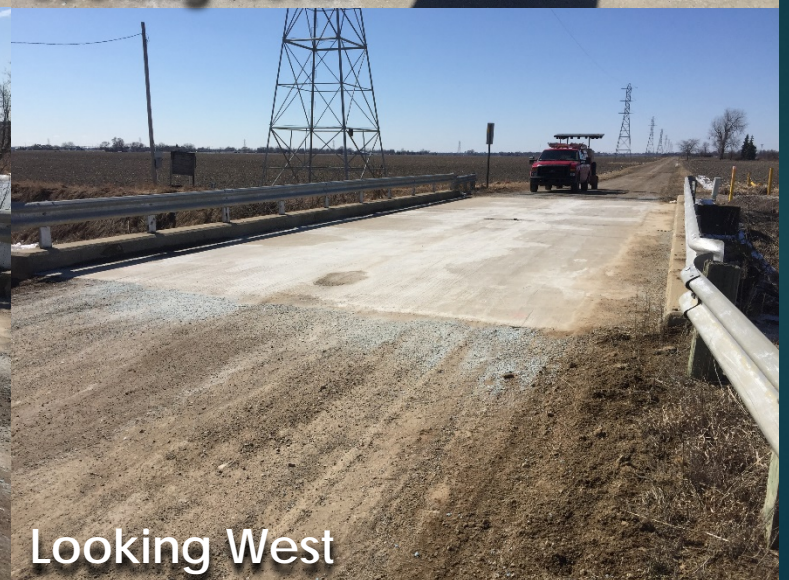
► Photos of Bridge

Concrete deck has scattered gravel. There is approximately 12 sft of spalls in 5 locations and approximately 15 sft of delamination in 5 locations. Largest spall at midspan centerline. Block cracking in the southeast corner in a 6'x6' area. Moderate map cracking in south lane. There are 6 transverse half width cracks. There is a monument in the deck near west abutment. There is debris along brush blocks. (10/16)

Roughly 4% of the deck has spalls, delaminations and heavy block cracking.

Moderate map cracking in left lane. Moderate crack thickness ranges from 0.012 to 0.05 inches.

5

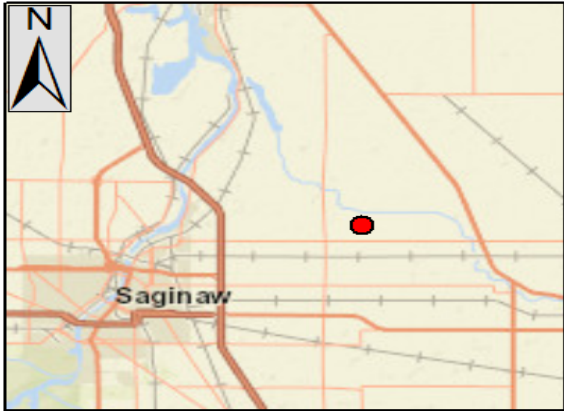
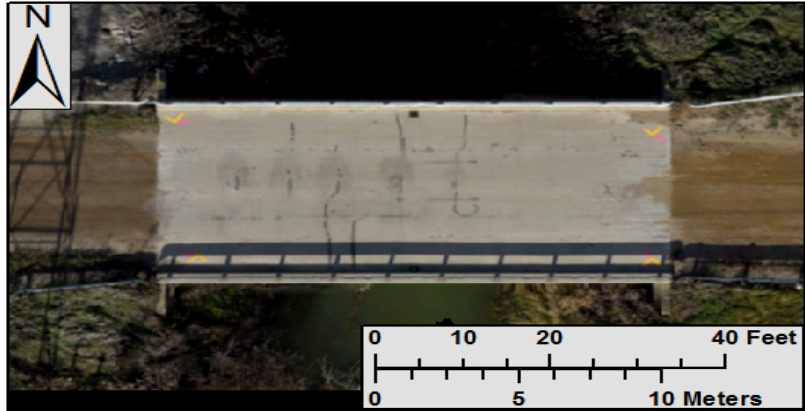
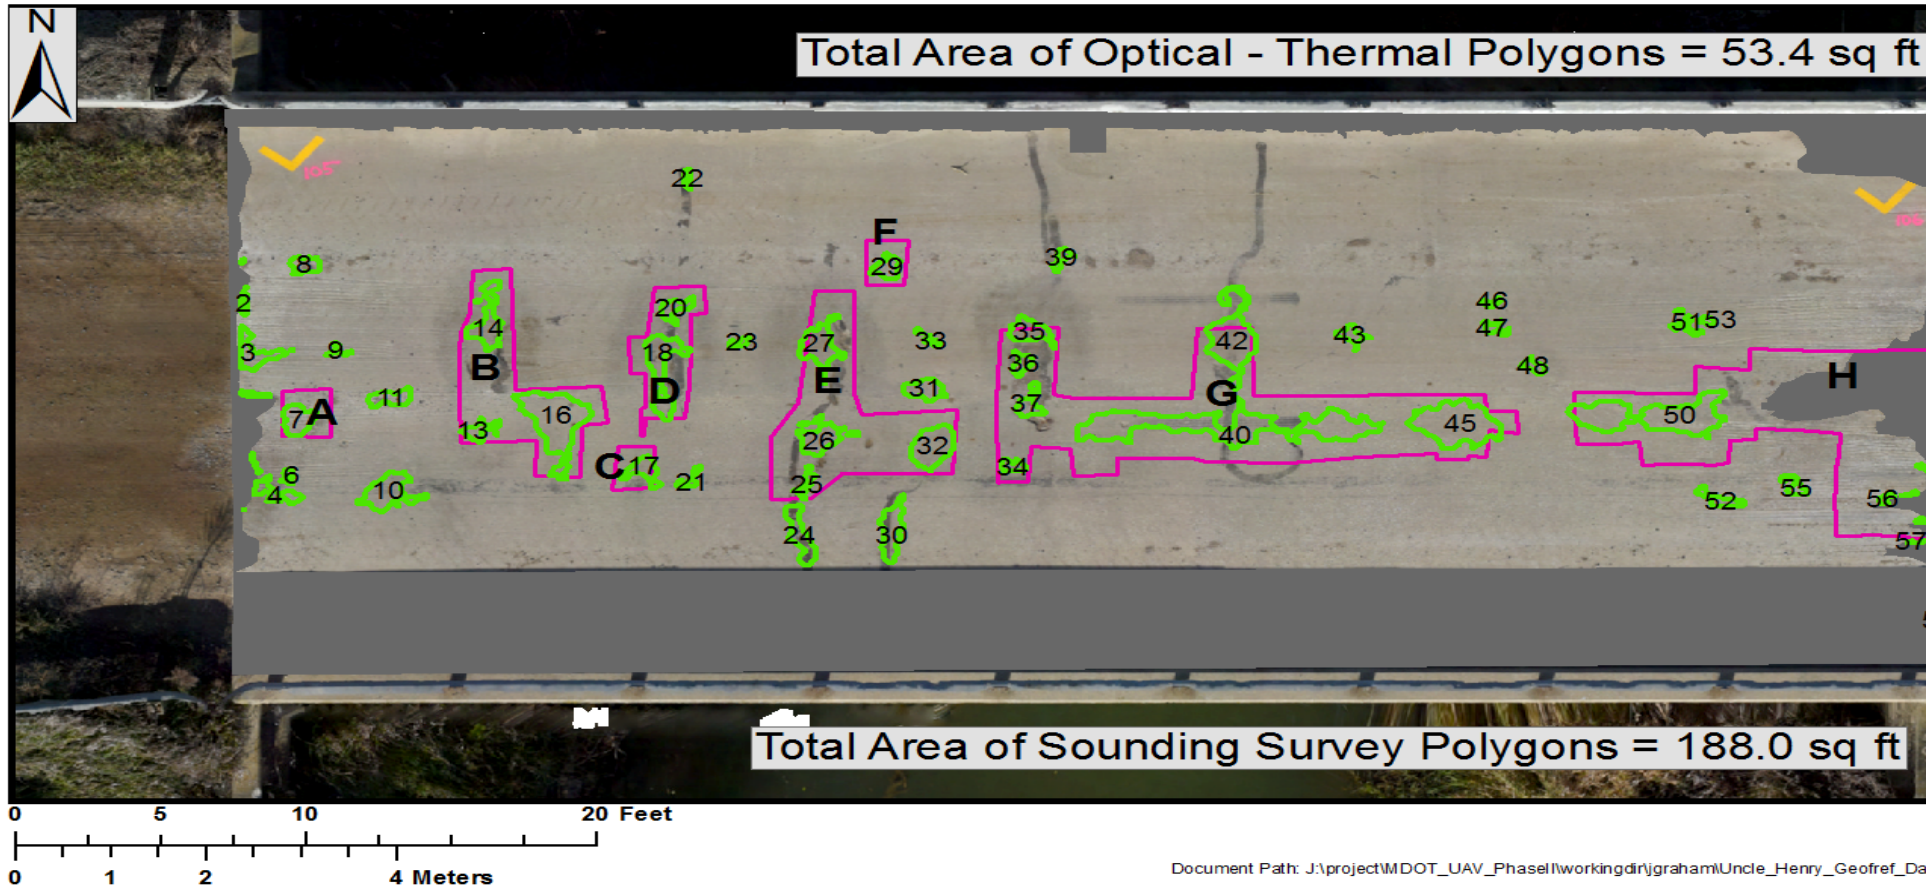
UAV Data Uncle Henry Rd Bridge Sounding Survey 12/30/16 Thermal - Optical Algorithm Derived Delaminations STR#9289 Saginaw, MI

Results show 188 sft of delamination and spalls.

Roughly 12+% of the deck surface has spalls, delaminations and heavy block cracking.

UAV determined that there was 188 sft of delaminations (included in the 12+%)

4-POOR

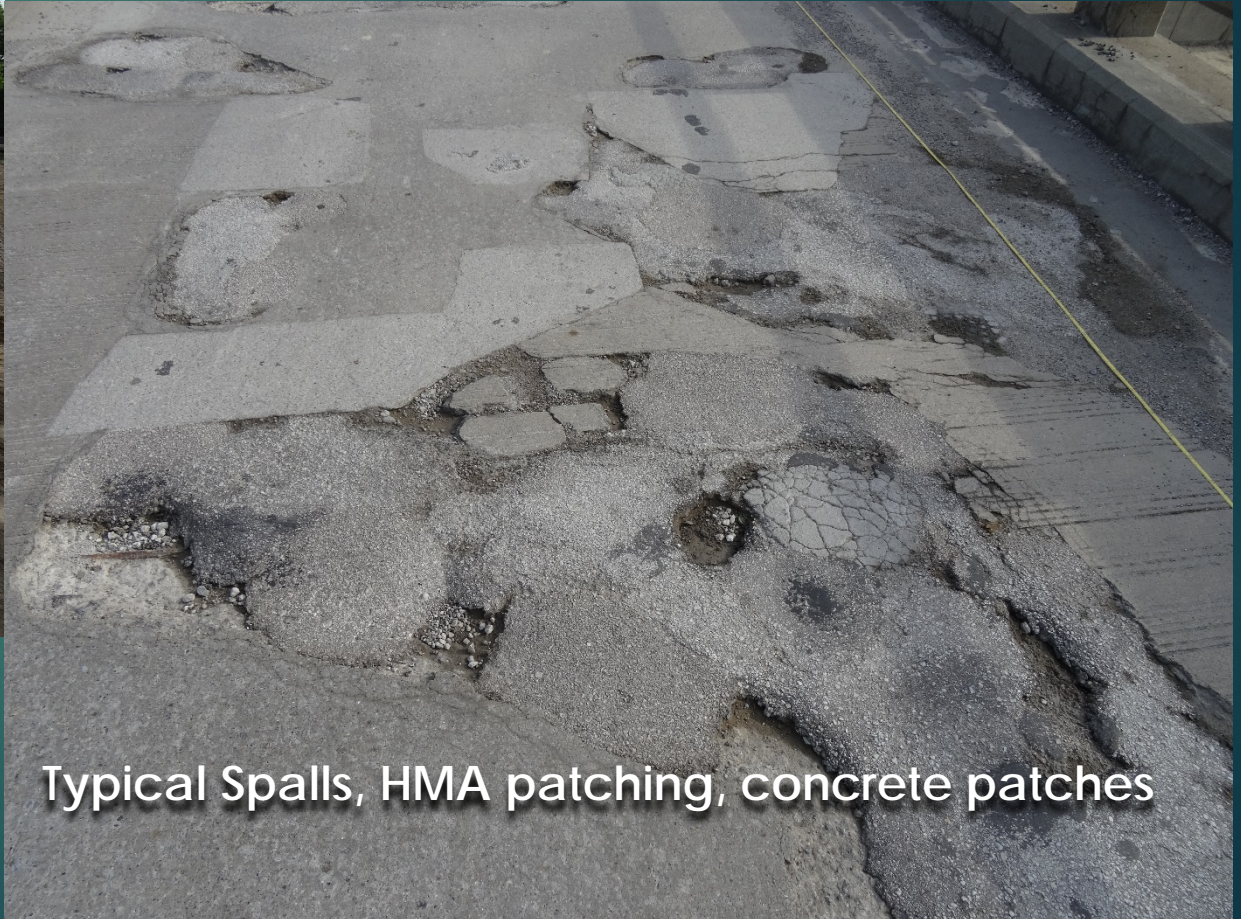
Typical Spalls, HMA patching, concrete patches

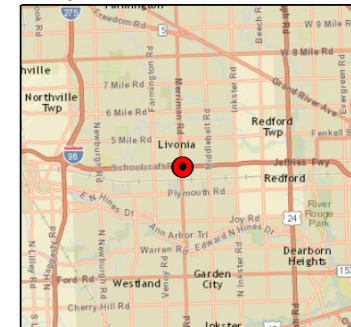
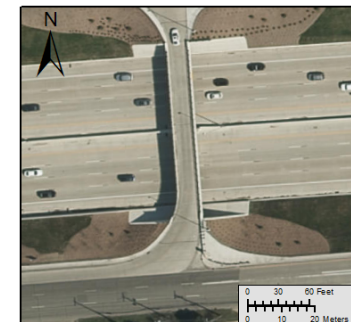
UAV Data
Merriman Rd East Bridge
Thermal-Optical Algorithm
Derived Delaminations
Application Detected Spalls
STR# 11516

Total Detected Spall
Polygon Area = 150.44 sq ft
Total Area of Optical - Thermal
Polygons = 92.79 sq ft

Inspection notes noted numerous open spalls, bit filled spalls, and concrete patches throughout the entire deck. Most concrete patches were in good condition.

UAV detected 243 sft of delamination and spalls

Roughly 6+% of the deck surface has spalls, delaminations, from UAV data

Deficiencies could not be picked up in the shaded areas

4-POOR
