# Anatomy of a Bridge Deck Rehabilitation

The restoration of the CR 581 bridges  
in Dickinson County

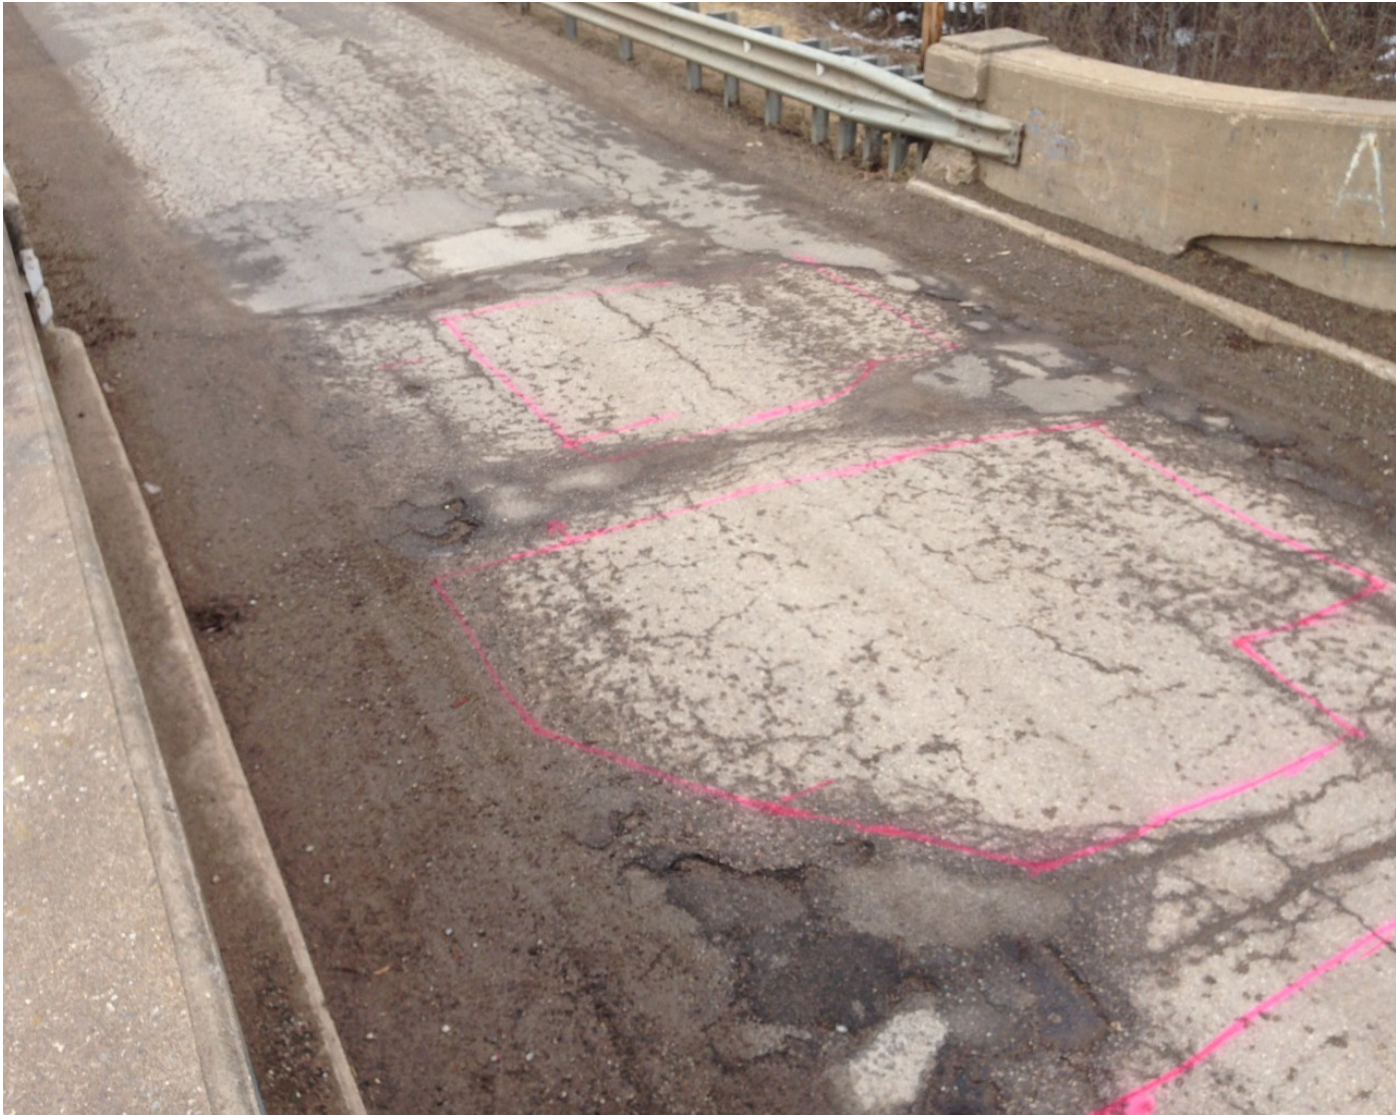
# After Chain Drag

- Field Work
  - CHAIN DRAG
    - Method used to determine limits of deck delamination
    - Heavy steel chain pulled by hand across bridge deck surface longitudinally and transversely
    - Hollow sound indicates delamination
    - High pitched “pingy” sound indicates solid condition
    - Areas measured and recorded
  - HAMMER SOUNDING
    - Used around deck drains and areas with excess dirt

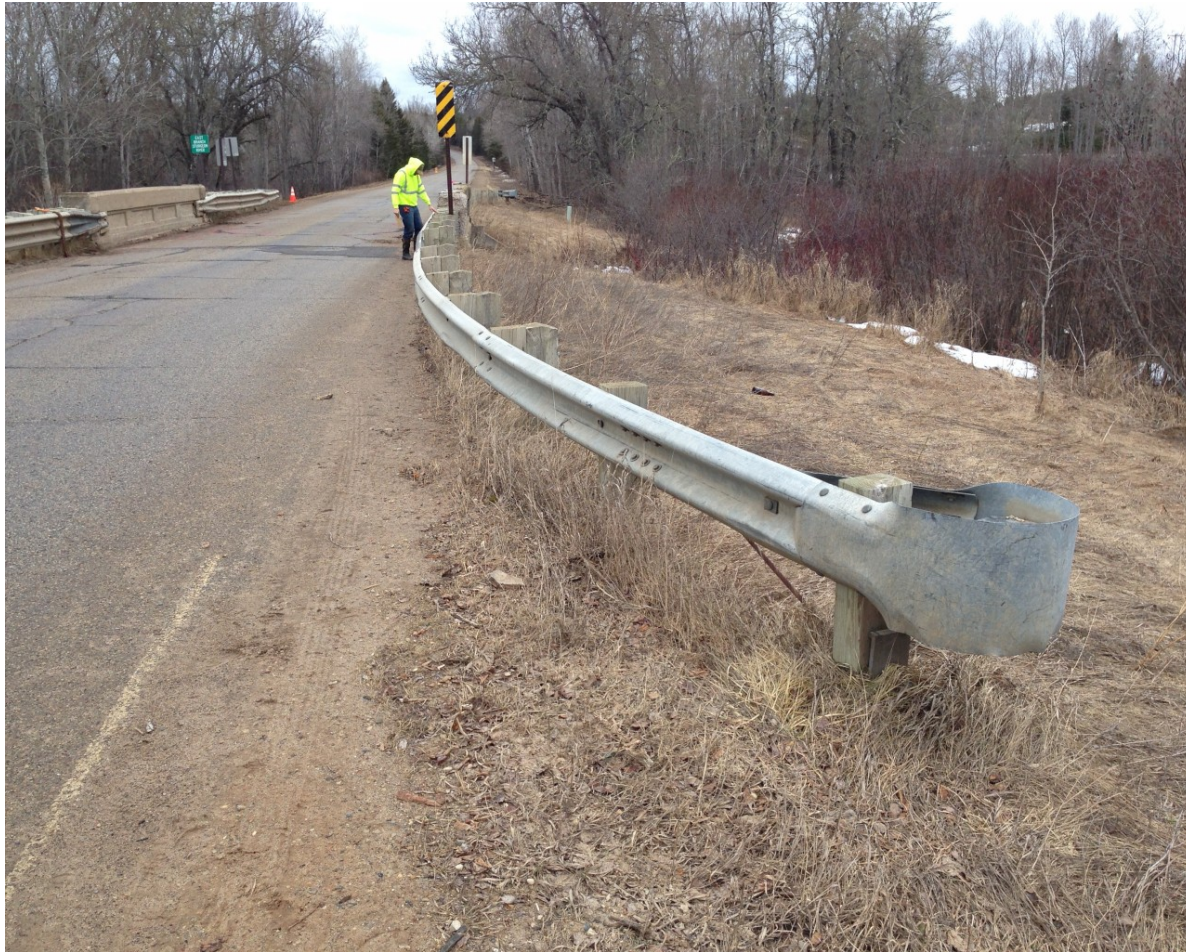
# Substandard Guardrail Terminal

(not SRT or EAT, but good side slopes)

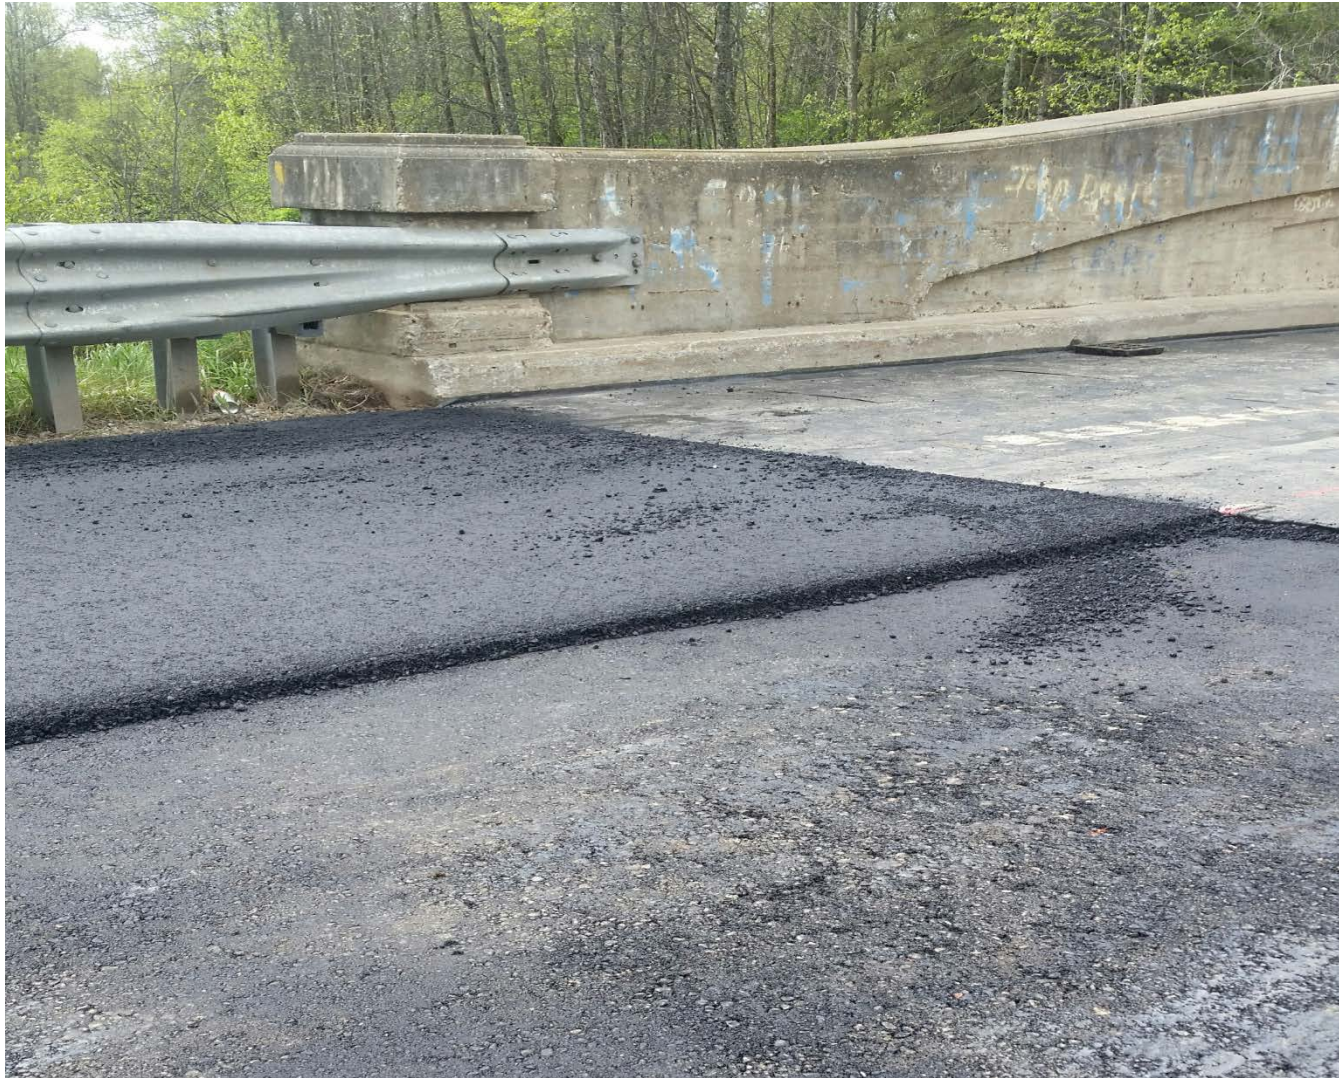
- Bid Price: \$141,778
- Actual Price: \$134,353
- Overruns in HMA since approaches had 9" of asphalt
- Decrease in patching and forming costs

# Repair Approaches
