2023 Highway Maintenance Conference

Bridge Maintenance

Superior Region

Phase 1 – Timber Repairs

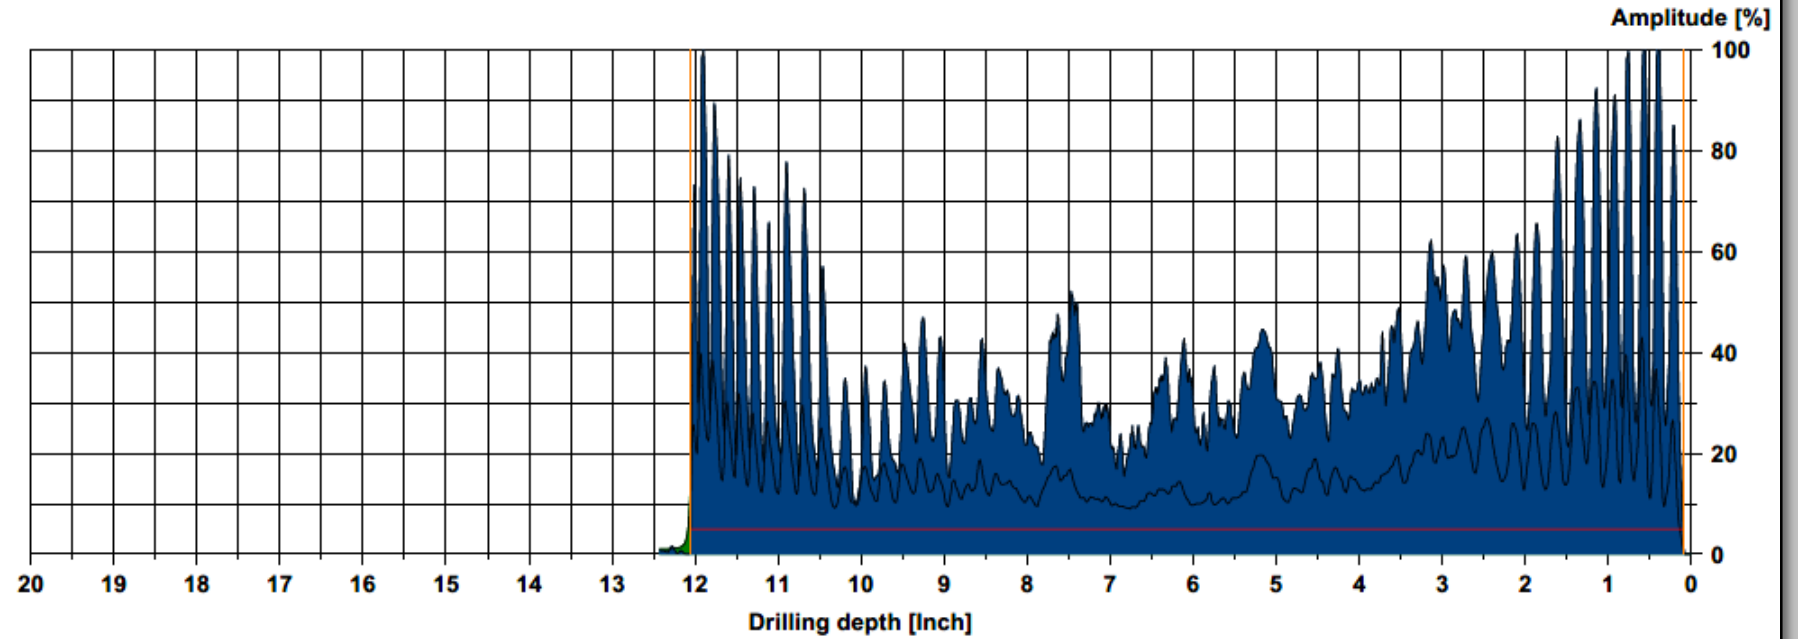
PIER2W P7S MID

Measurement no. :	29	Needle speed :	3000 r/min	Diameter :	
ID number :	3398	Needle state :	---	Level :	
Drilling depth :	12.425 "	Tilt :	0°	Direction :	West
Date :	14.09.2021	Offset :	115/290	Species :	
Time :	10:21:49	Avg. curve :	off	Location :	Pier 2 West
Feed speed :	40 "/min			Name :	Pile 7 South

Program :	Standard
Mode :	Full piercing
Start / stop :	0.098 " / 12.055 "
Effective length :	11.957 "
Cavity detection :	0.000 " / 0%

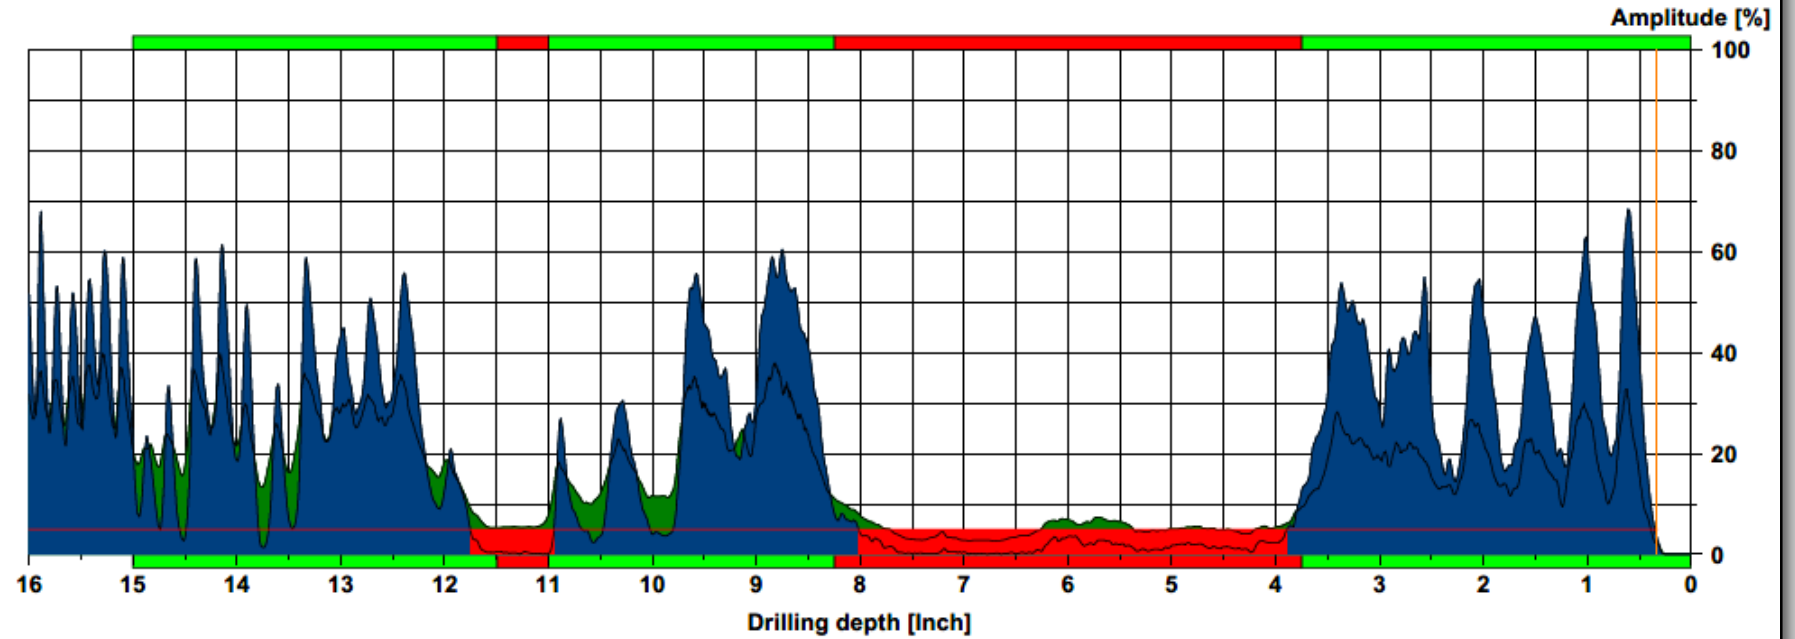
PIER1 P11N

Program :	Standard
Mode :	Full piercing
Start / stop :	0.327 " / 16.996 "
Effective length :	16.669 "
Cavity detection :	4.933 " / 30%

From 0.00 " to 3.75 " :	No Rot
From 3.75 " to 8.25 " :	Rot
From 8.25 " to 11.00 " :	No Rot
From 11.00 " to 11.50 " :	Rot
From 11.50 " to 15.00 " :	No Rot
From 0.00 " to 0.00 " :

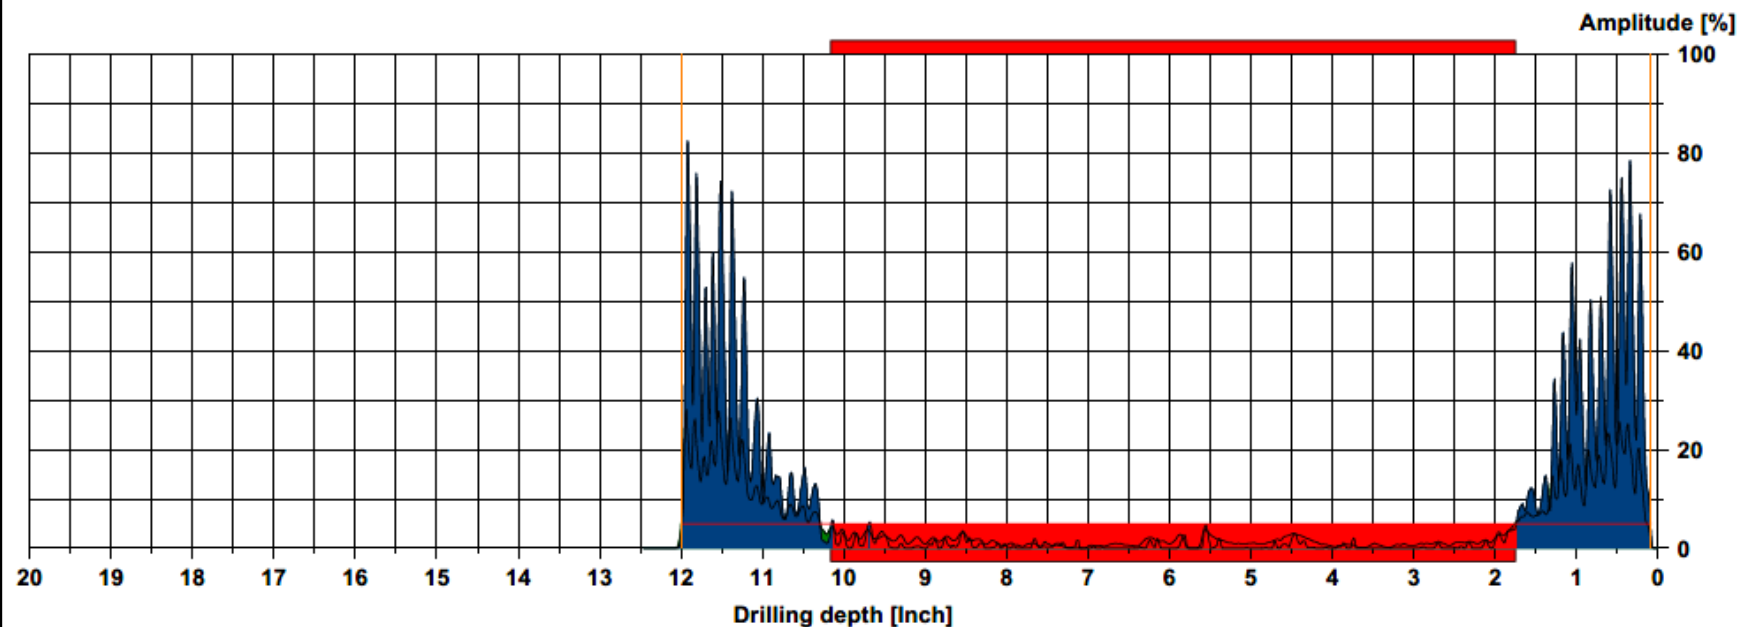
PIER2W P3S MID

Measurement no. :	33	Needle speed :	3000 r/min	Diameter :	
ID number :	3398	Needle state :	---	Level :	
Drilling depth :	12.461 "	Tilt :	0°	Direction :	West
Date :	14.09.2021	Offset :	121/294	Species :	
Time :	10:26:17	Avg. curve :	off	Location :	Pier 2 West
Feed speed :	40 "/min			Name :	Pile 3 South

Program :	Standard
Mode :	Full piercing
Start / stop :	0.087 " / 11.996 "
Effective length :	11.909 "
Cavity detection :	8.362 " / 70%

■	From	1.75 "	to	10.16 "	: Decay
□	From	0.00 "	to	0.00 "	:
□	From	0.00 "	to	0.00 "	:
□	From	0.00 "	to	0.00 "	:
□	From	0.00 "	to	0.00 "	:
□	From	0.00 "	to	0.00 "	:
