# MDOT ANCILLARY STRUCTURES – MANAGING AGING CULVERTS

NICHOLAS GREEN, HNTB

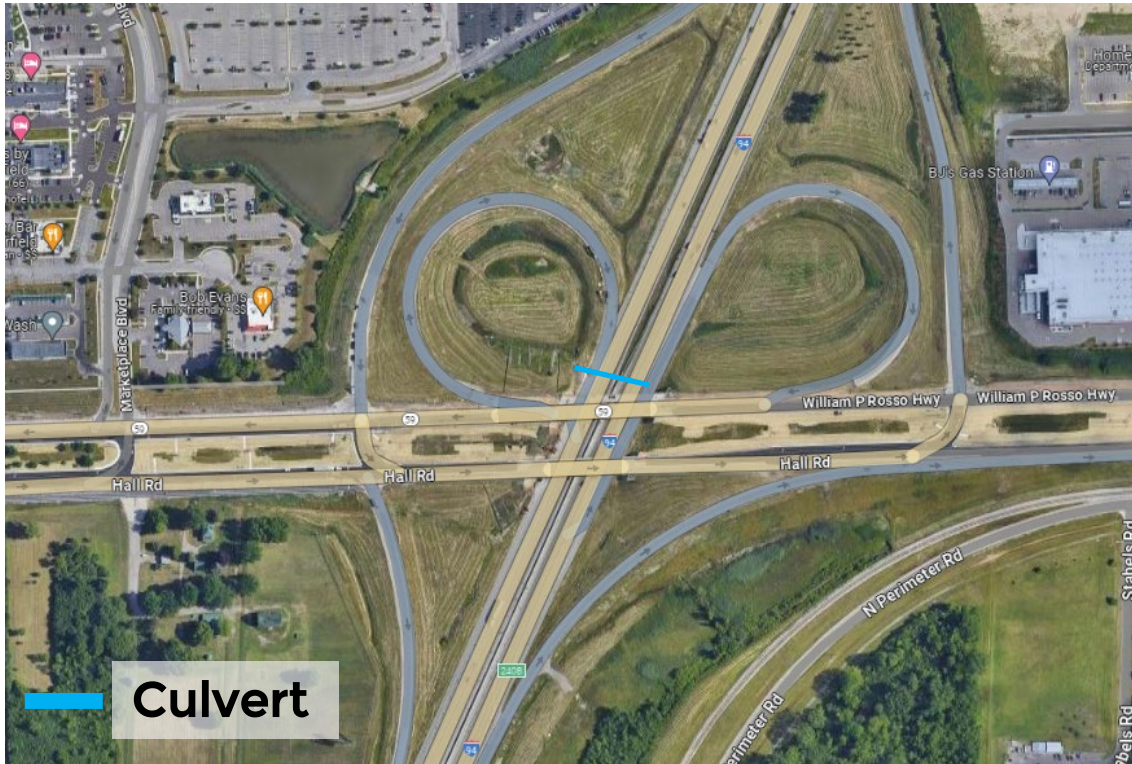
# I-94 NORTH OF M-59 – EXISTING CONDITIONS

- 83" x 53" Concrete horizontal elliptical culvert
- Constructed in 1962 and extended in 1997
- Asset defects include:
  - Joint separation with active water & soil infiltration
  - Barrel Failure
- Culvert Crosses 8 lanes of traffic

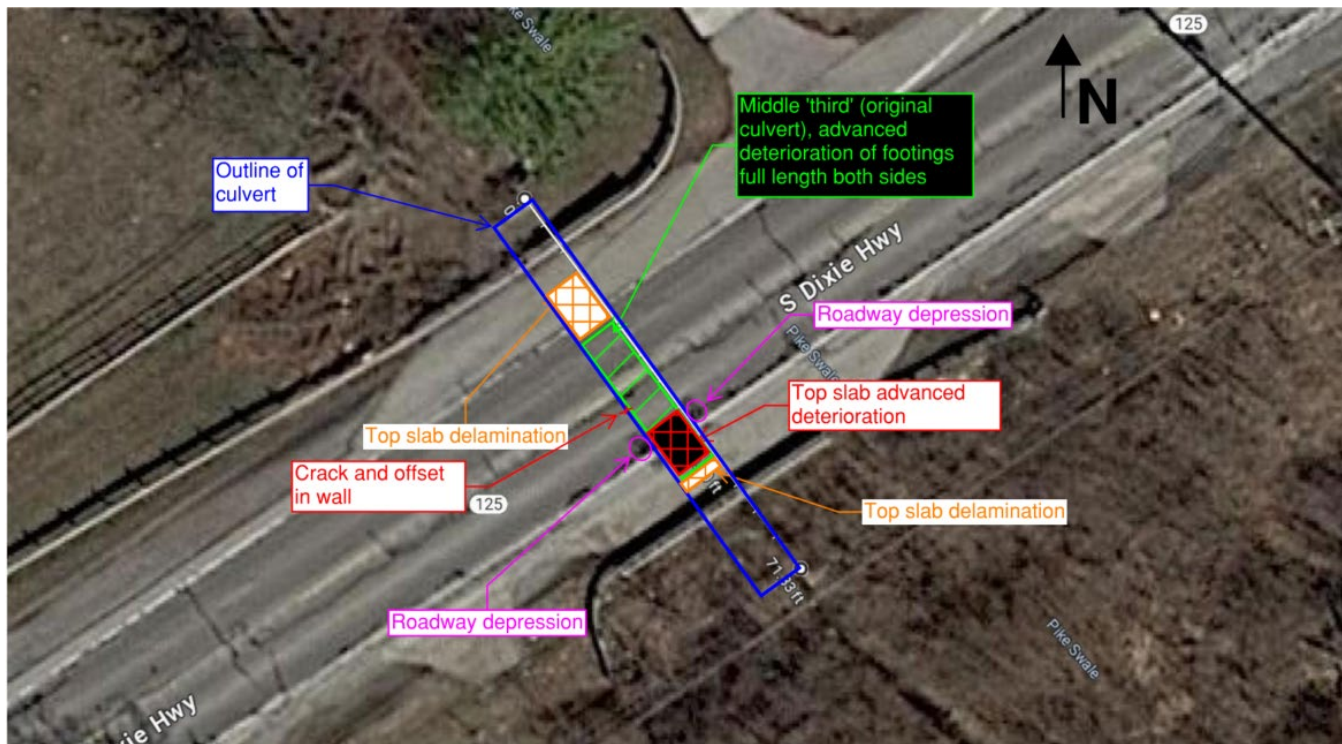
# M-125 OVER PIKE SWALE – EXISTING CONDITIONS

- 48" x 72" Three-Sided Concrete Culvert
- Constructed in 1930s
- Asset defects include:
  - Structural cracking
  - Deterioration of concrete footings
  - Spalling of culvert soffit exposing reinforcement
  - Depression in roadway above soffit deterioration
- Deemed RFA Priority Level 1 in February 2024

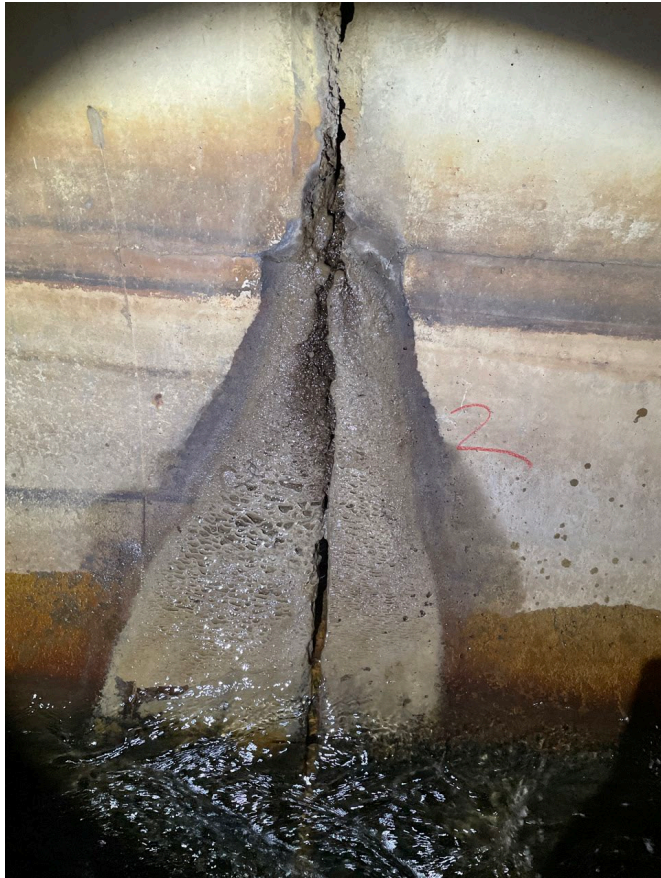
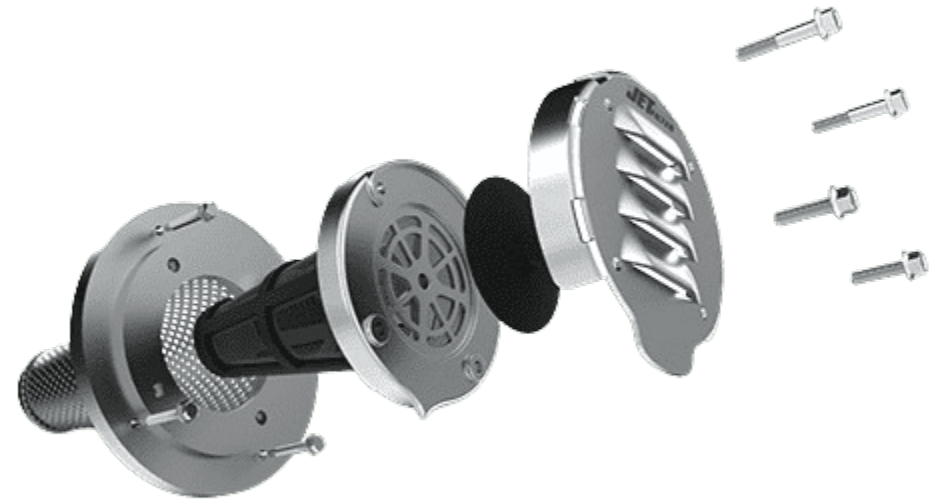
# M-79 OVER FOWLER DRAIN- EXISTING CONDITIONS

- 72" Circular Concrete Culvert
- Asset defects include:
  - Joint Separation with active water & soil infiltration
