MDOT
Michigan Department of Transportation

Michigan DOT Best Practices

Identifying Maintenance Needs & Properly Addressing

2017 CTT Michigan Bridge Workshop

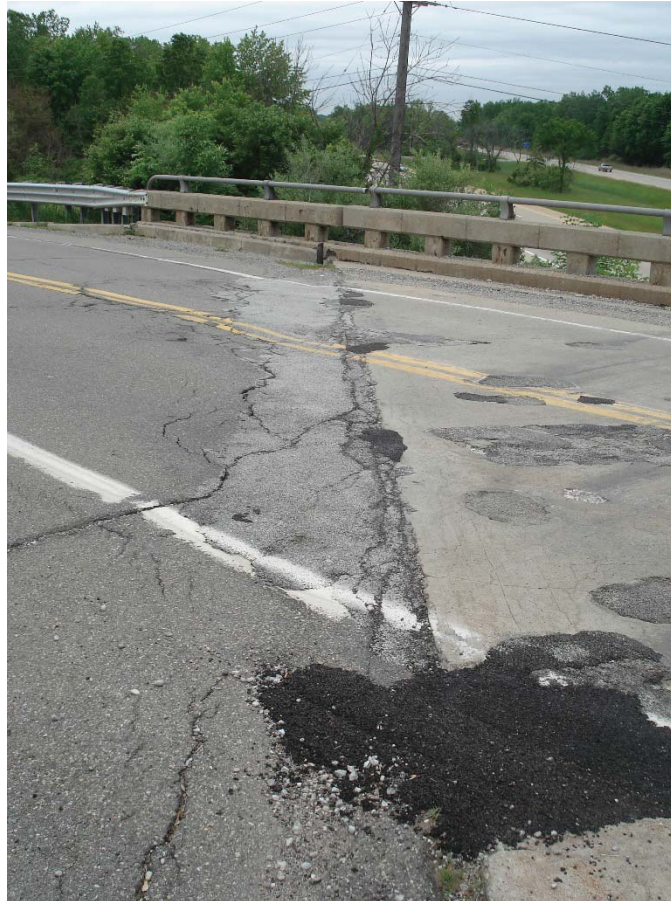
- Settlement – Impacting Vehicles Accelerate Tailspan Deterioration

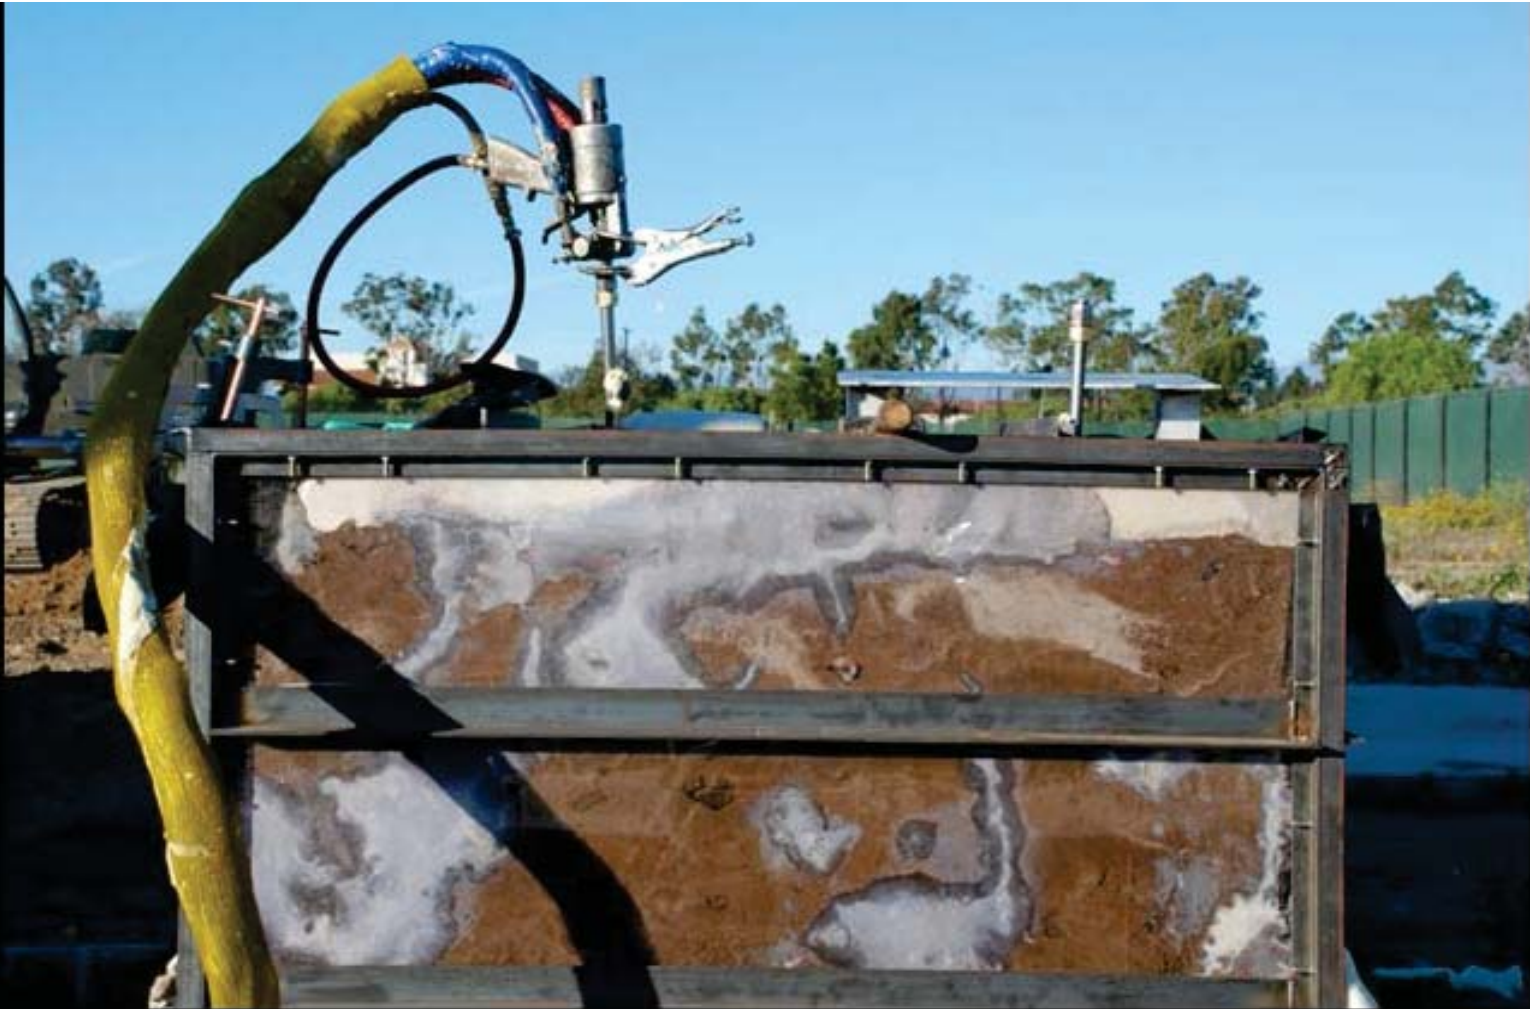
Injection inside steel reinforced, plexi-glass box
so material flow could be observed

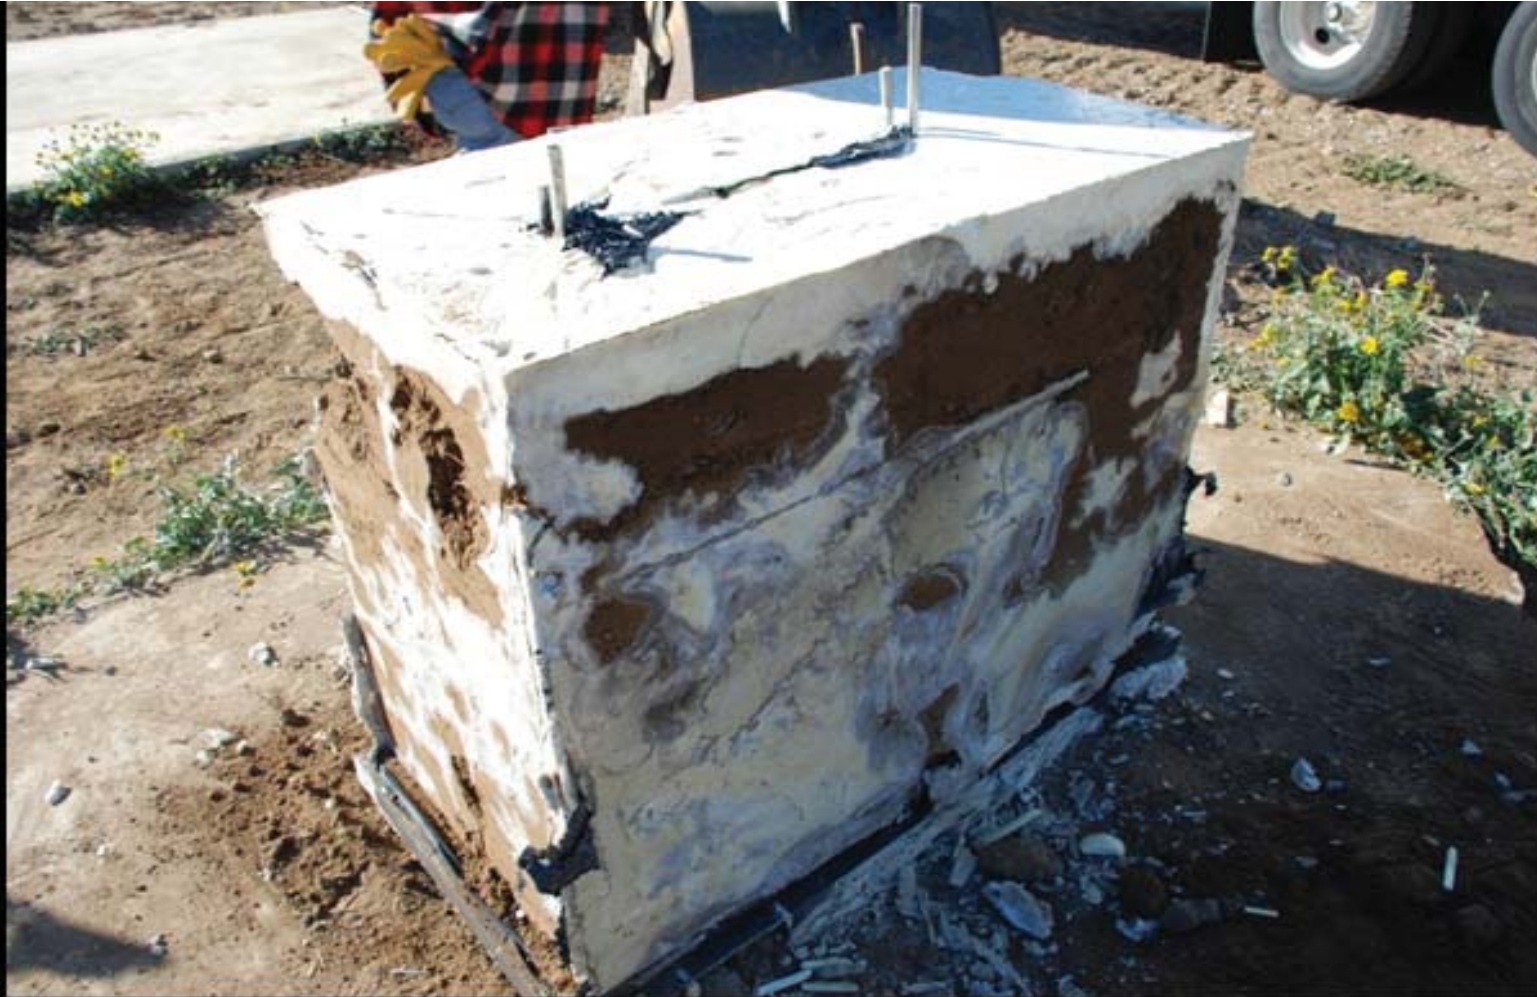
**Stabilized soil mass was free-standing
after box removed**

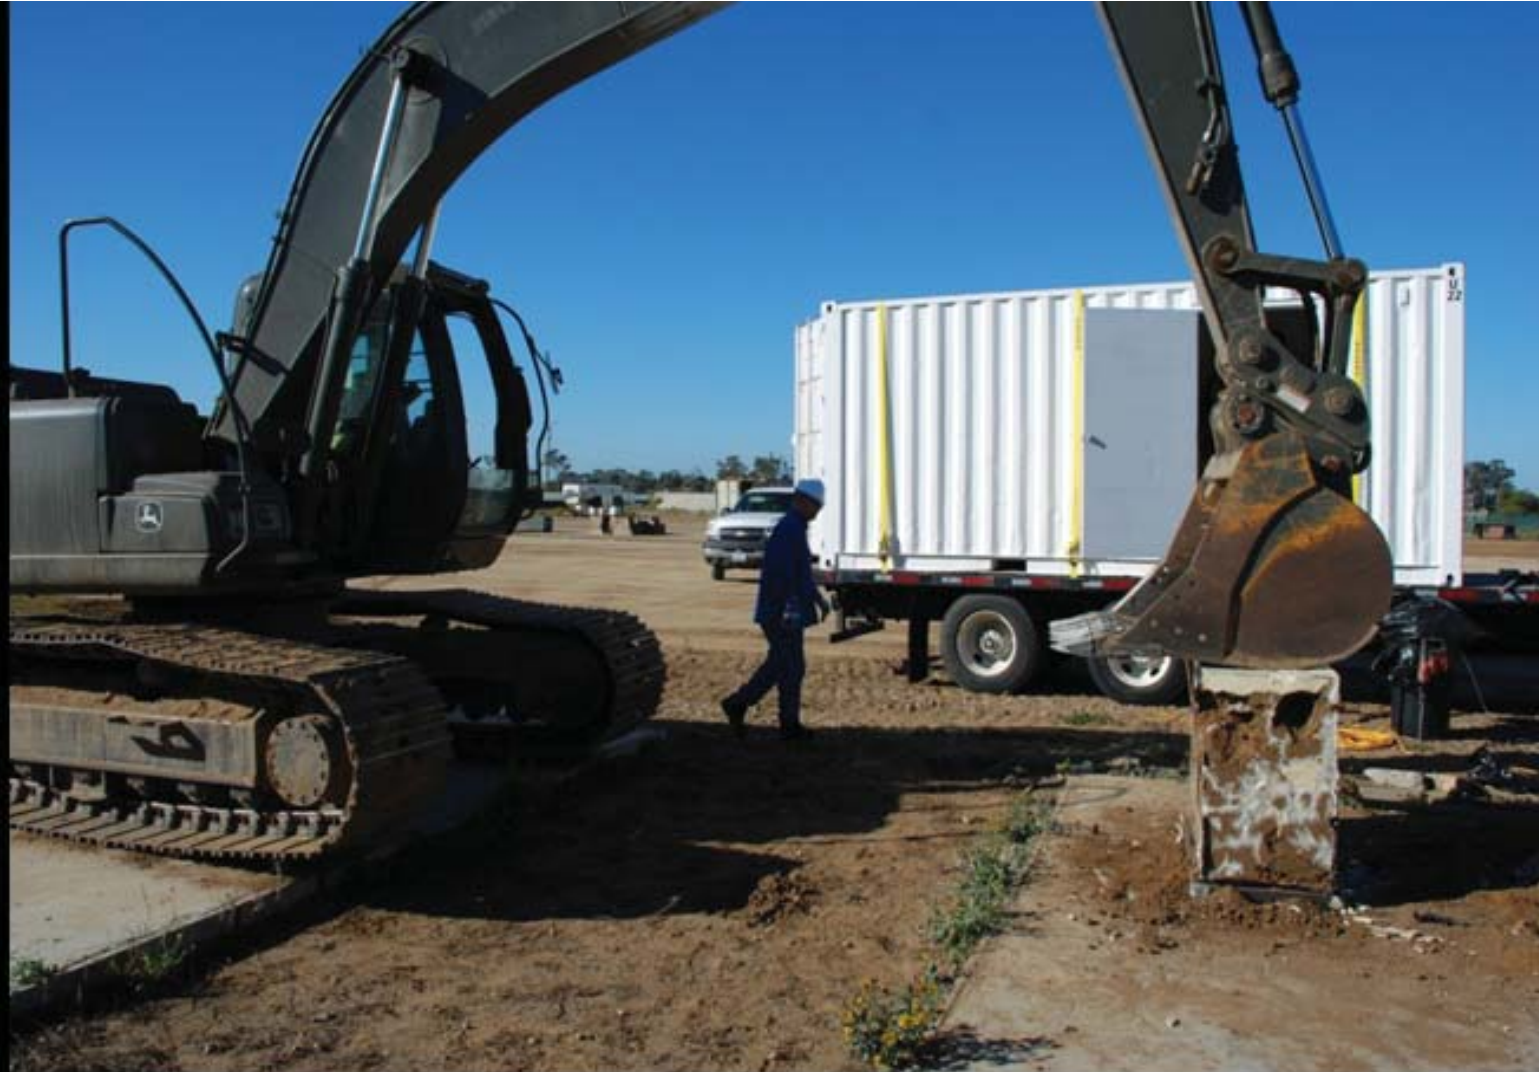
Vertical load applied using an excavator

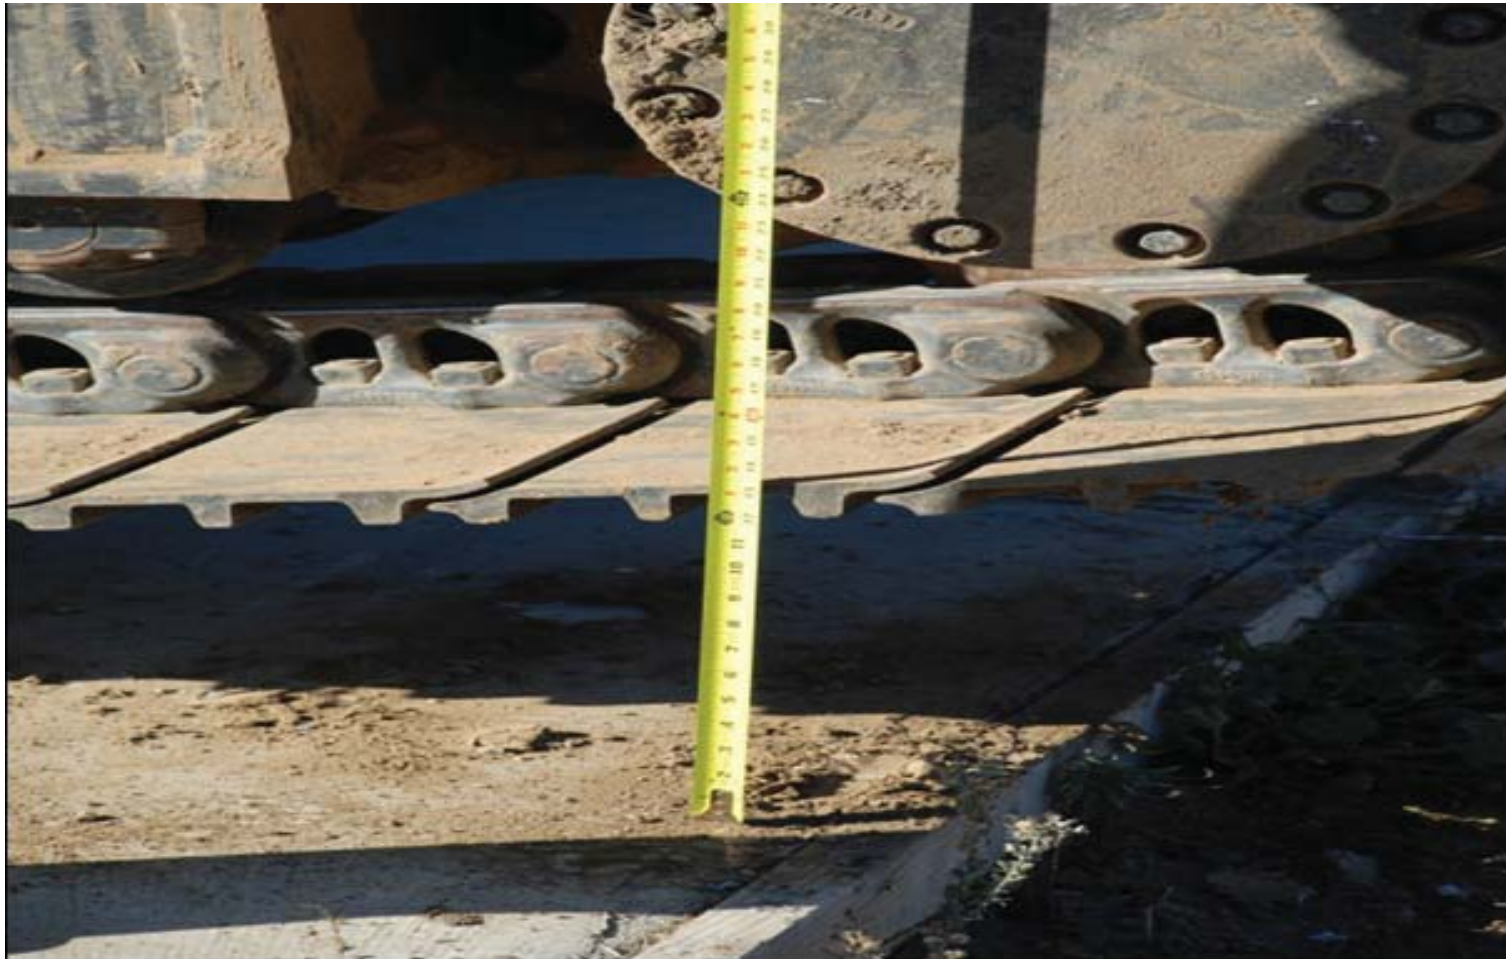
Soil mass would not crush, but
excavator was lifted 11 inches

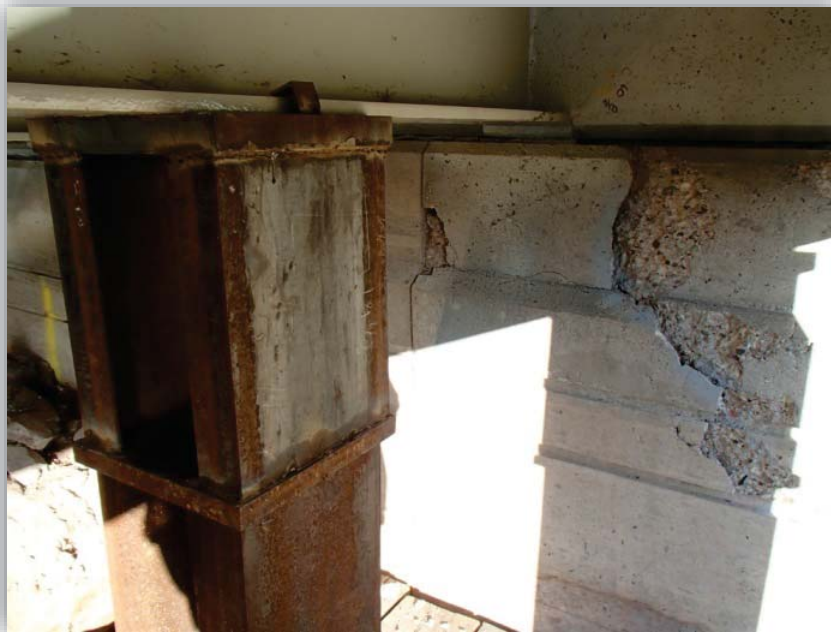
- North Abutment
- Spalls to Steel
 - Beams 7W and 8W

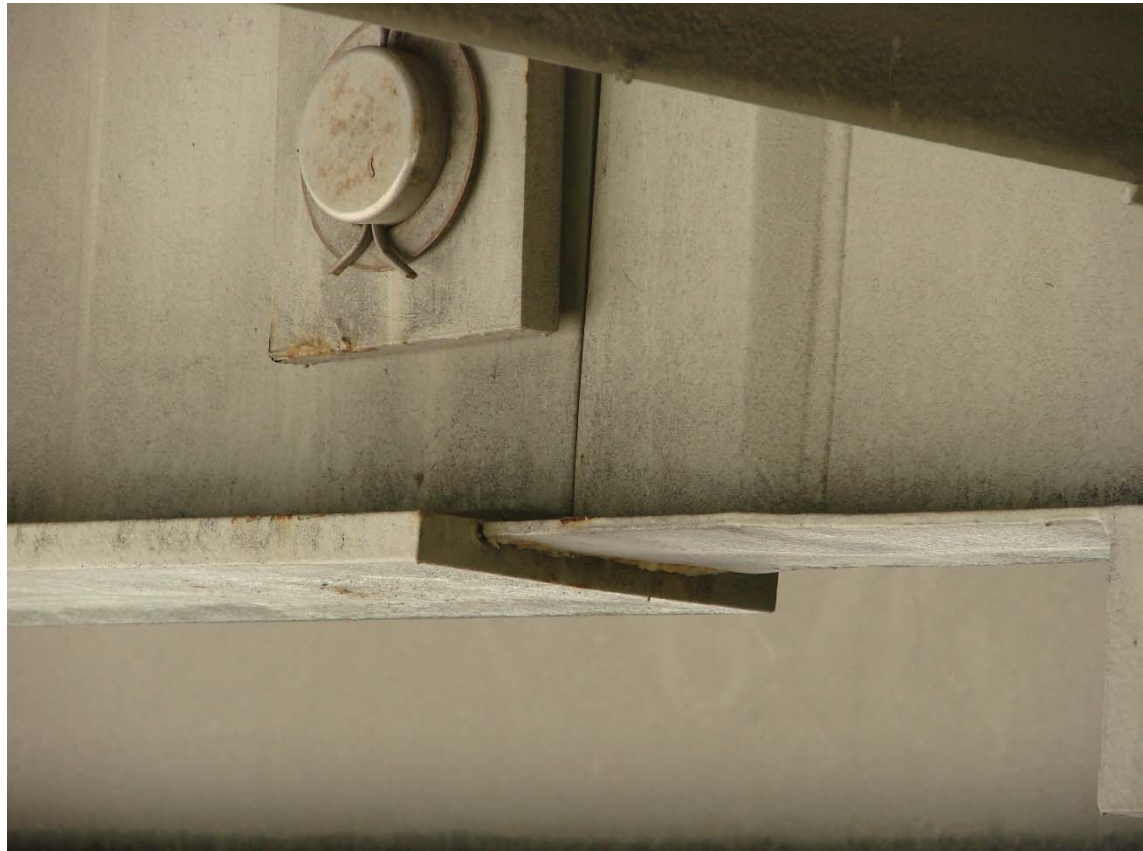
- Is fixing the Abutment Enough?
 - Not if caused by pavement growth.

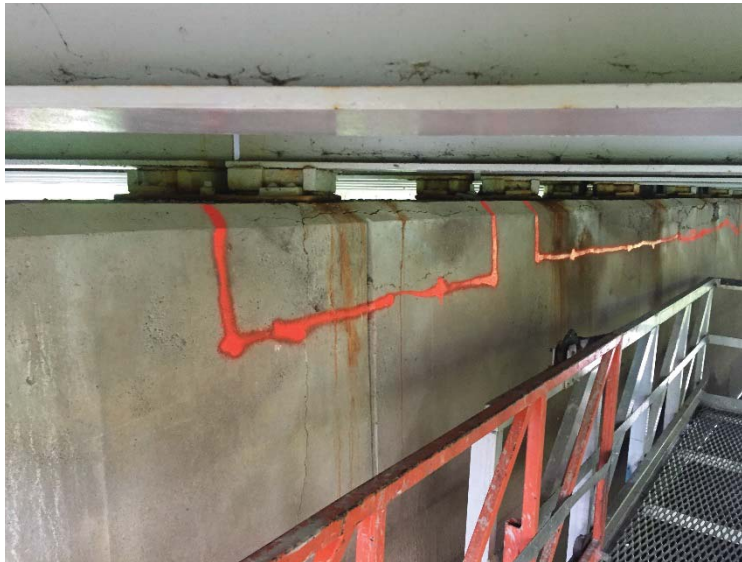
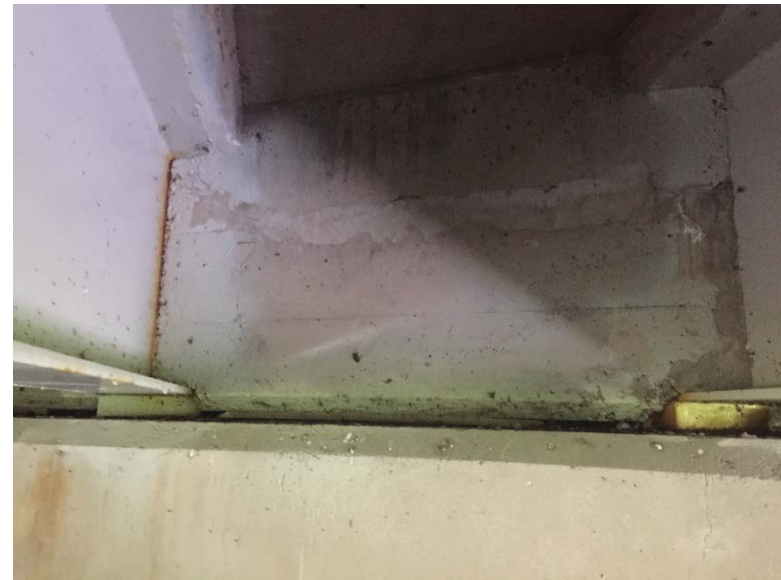
- Is fixing the Abutment Enough?
 - Not if caused by frozen or improperly designed bearings.

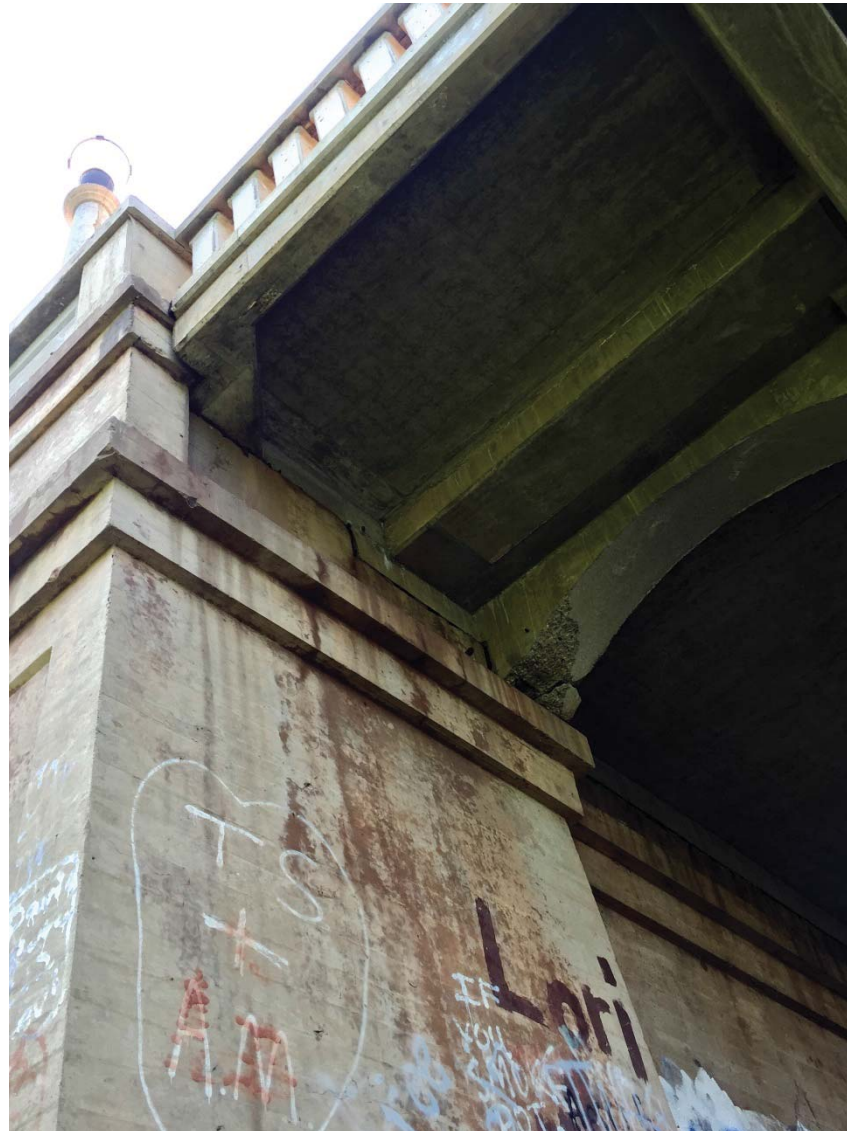
Bad Joint Details
