Michigan DOT Best Practices

Identifying Maintenance Needs & Properly Addressing

2017 CTT Michigan Bridge Workshop

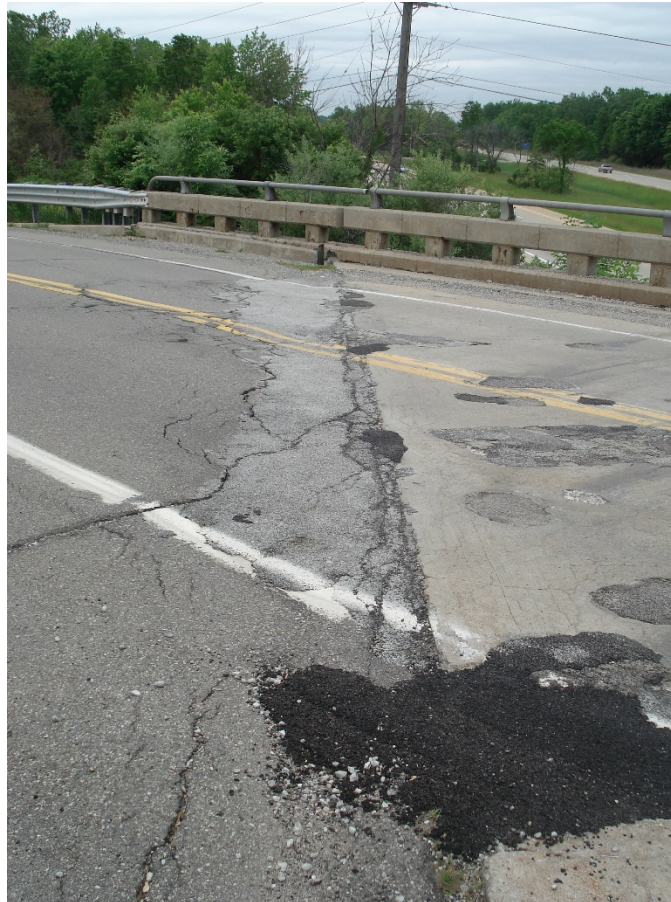
- Settlement – Impacting Vehicles Accelerate Tailspan Deterioration

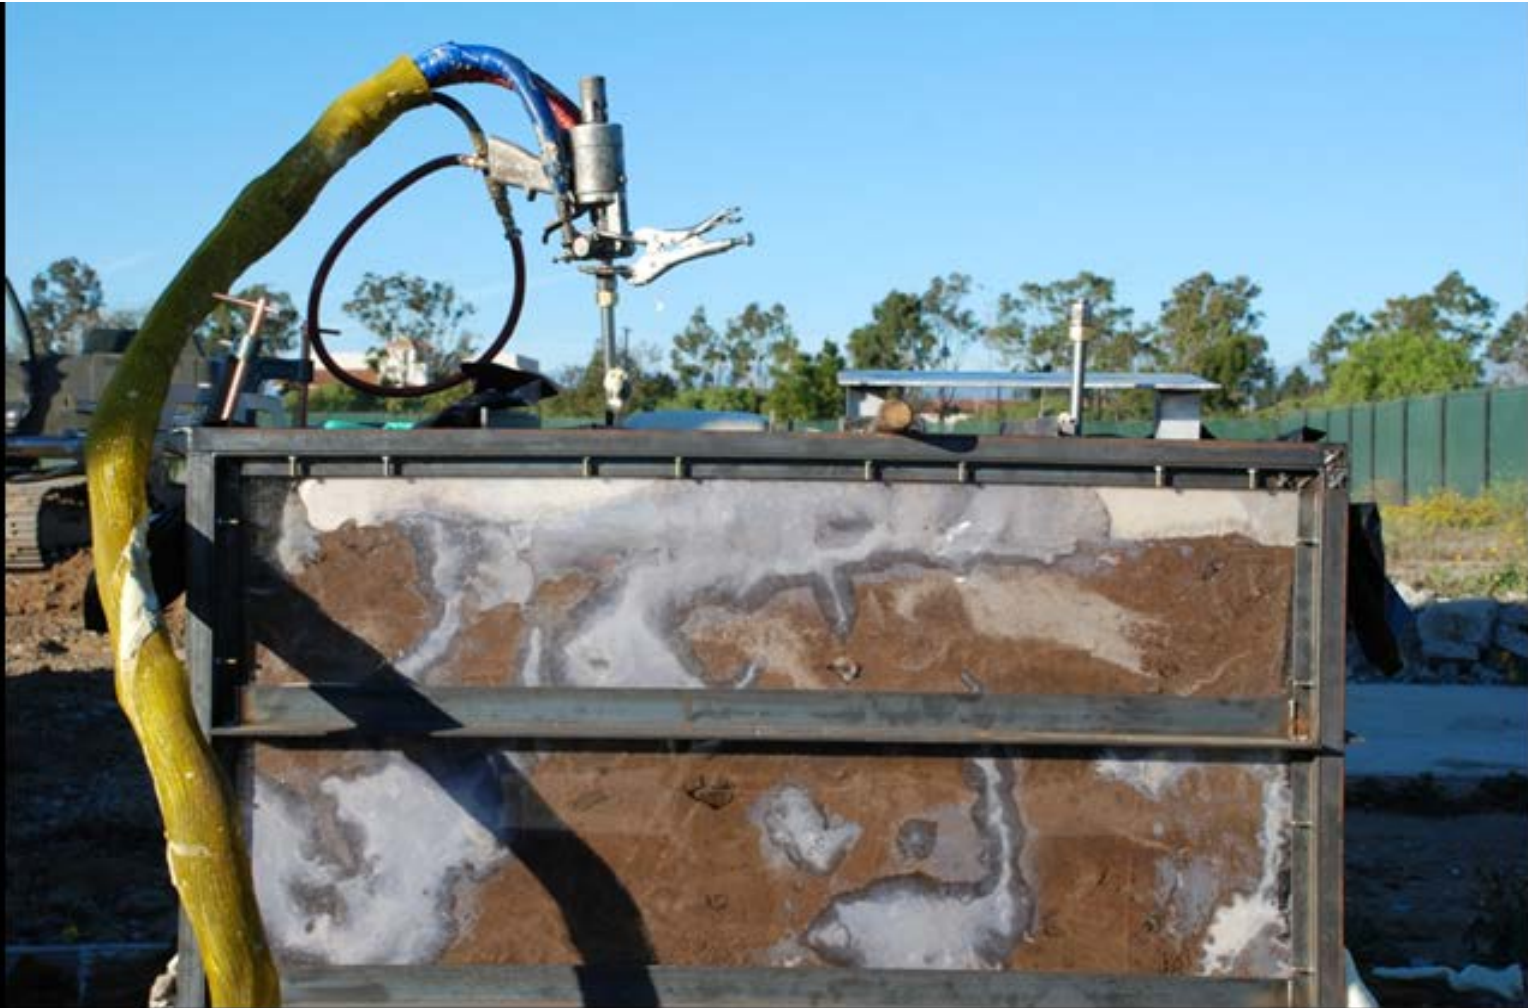
Injection inside steel reinforced, plexi-glass box
so material flow could be observed

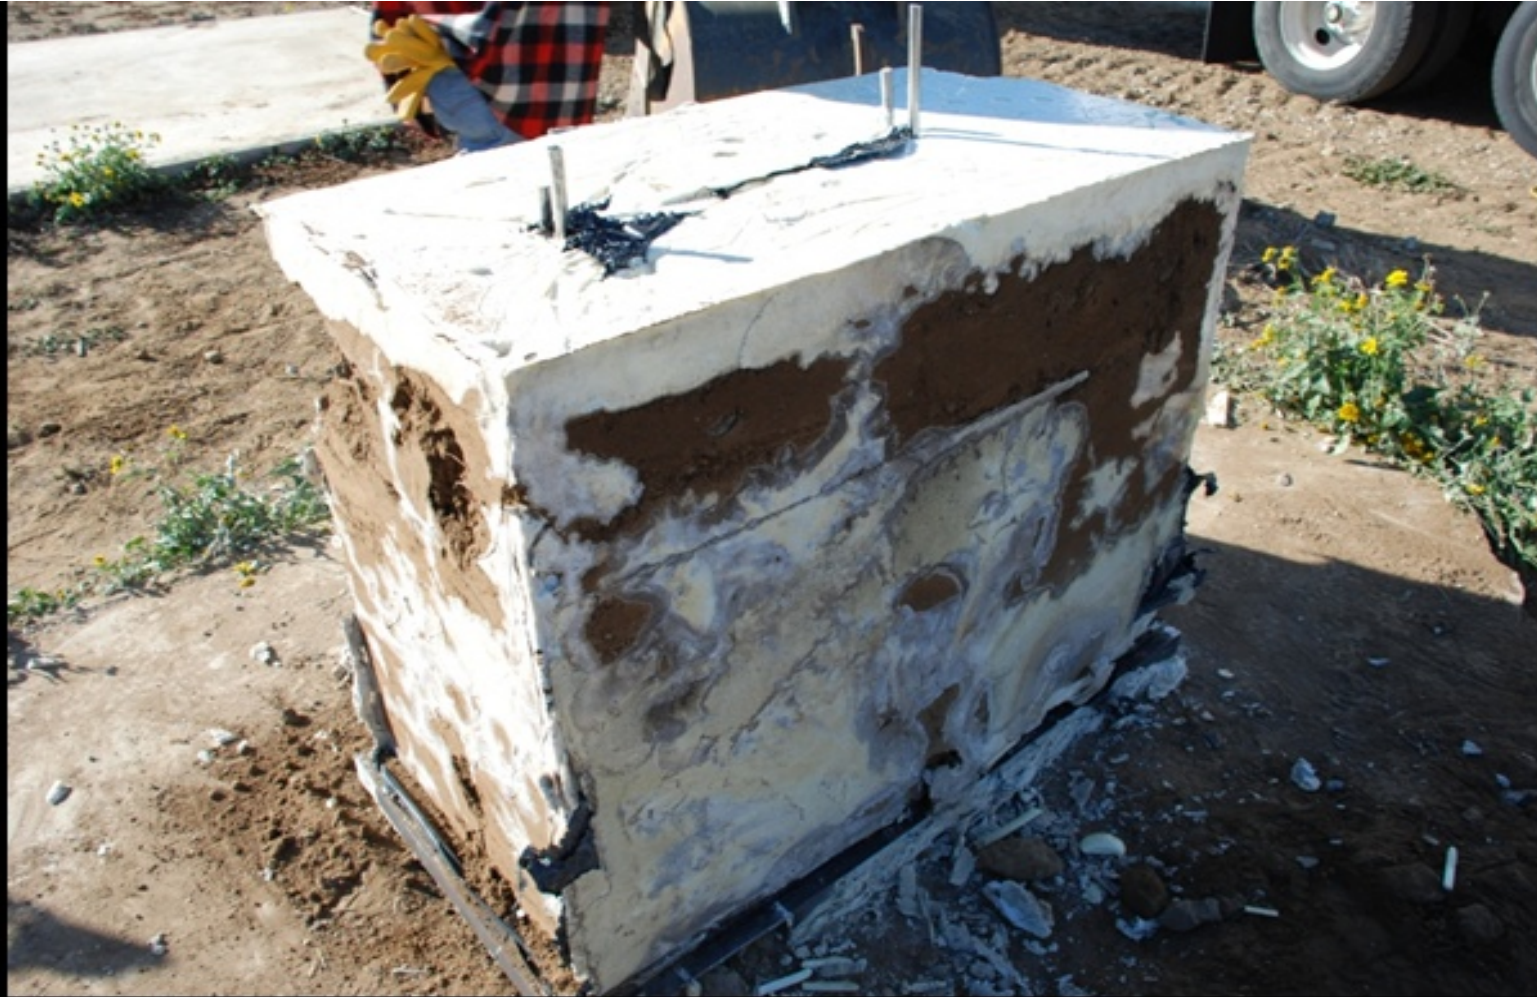
**Stabilized soil mass was free-standing
after box removed**

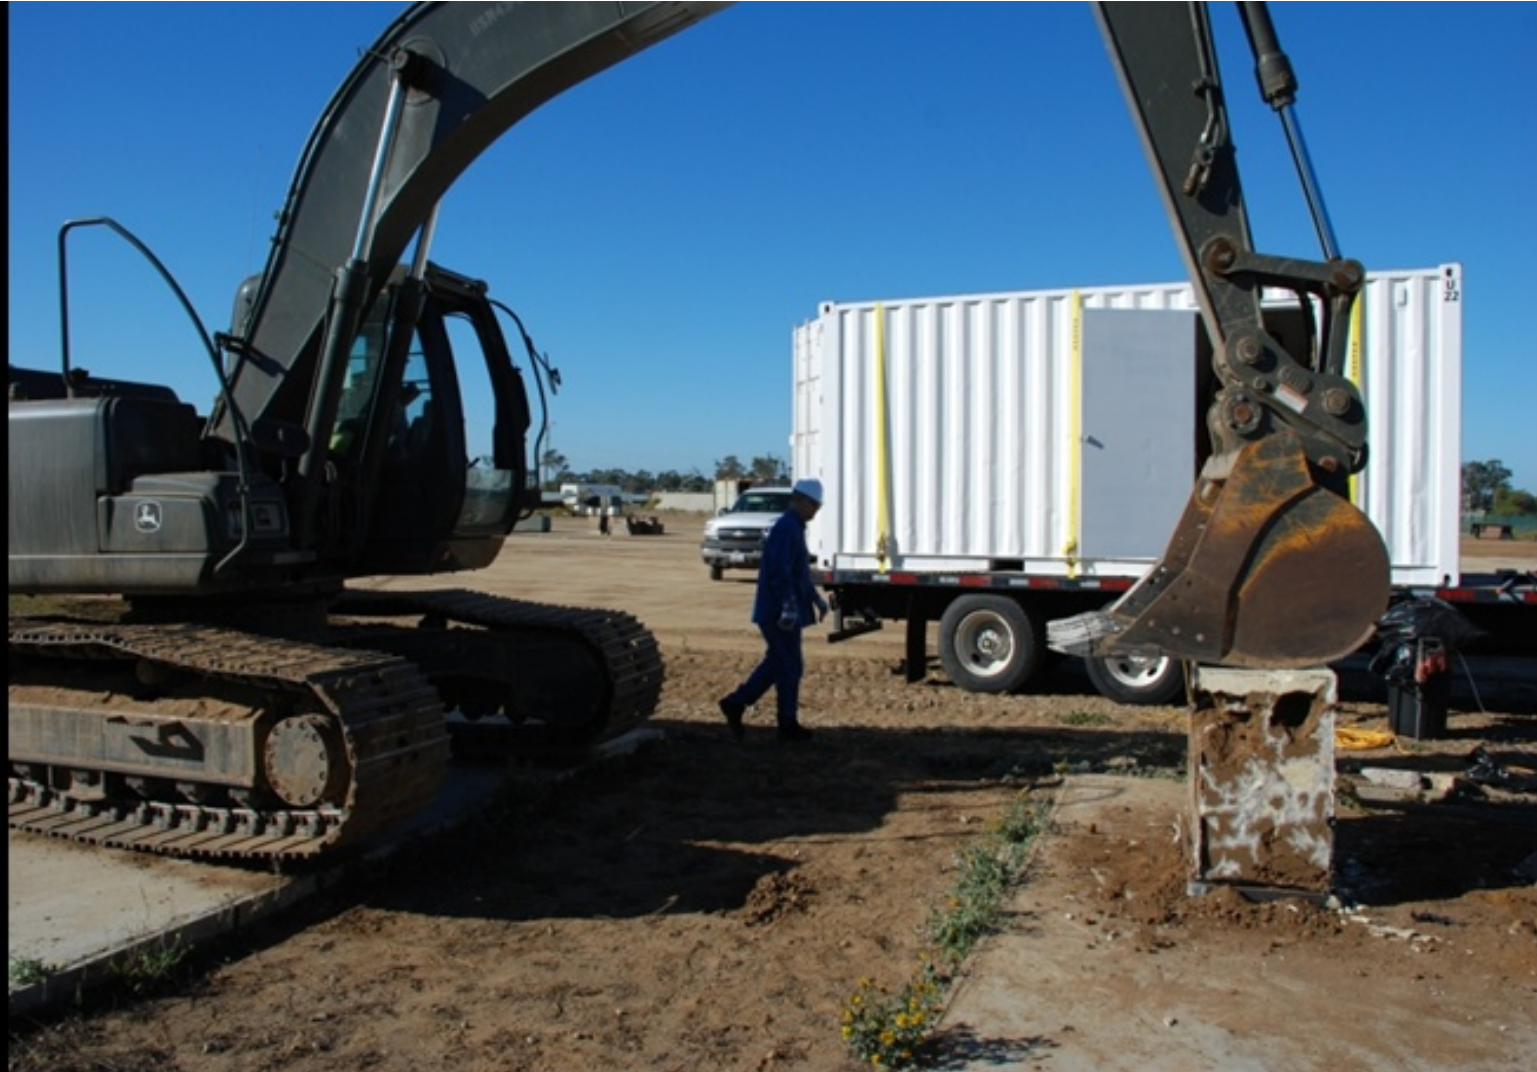
Vertical load applied using an excavator

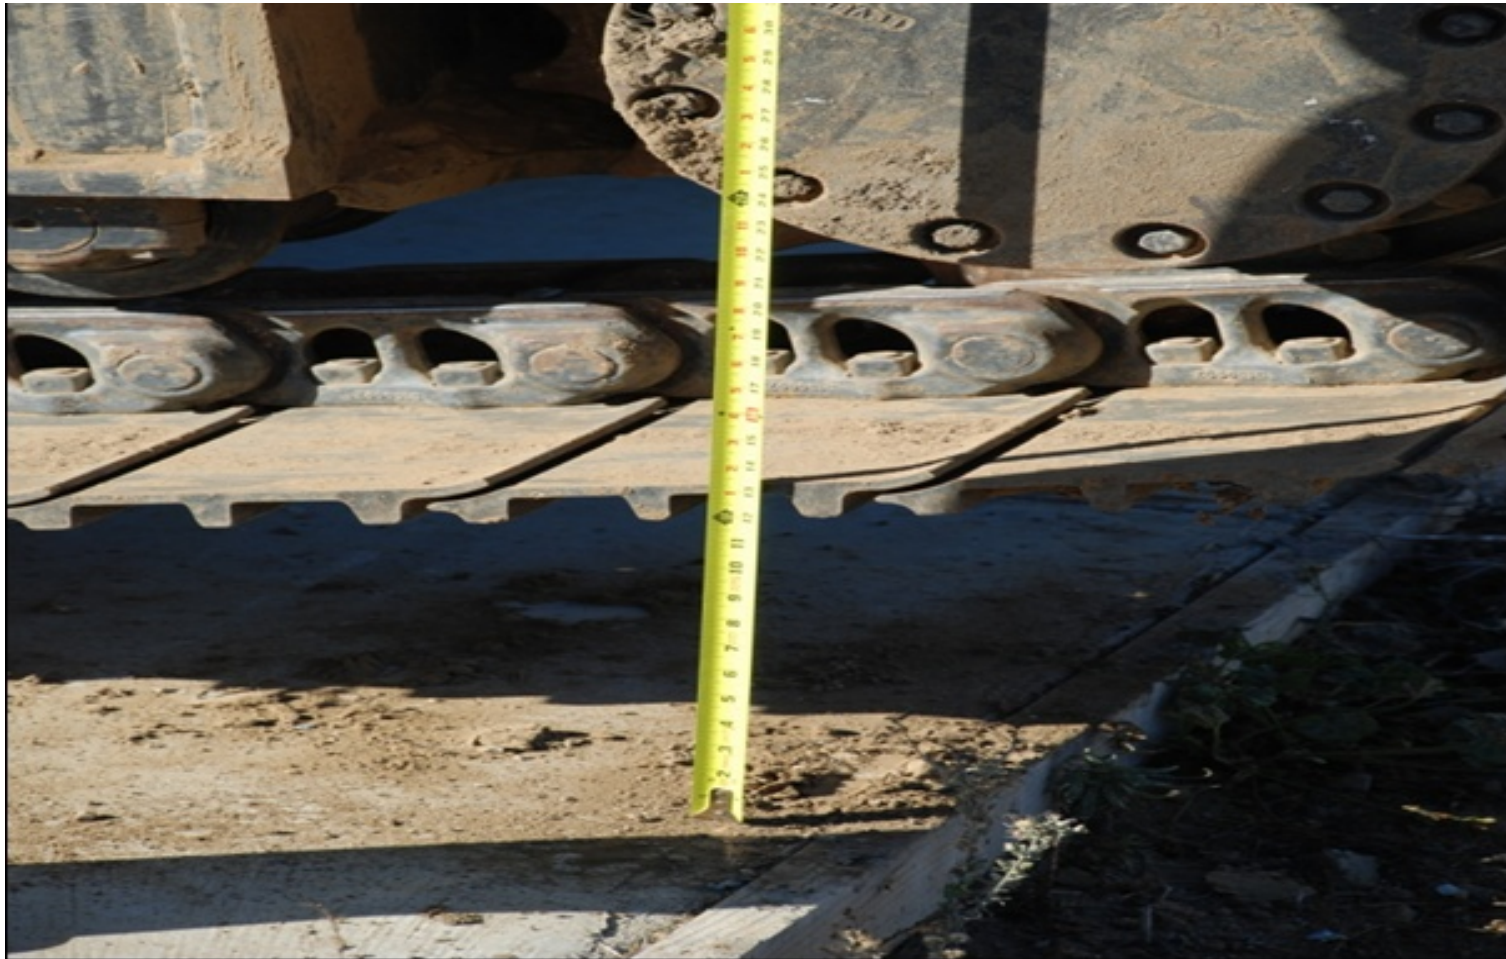
Soil mass would not crush, but
excavator was lifted 11 inches

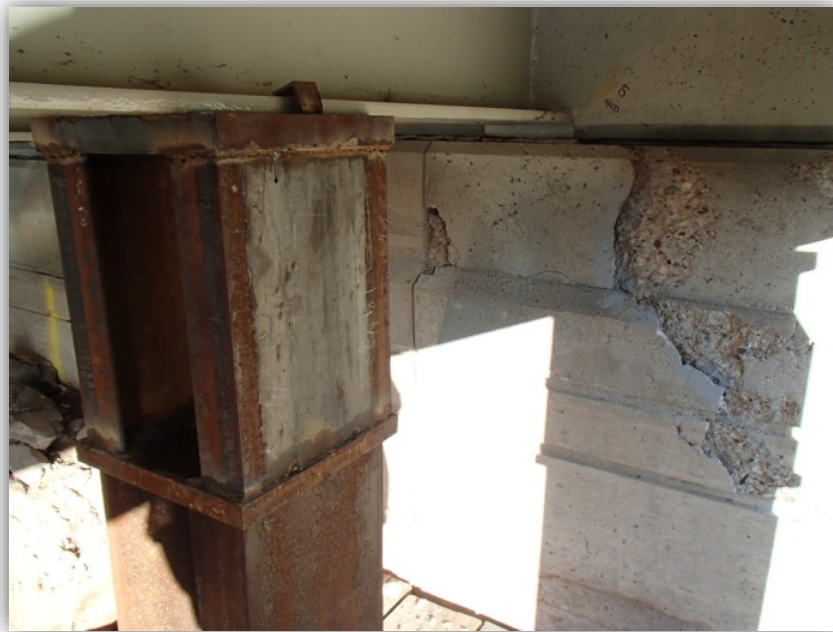
- North Abutment
- Spalls to Steel
 - Beams 7W and 8W

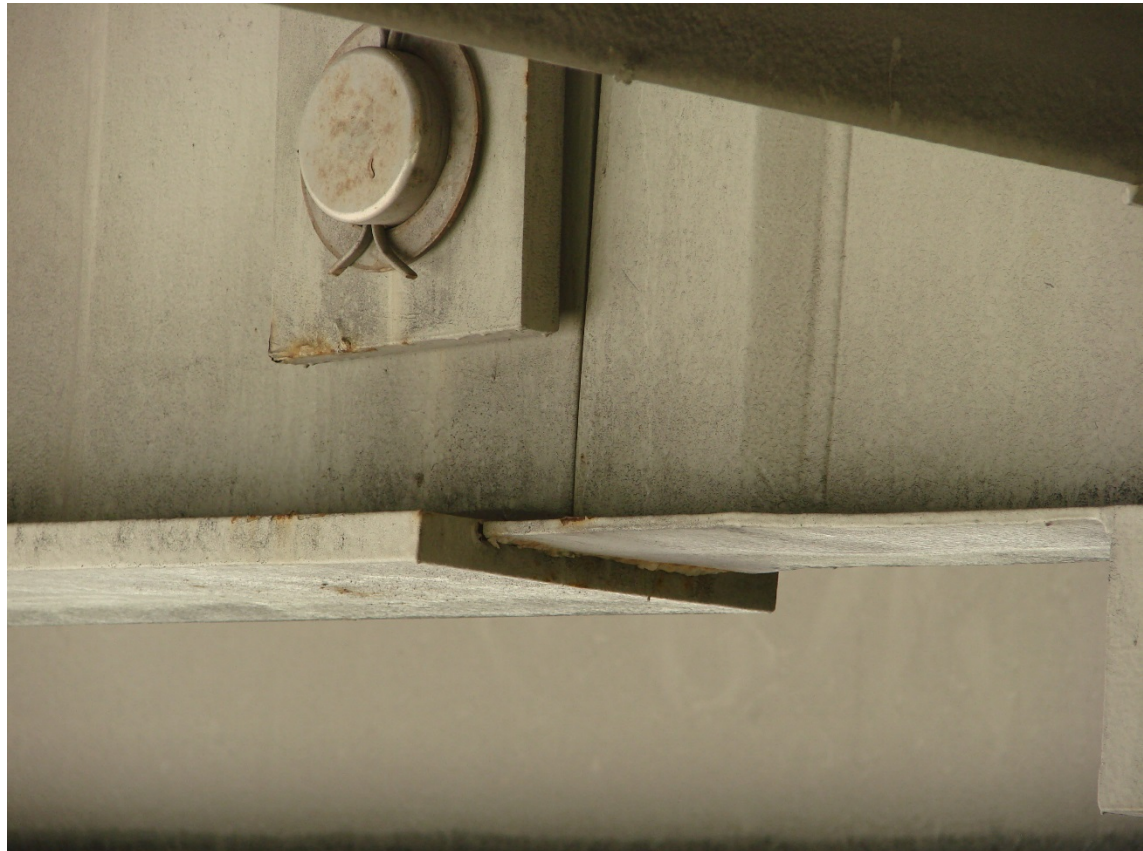
- Is fixing the Abutment Enough?
 - Not if caused by pavement growth.

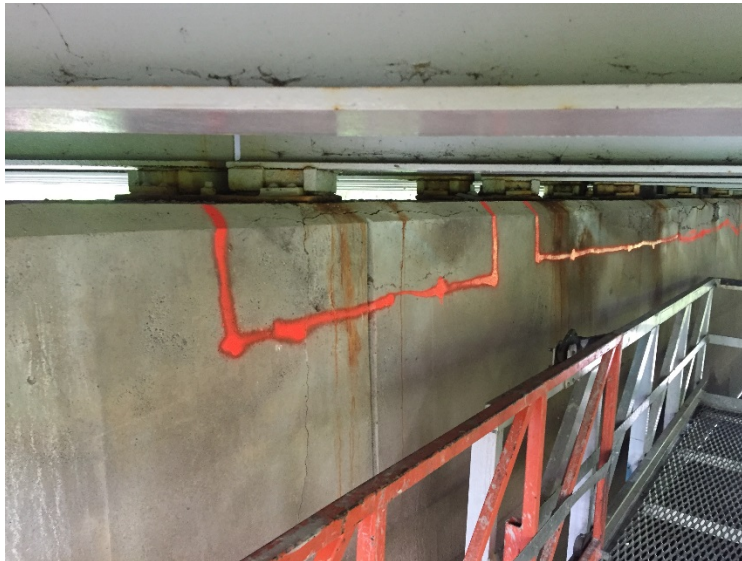
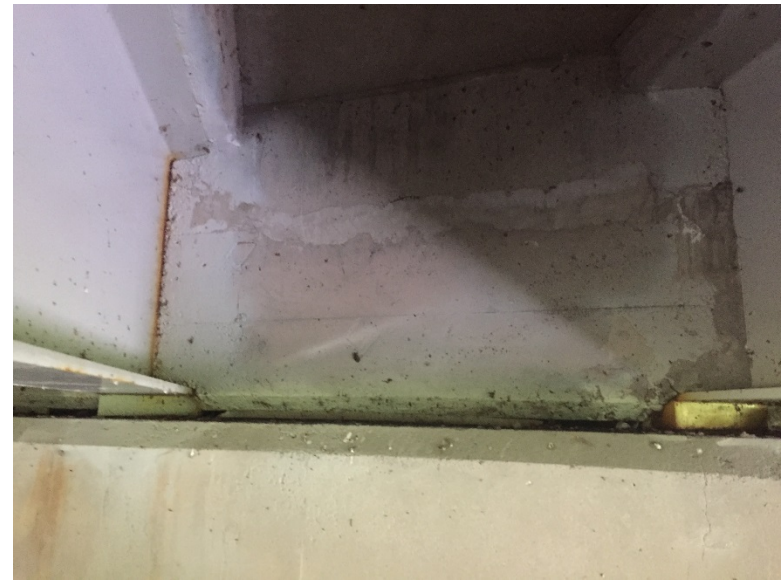
- Is fixing the Abutment Enough?
 - Not if caused by frozen or improperly designed bearings.
