# History Repeats Itself

## Relocation and Restoration of Historic Truss Bridges

Bridge Week  
March 12, 2024

# Relocation and Restoration of M-86 Historic Truss

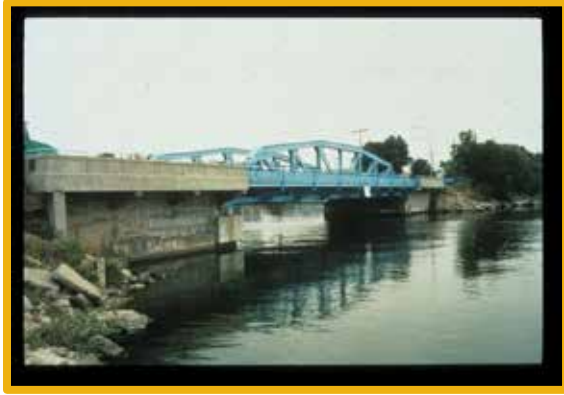
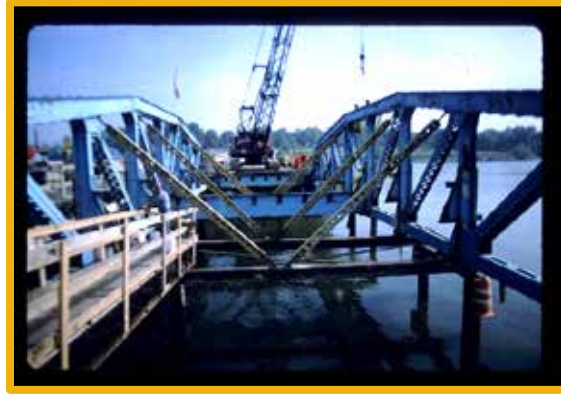
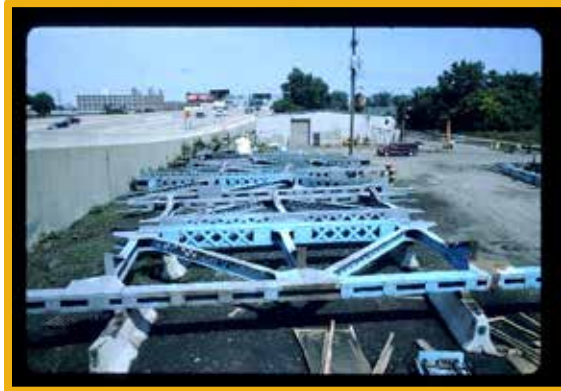
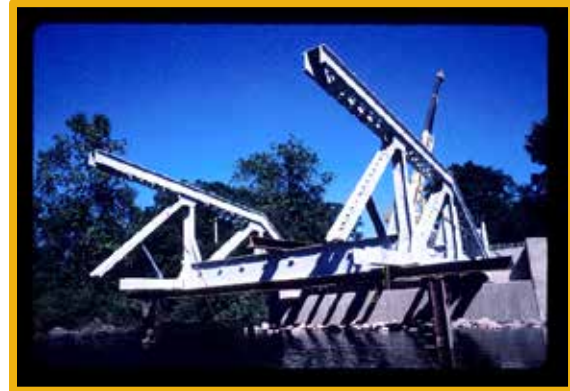
Dis-assembled, moved to Grand Rapids  
for painting and installation in Kent County

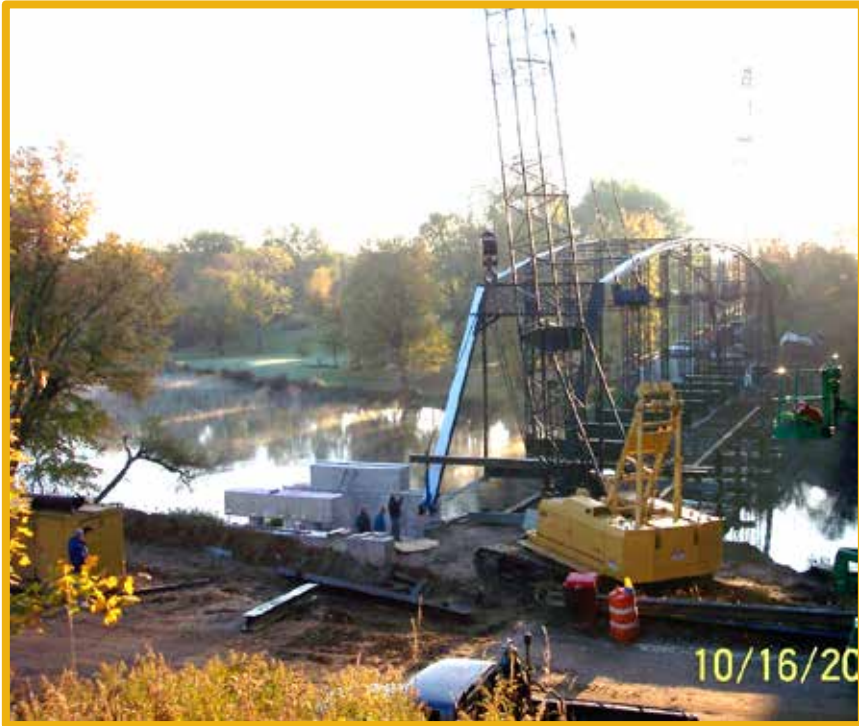
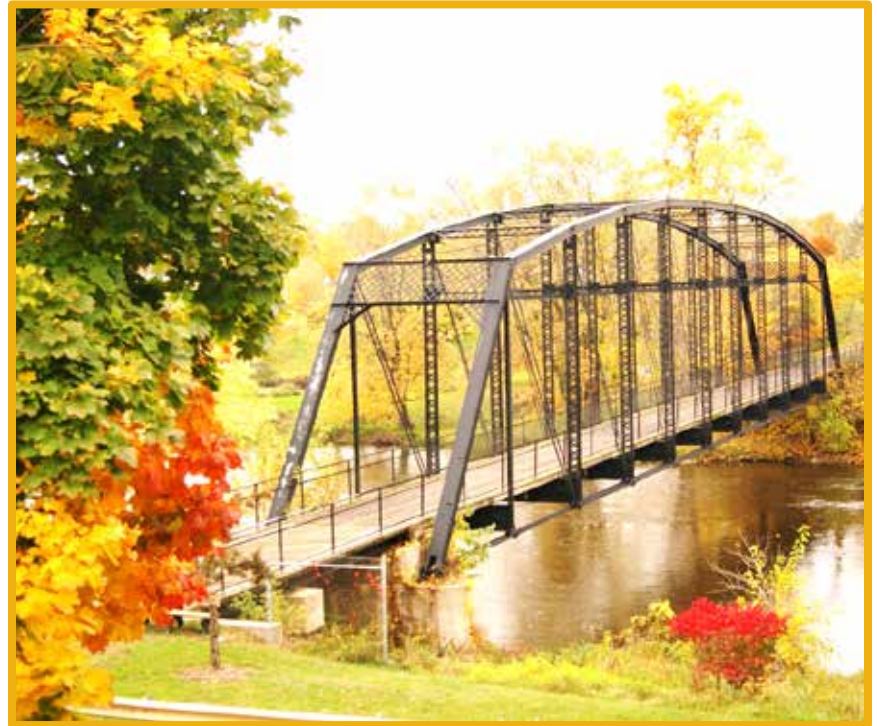
**Portland Trail - 220 foot Parker Truss relocated from Kent Street (south of I96)  
to Trail (north of I96) over Grand River.  
Used some rivets for replacement of damaged vertical member with lacing bars.**

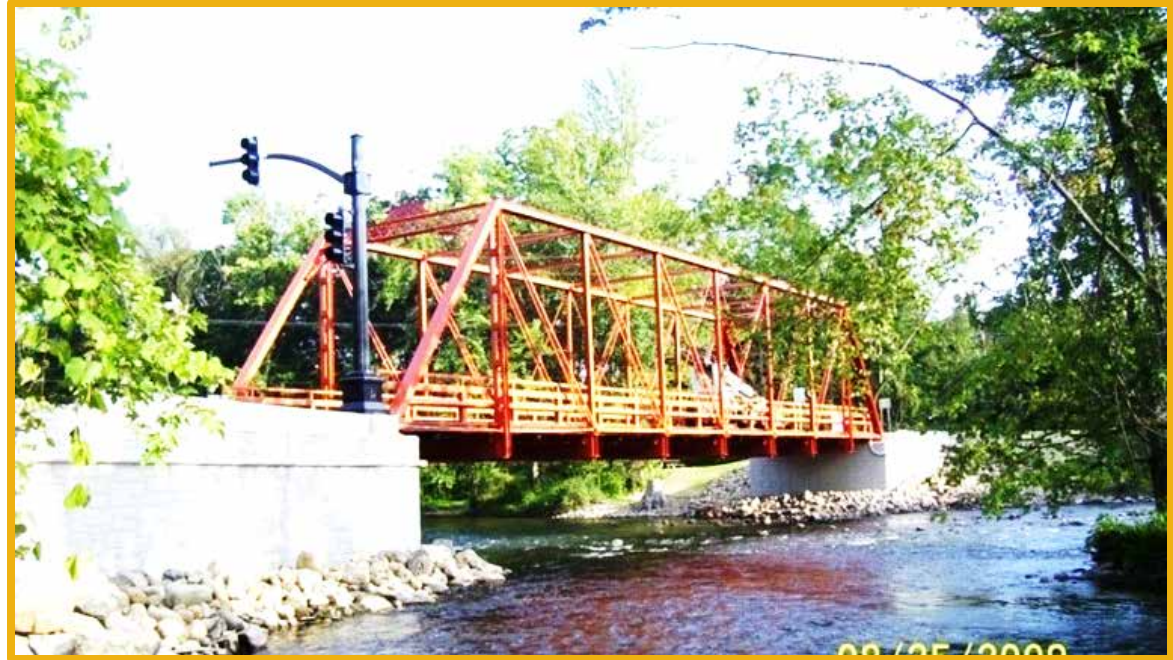
East Delhi Road over  
Huron River

Restored on site and  
reinstalled on new  
foundations

Did not use rivets for  
replacement of floor  
beams  
(lost some CDBG  
funding)

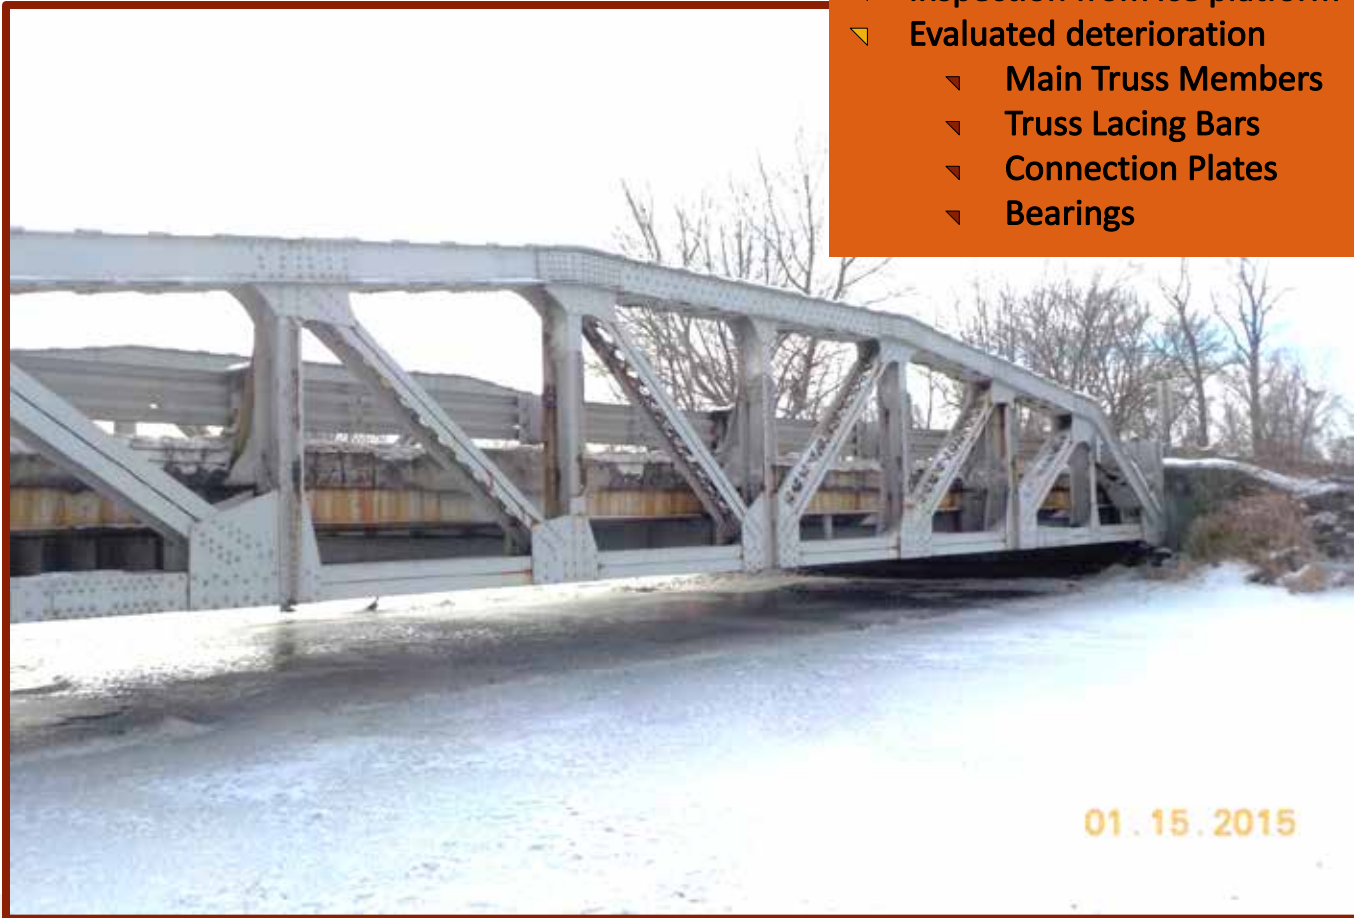
- ▼ Inspection from ice platform
- ▼ Evaluated deterioration
  - ▼ Main Truss Members
  - ▼ Truss Lacing Bars
  - ▼ Connection Plates
  - ▼ Bearings

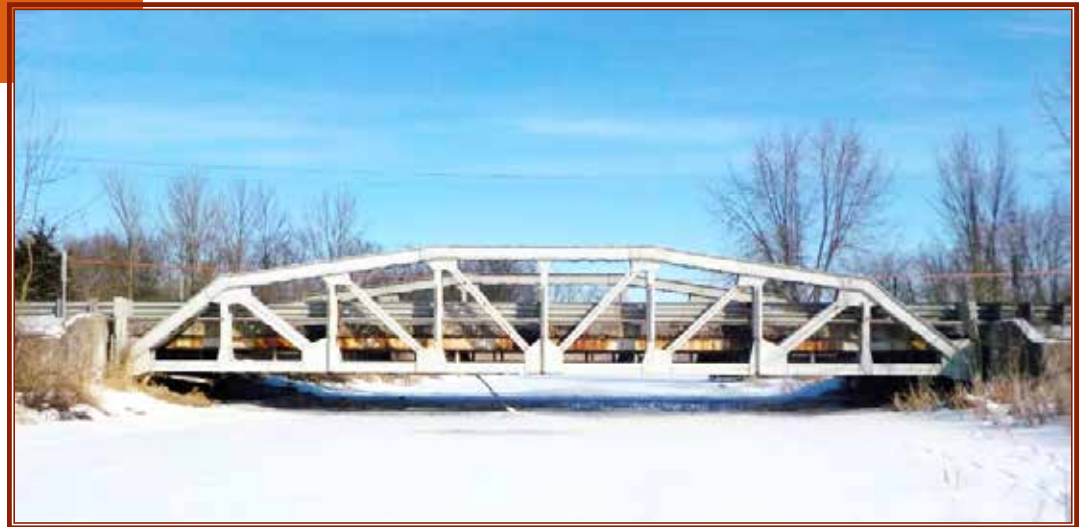
- ▽ Design plans for:
  - ▽ Disassembly
  - ▽ Rehabilitation
  - ▽ Reinstallation
  - ▽ New pile supported abutments
  - ▽ New approaches

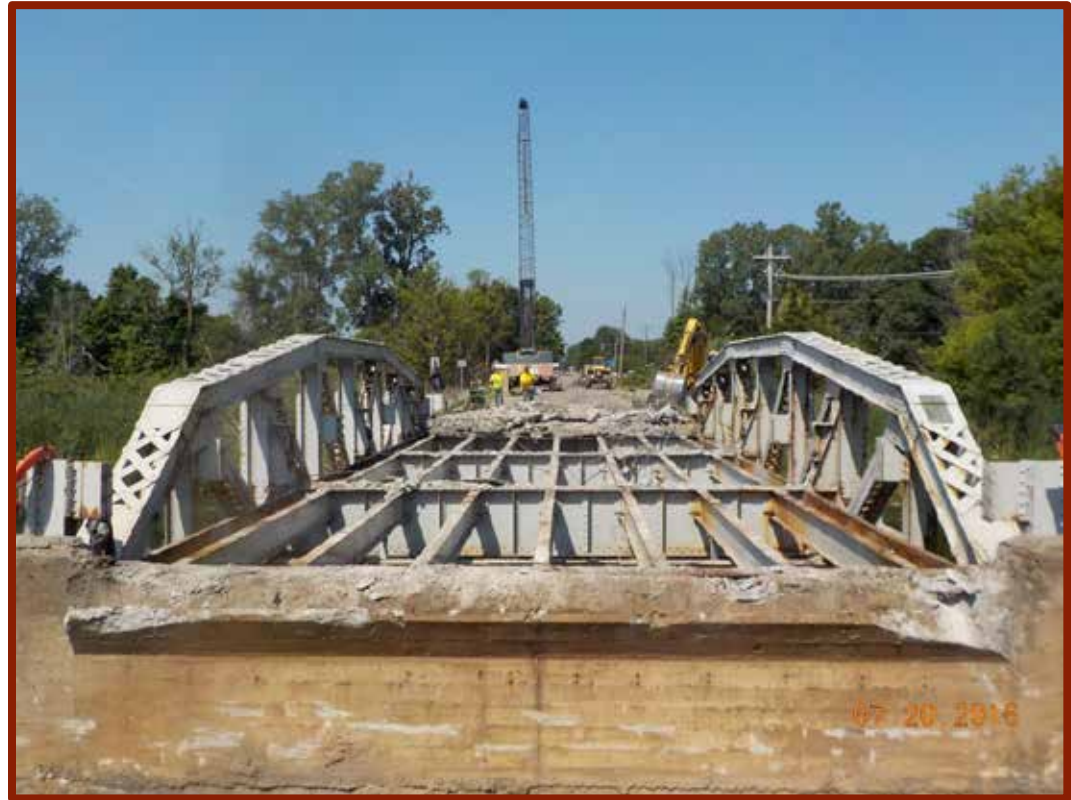
Deck removal  
July 2016

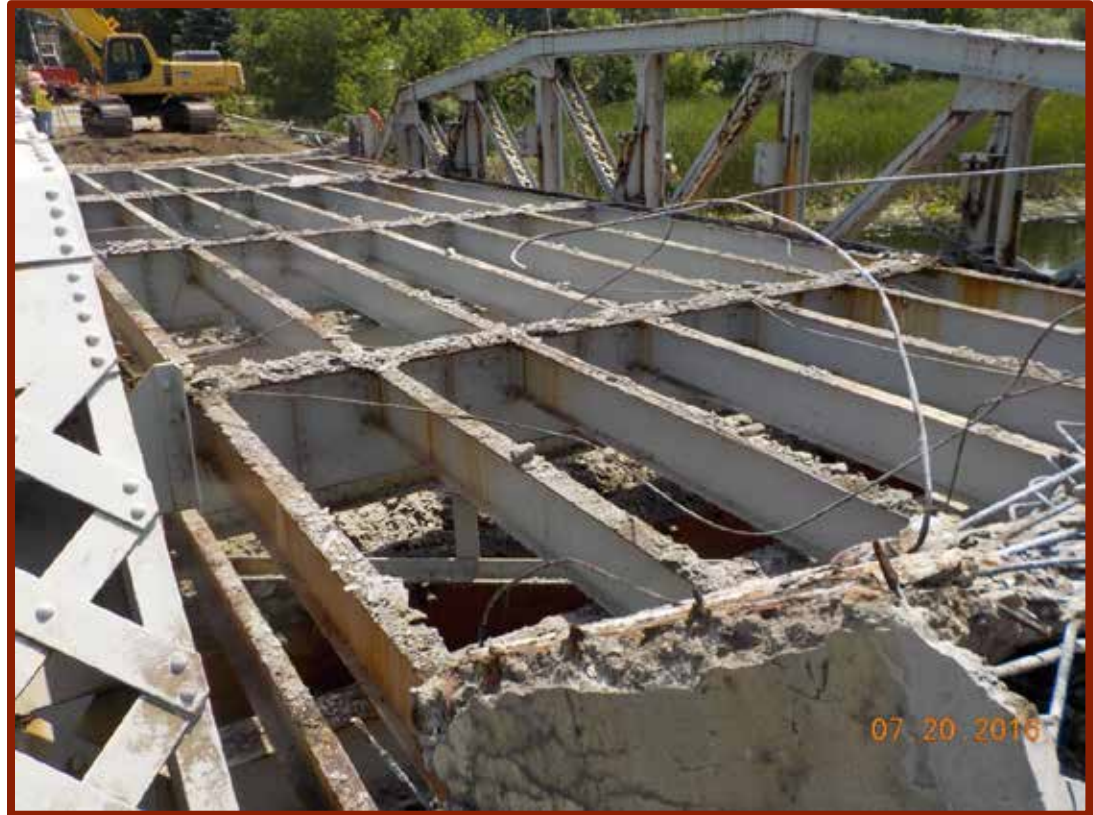
Fascia channels in worst condition. Load rating determined they were not needed. Some channels were replaced.

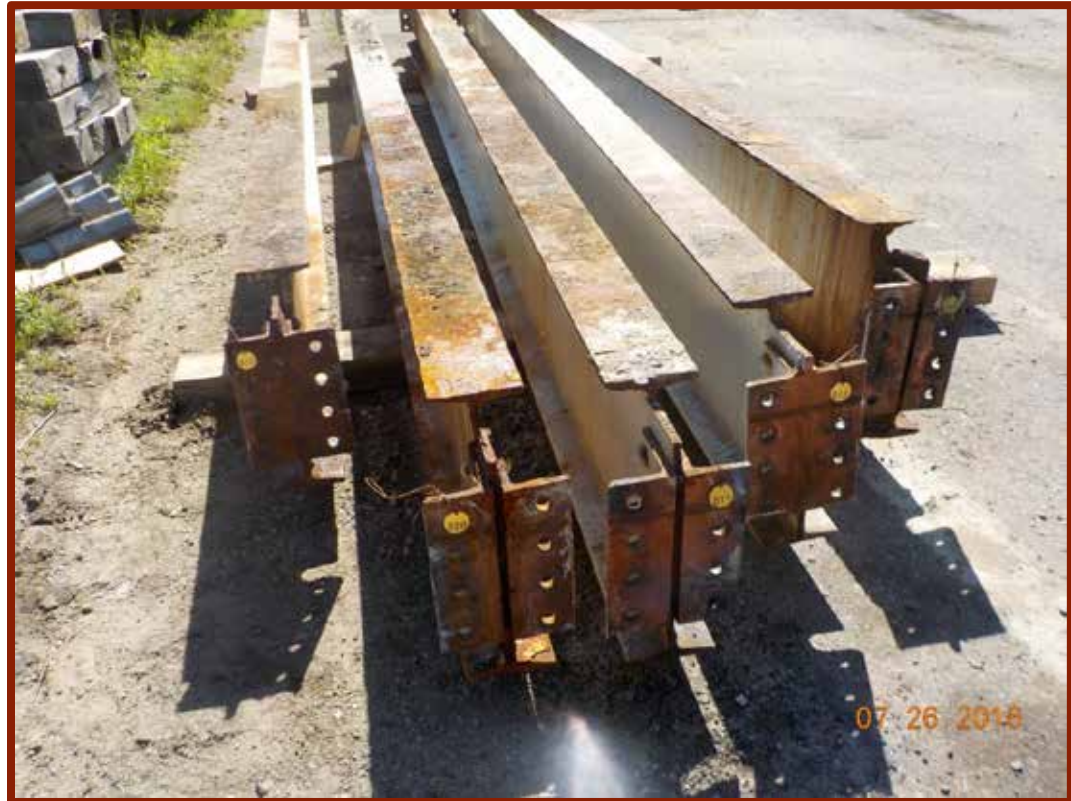
Salvaged stringers.

Note the tags placed on each stringer to indicate location.

Elements to be replaced in original location.

Bolted beam end repairs used on exterior stringers at each corner.

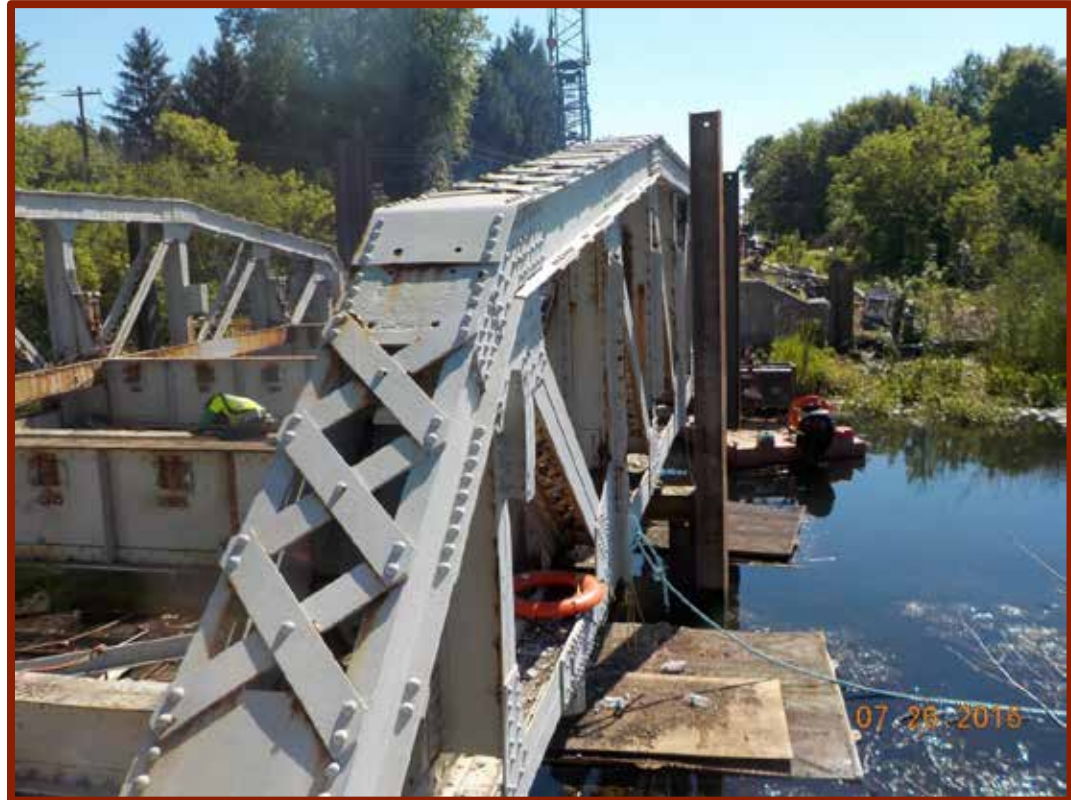
Temporary piles installed to facilitate disassembly of trusses.

Trusses had splice plates to separate into three sections.

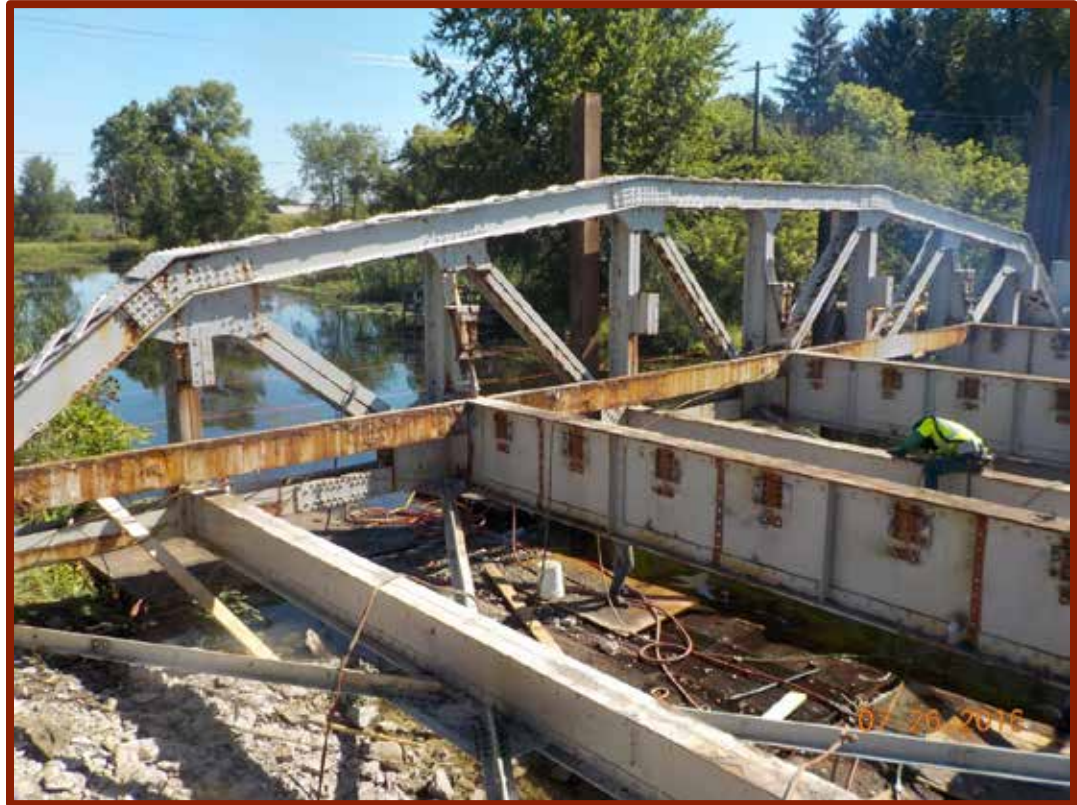
Transverse floor beams and lateral bracing after stringers removed.

Some lateral connection plates and bracing were replaced.

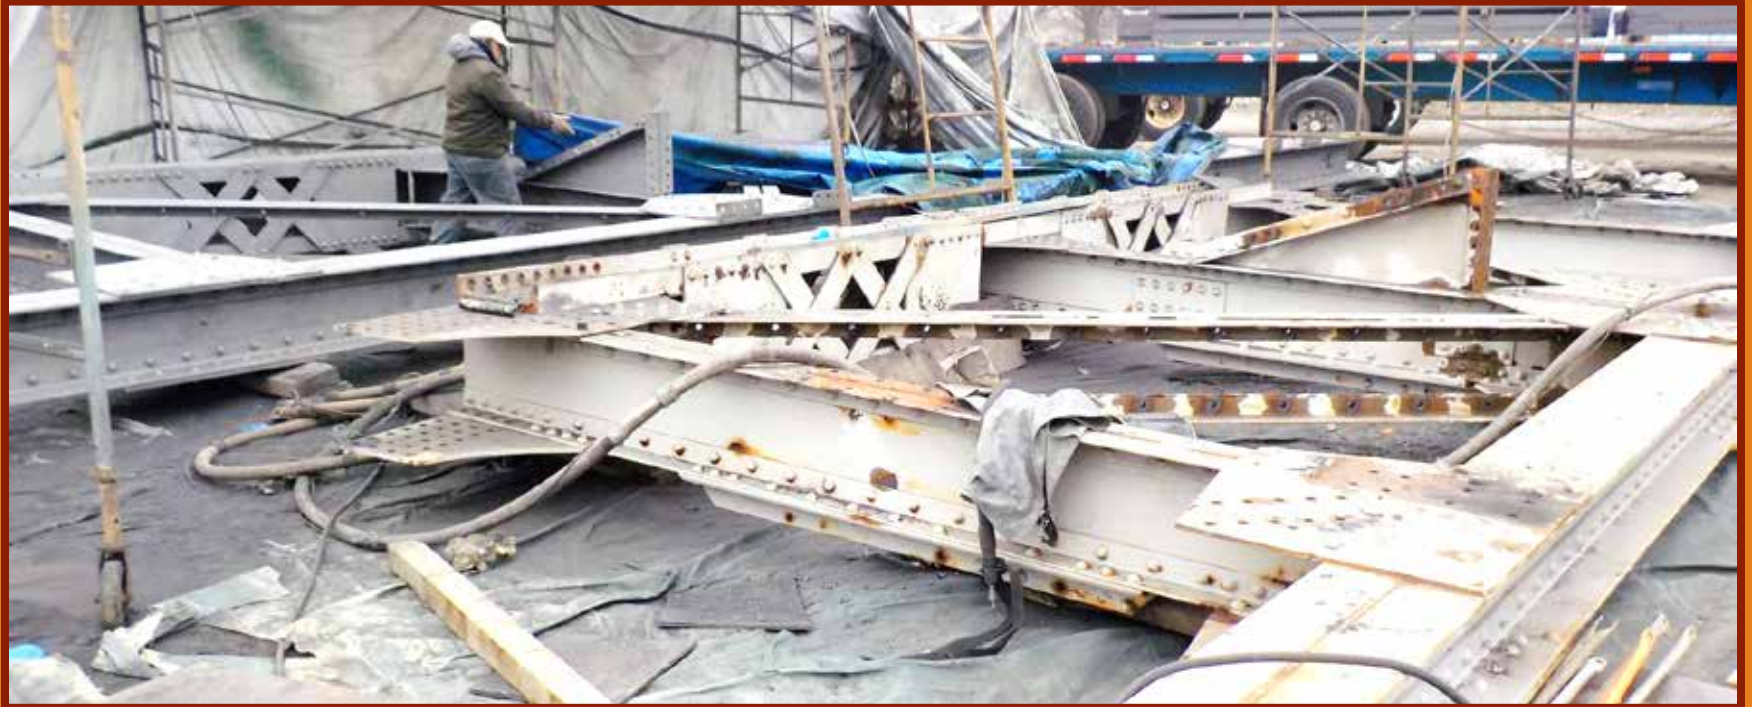
Trusses worked on outside, stringers and smaller elements inside

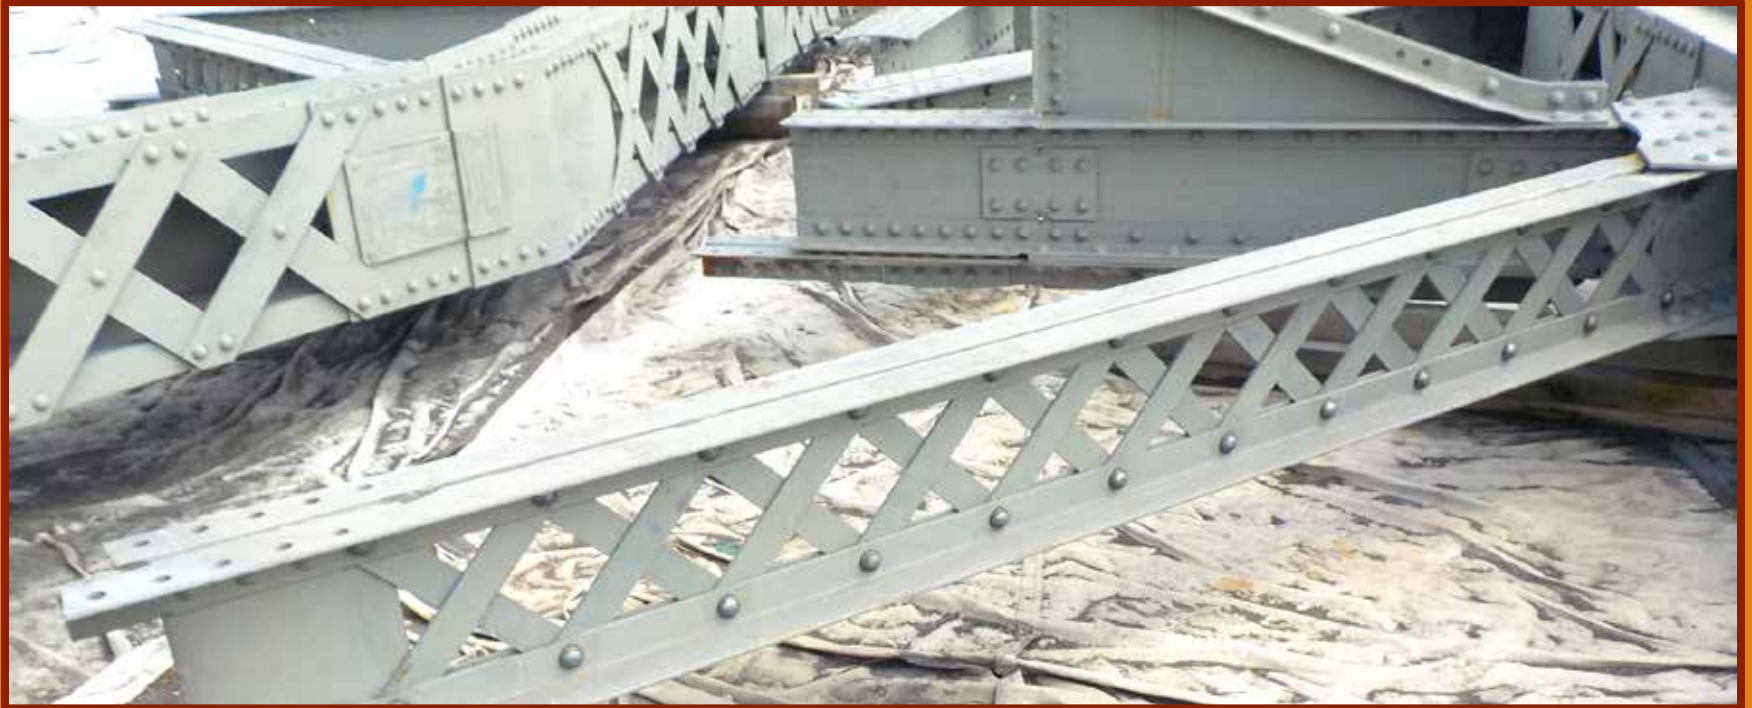
Many of the lacing bars on interior diagonals replaced and new rivets

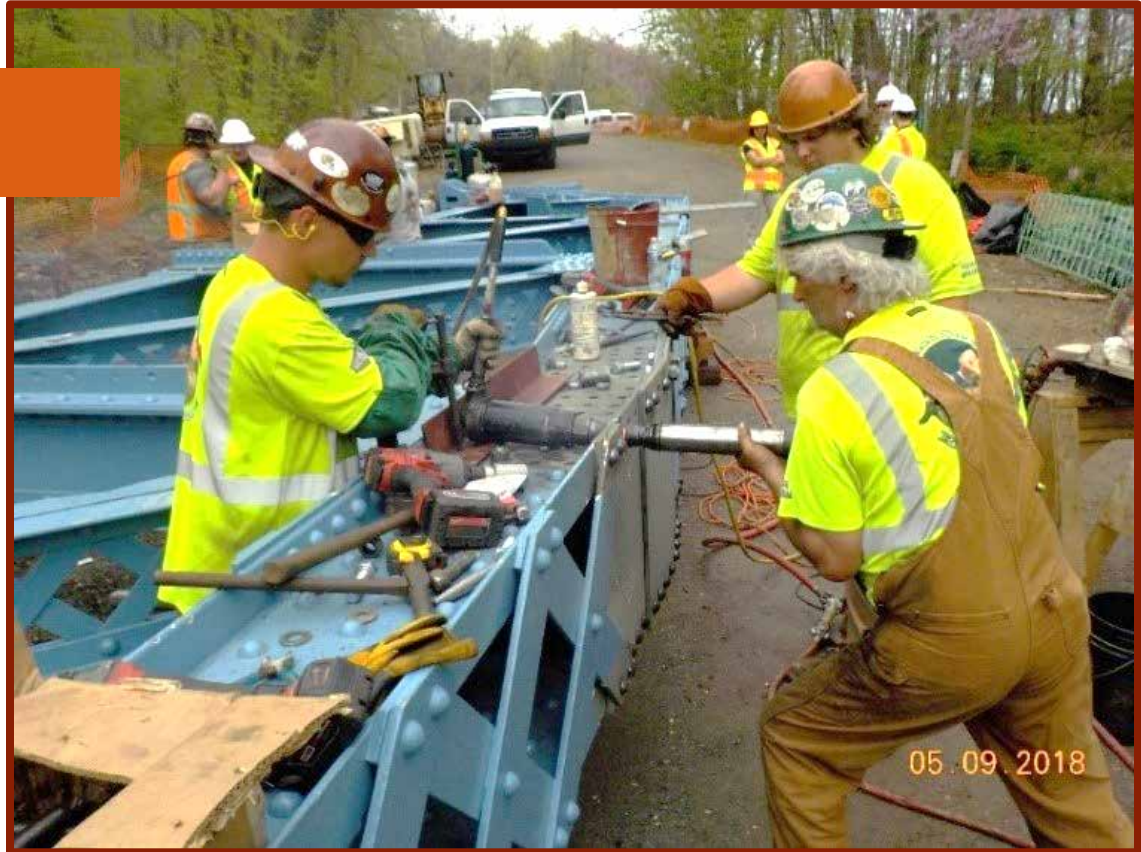
- ▼ Approximately 1800 rivets removed/reinstalled

Trusses  
re-assembled  
on site

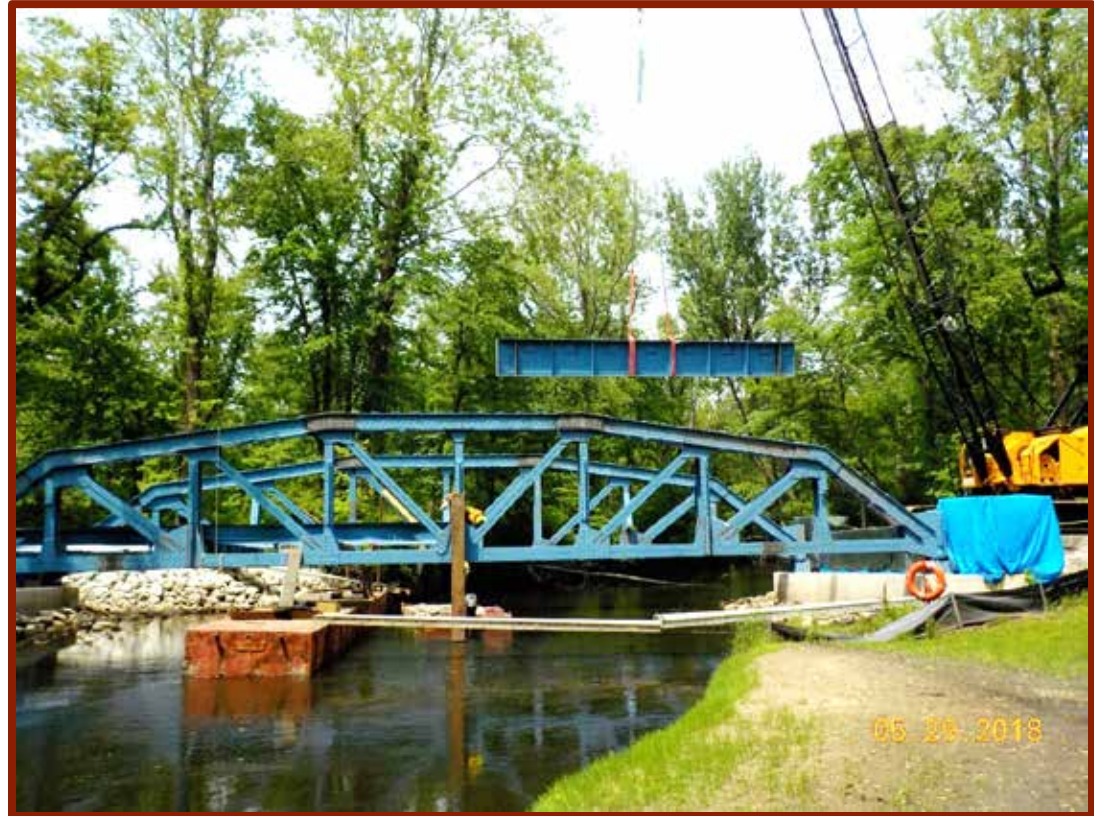
Trusses re-assembled on approaches and then set in place.

Temporary piles set to hold trusses while floor beams are installed

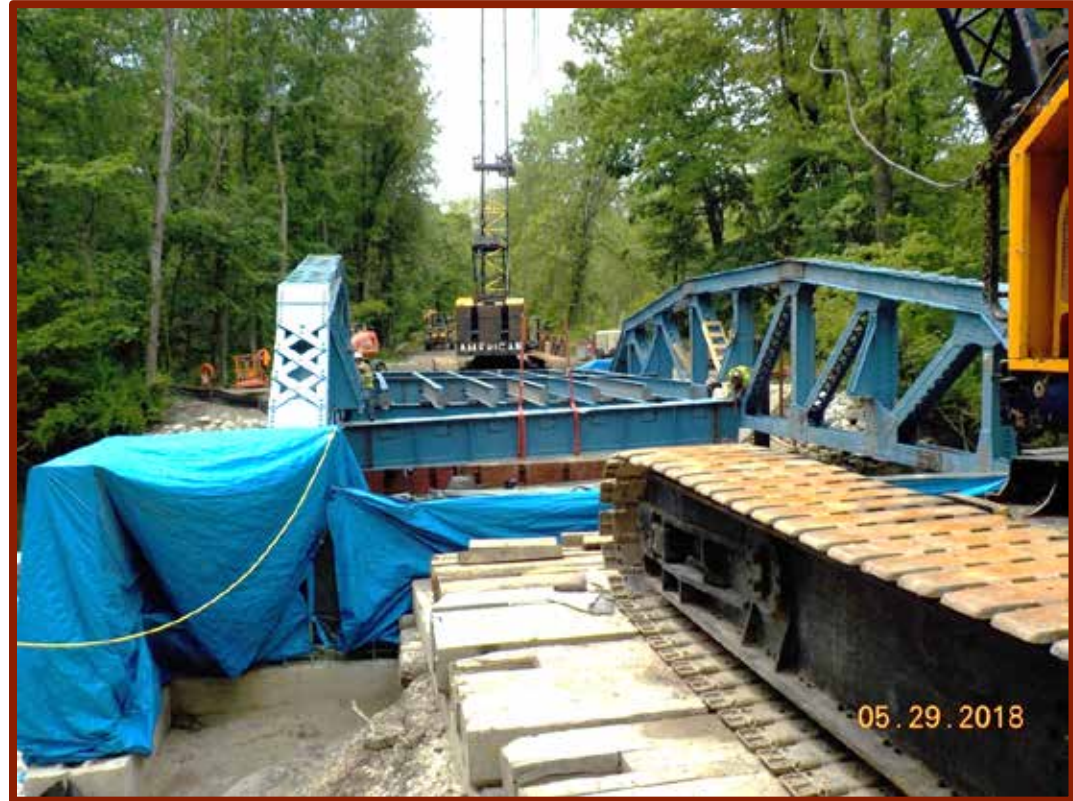
Installing floor beams and stringers.

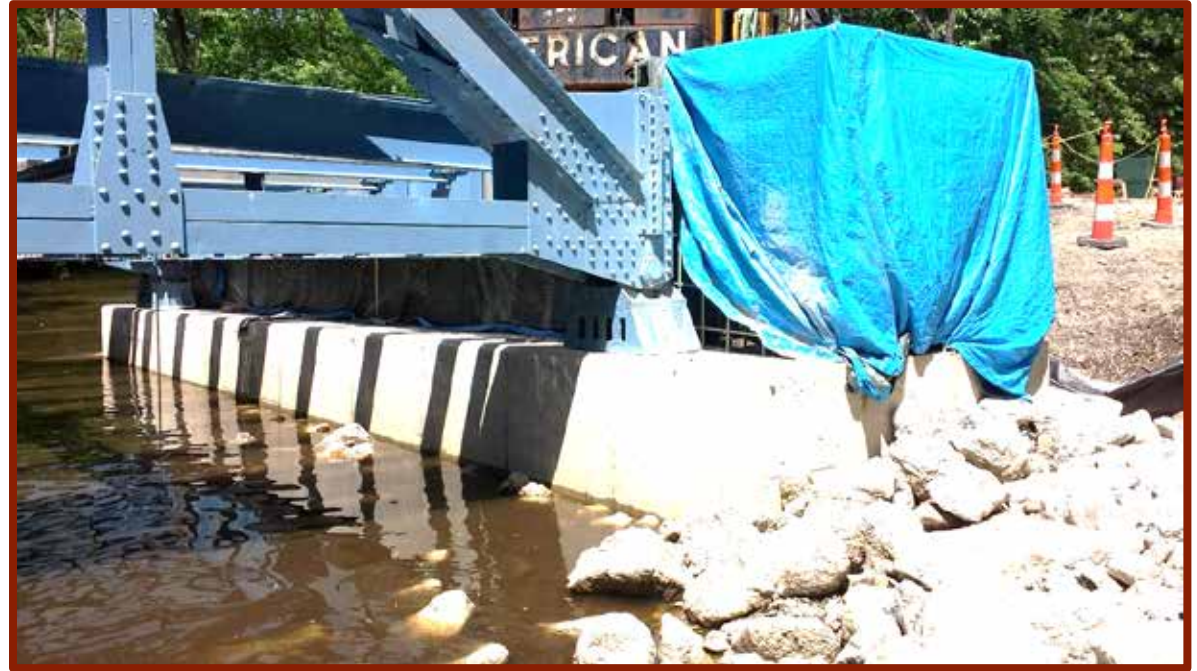
Fixed bearing on sloped abutment.

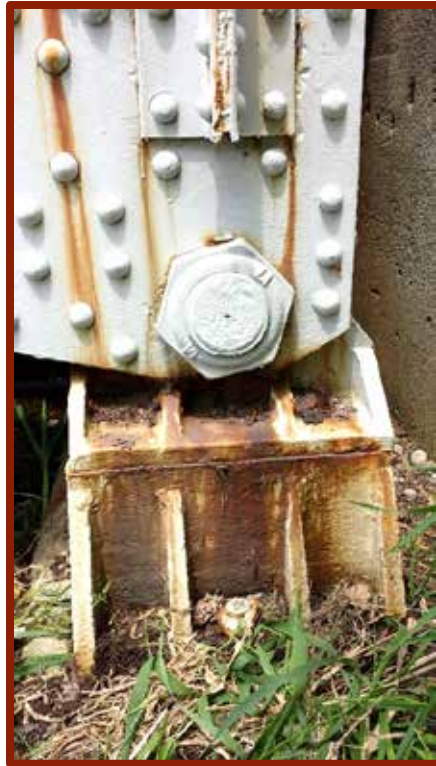
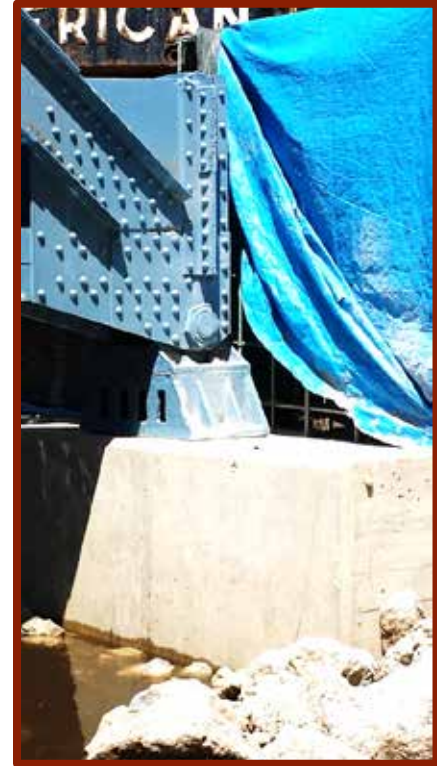
Fixed bearings before and after.

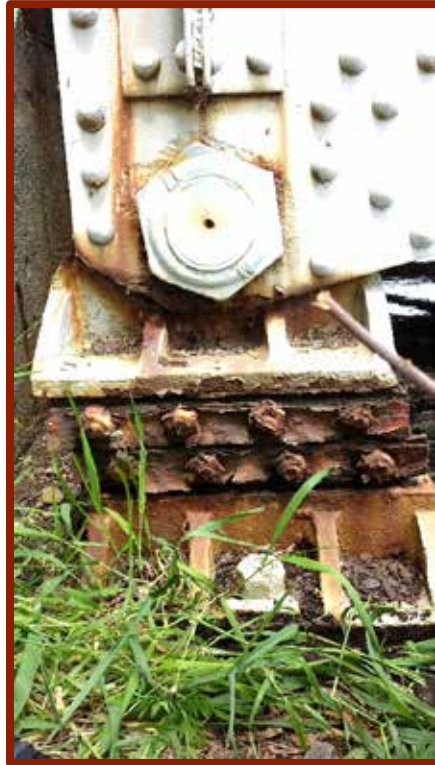
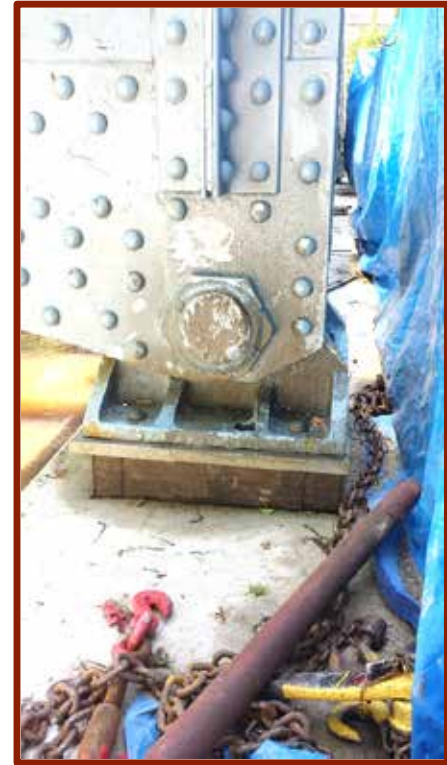
Expansion bearings  
before and after.

SHPO allowed  
replacement of roller  
bearings with  
laminated elastomeric  
pads.

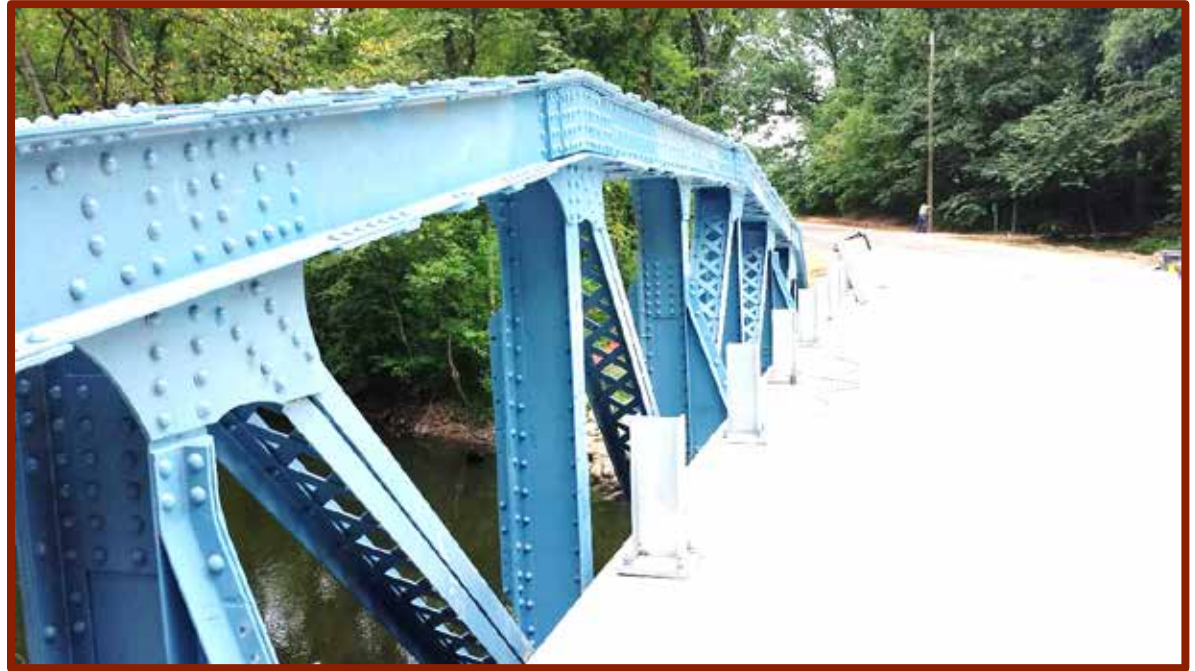
New bridge railing posts on concrete brush block. Old railings were attached to trusses.

SHPO allowed removal of plates for attachment of railings and other elements no longer used (cantilever sidewalk on original bridge).
