Emergency Relief Preparedness Gogebic County

By: Darren Pionk, P.E.
Engineer/Manager
Gogebic County RC

History of Natural Disasters in Gogebic County

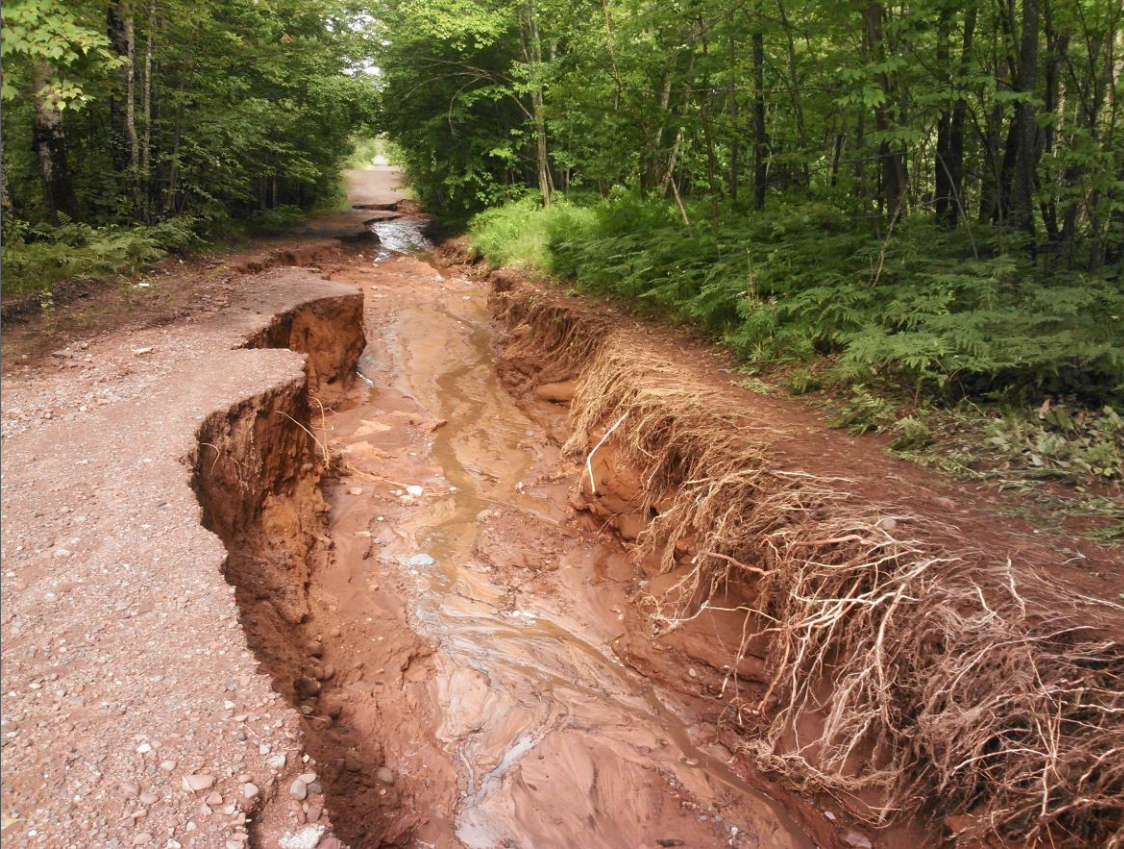
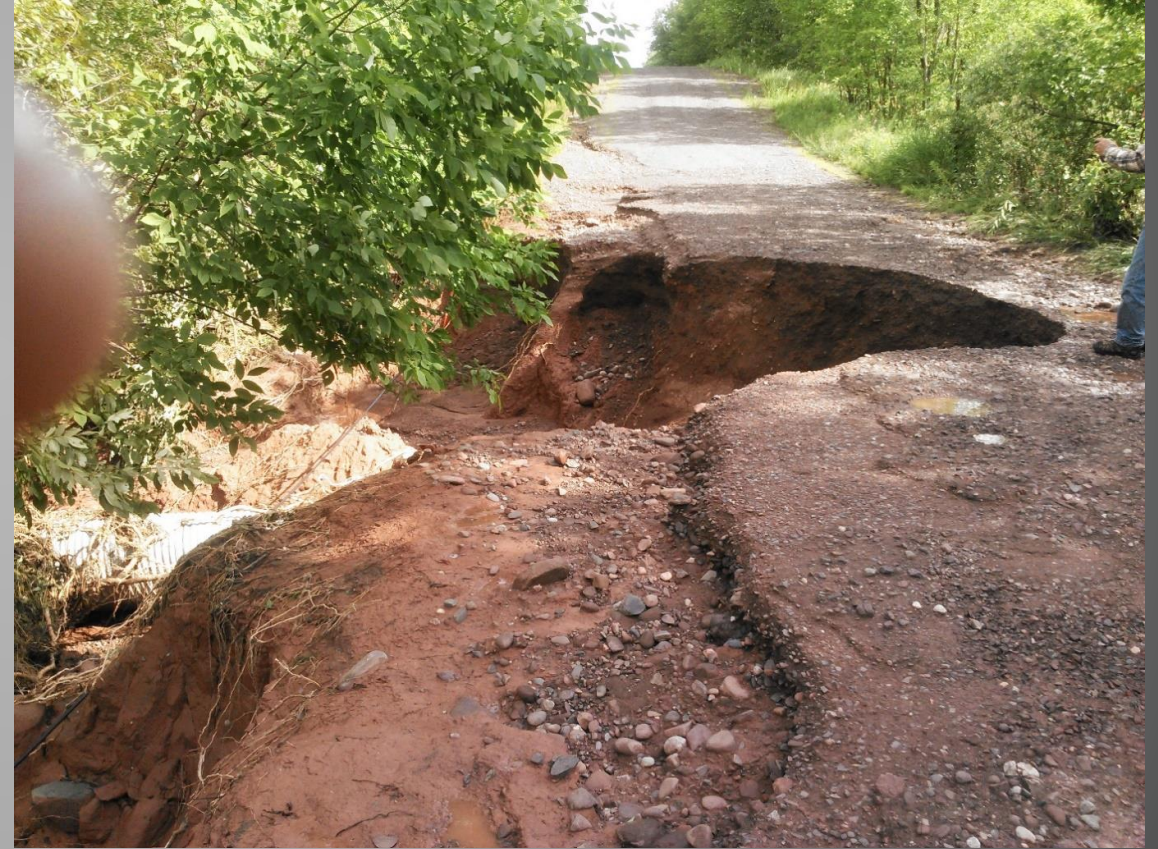
Powers Road Damages Local Roads

Washouts and Road Failures
(Several Locations over 8 miles)

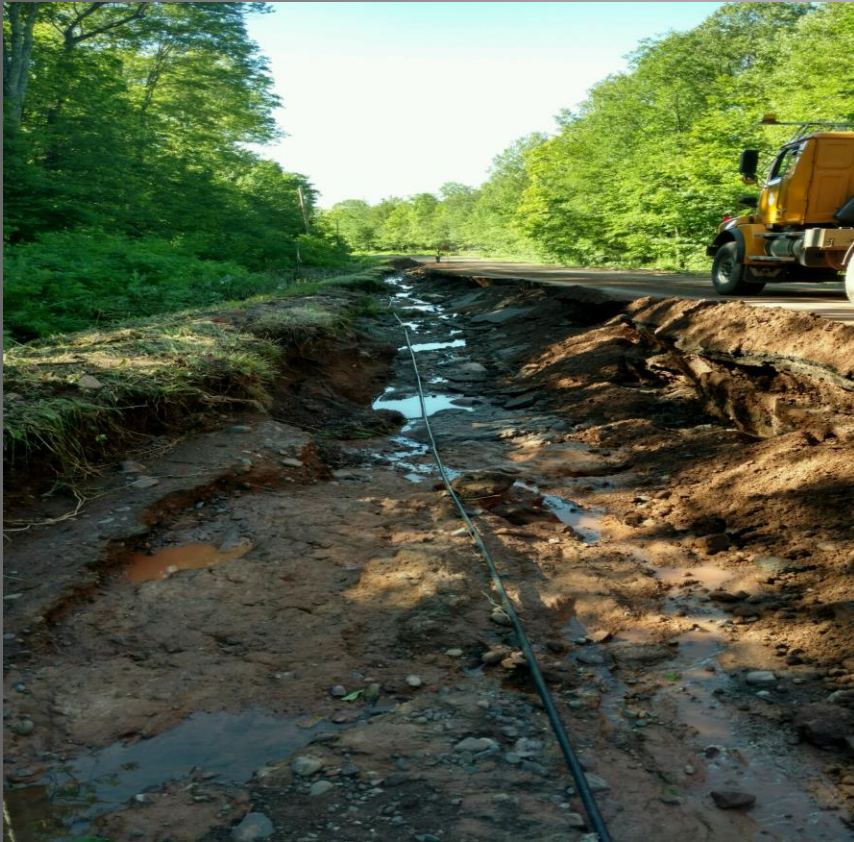
Lake Road ½ mile lane washout

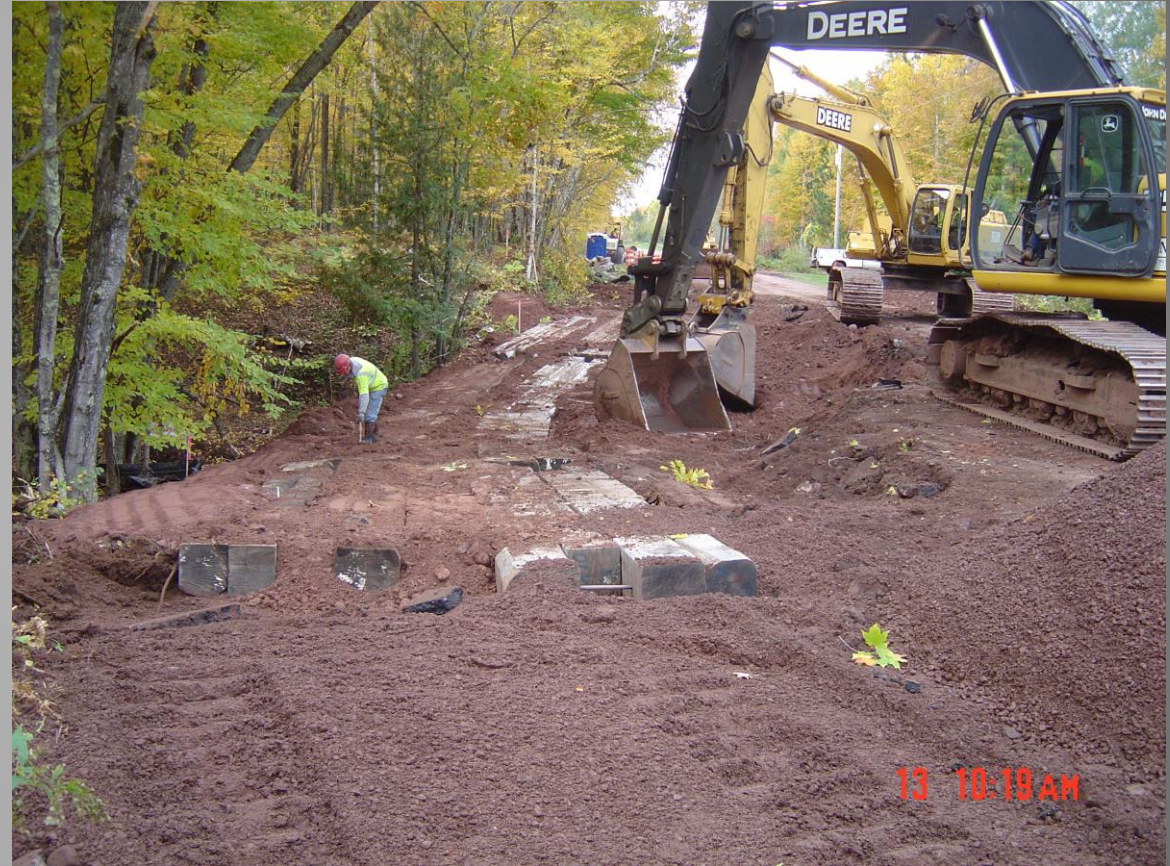
Culvert #17 temporary access lane

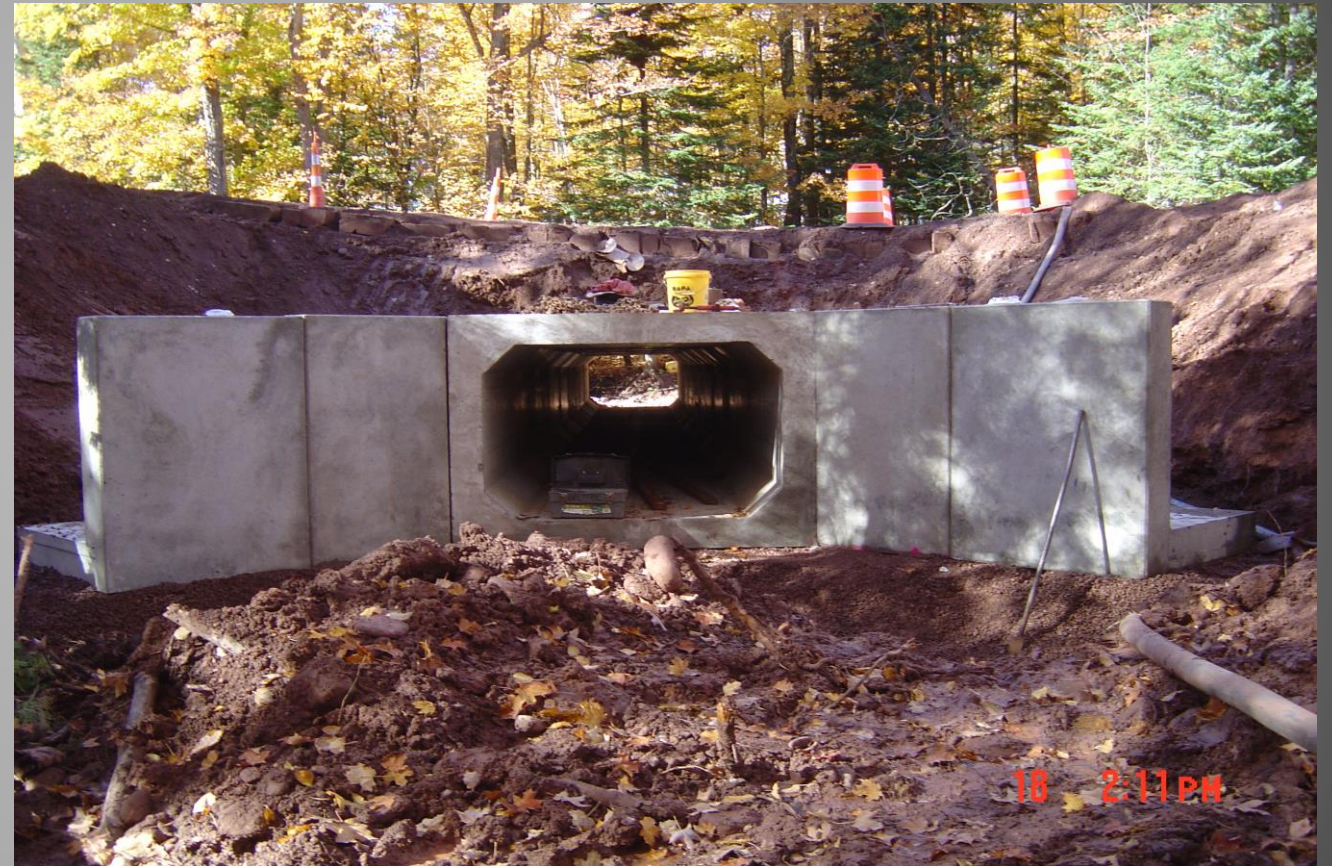
Culvert #18 Inlet

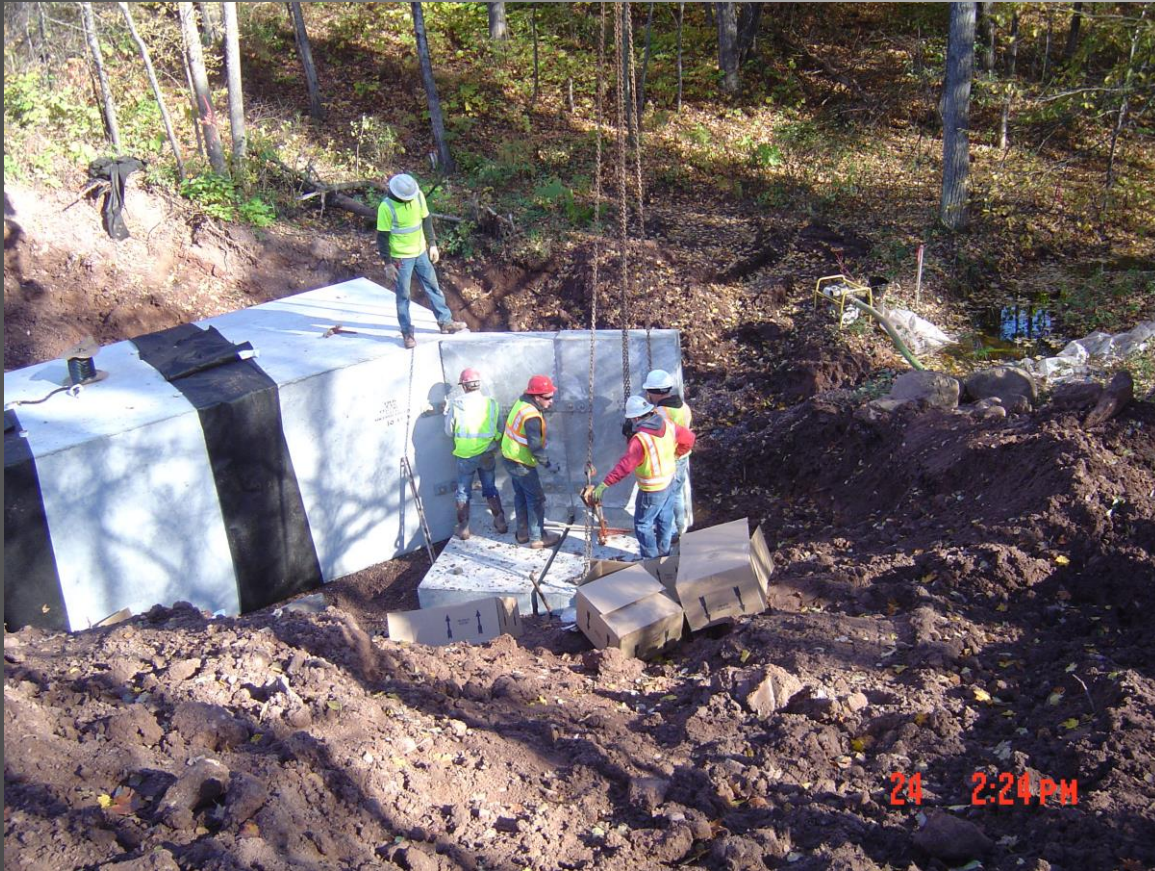
Culvert #21 Wingwalls

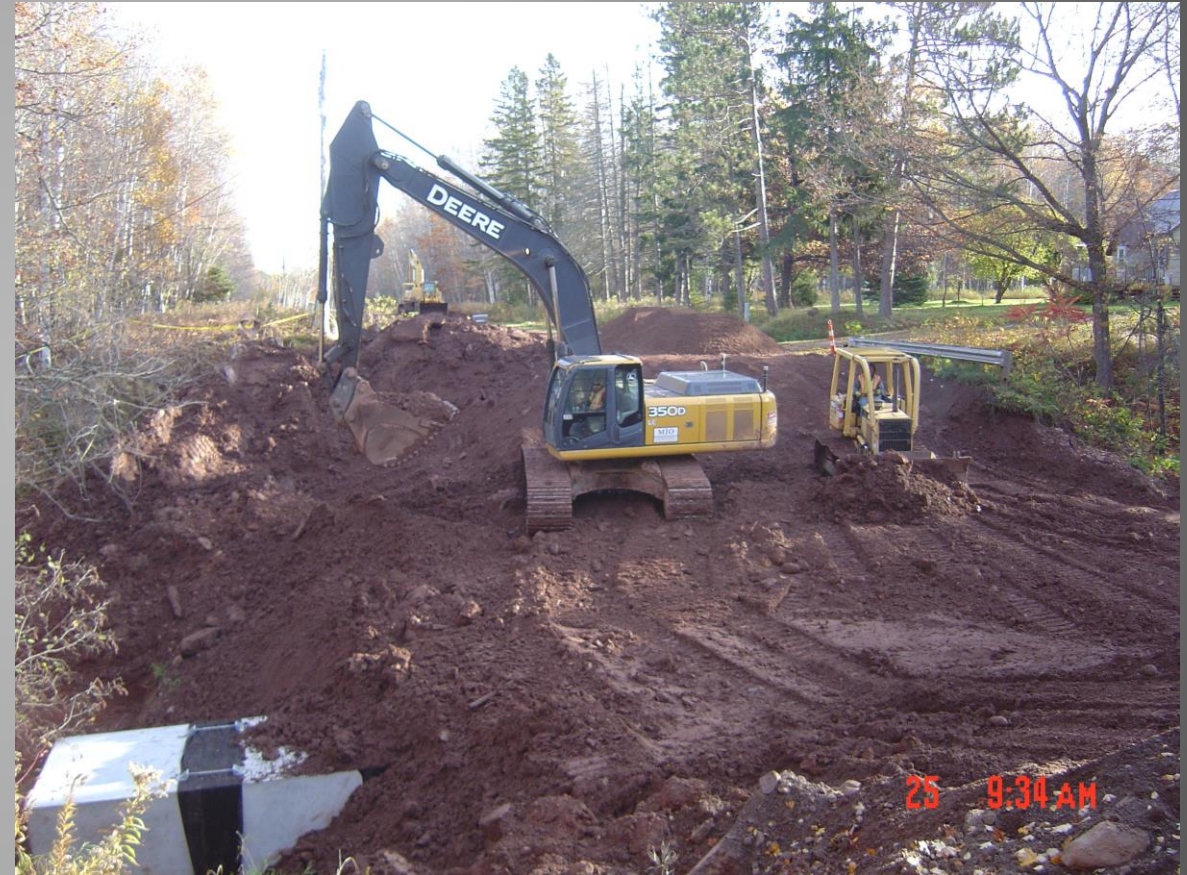
Culvert #21 Backfill

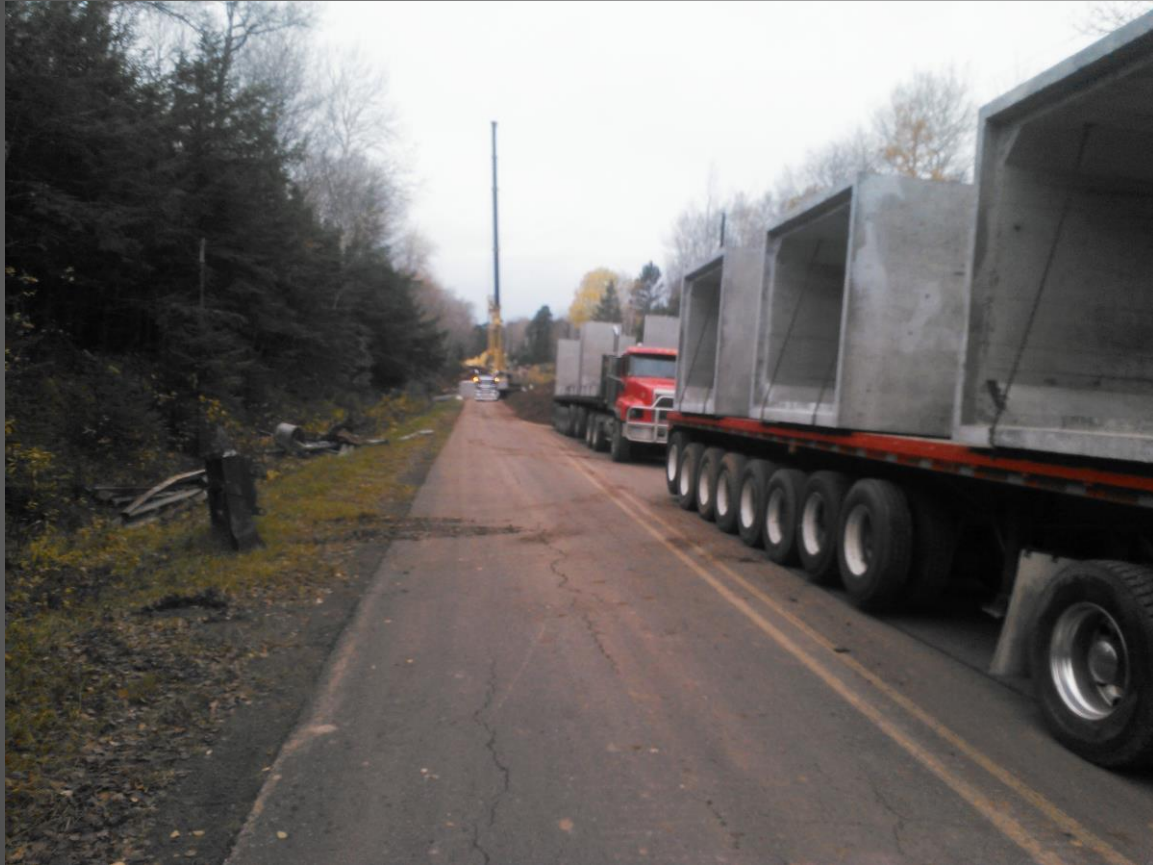
Culvert #27 Pipe Delivery

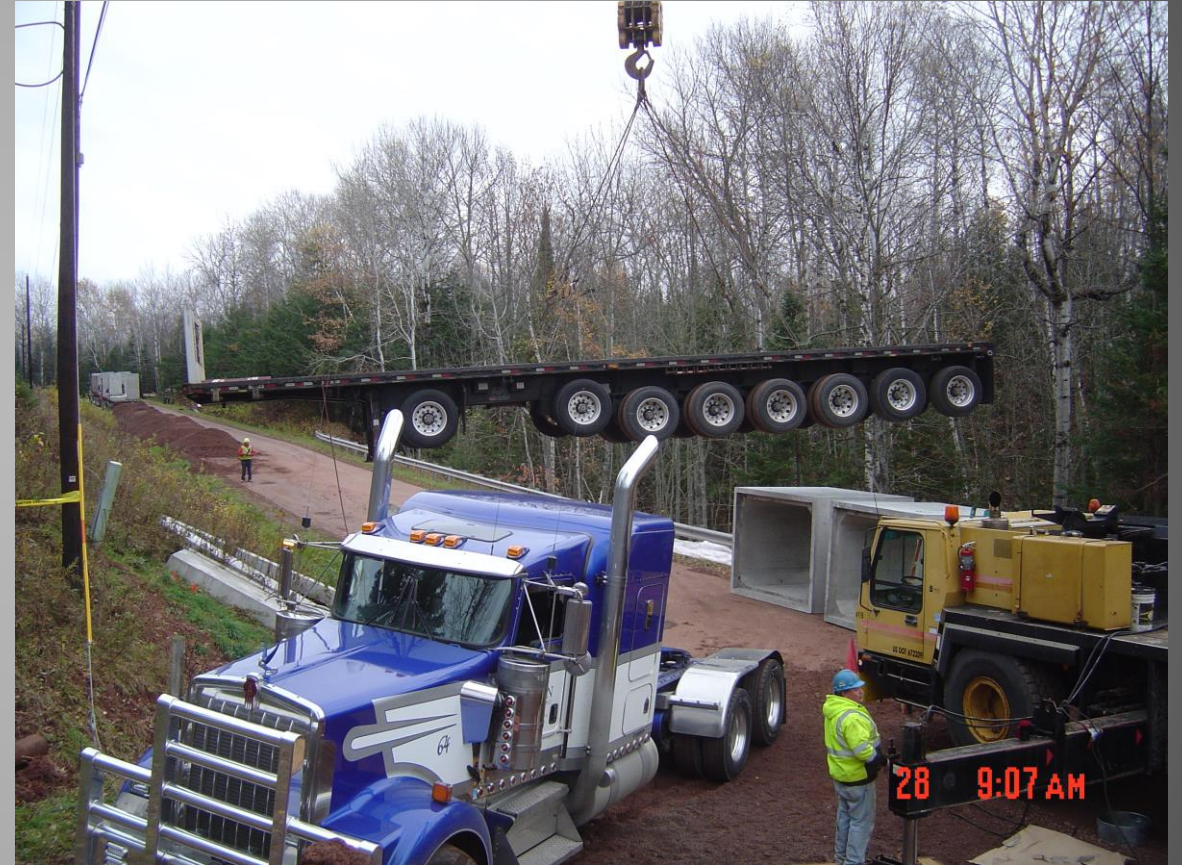
Tight Construction Sites

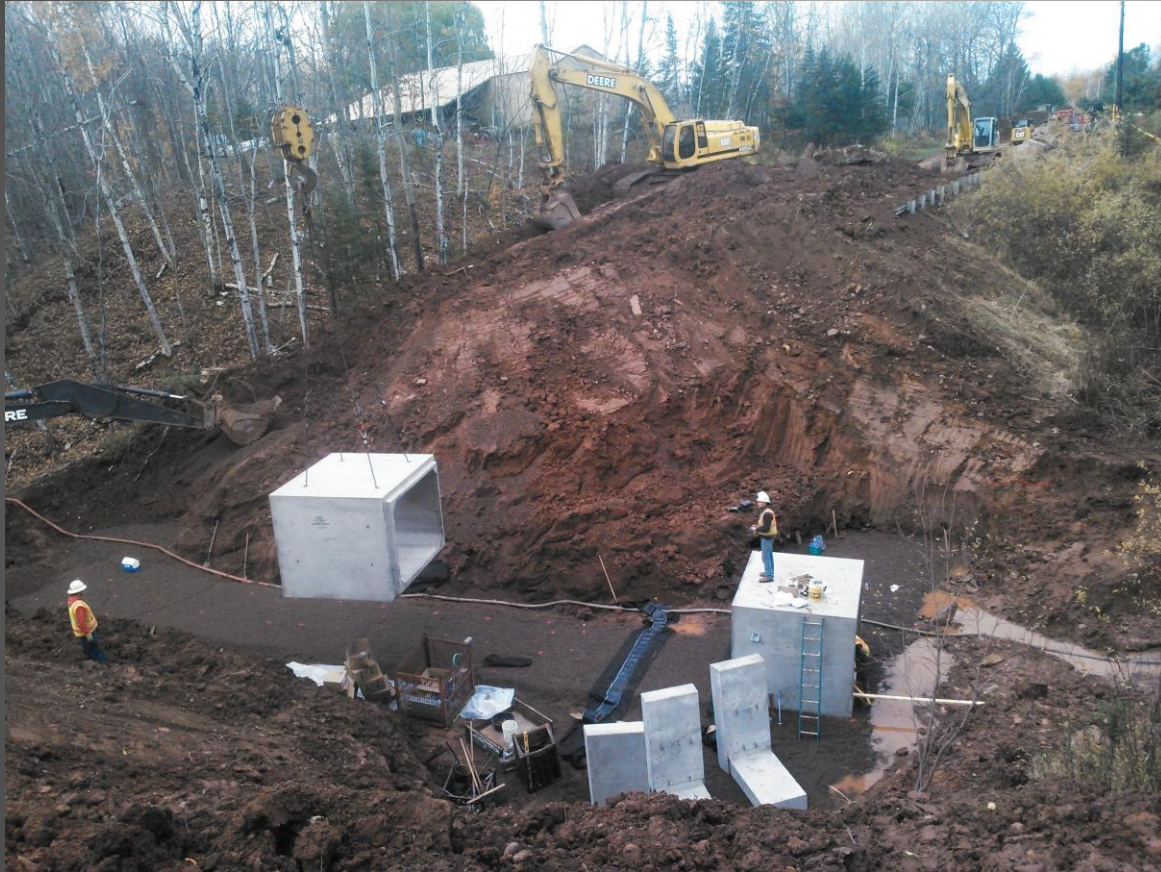
Culvert #27 Pipe Installation

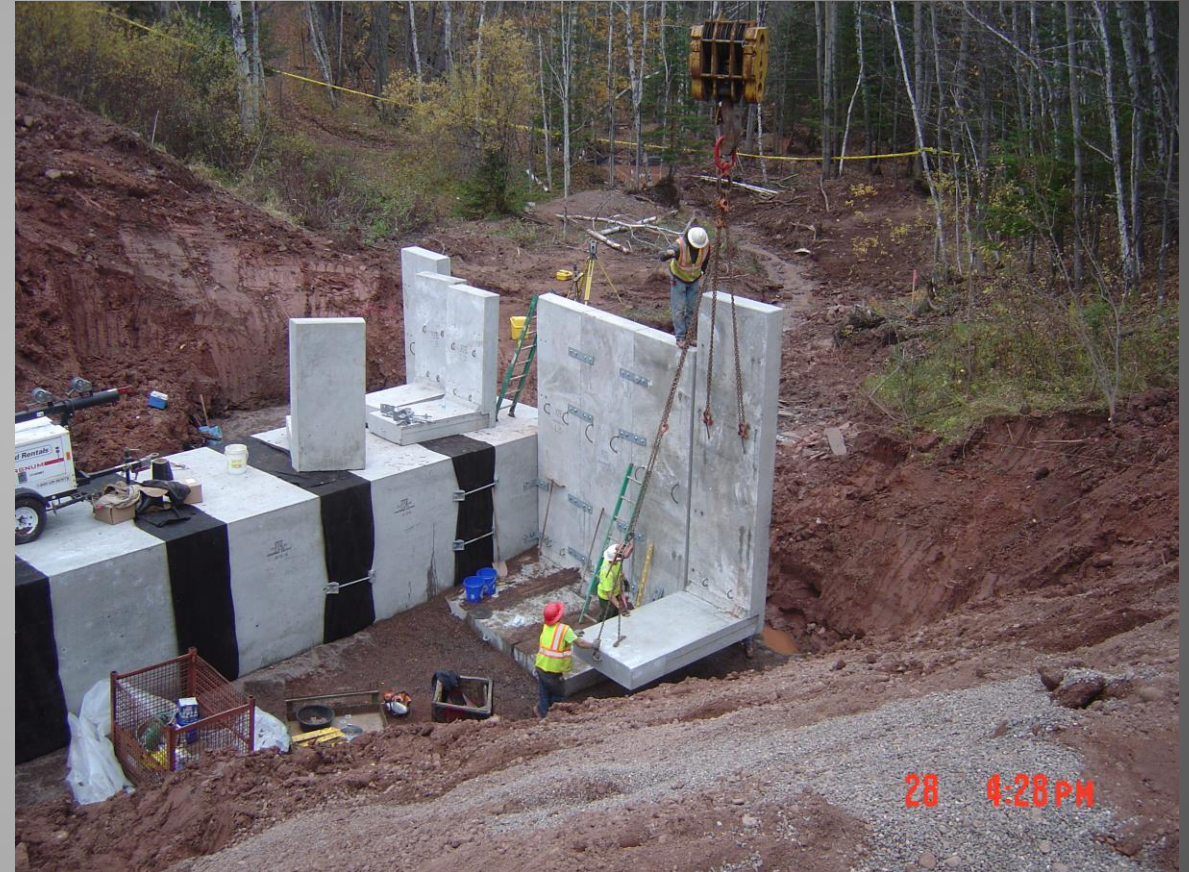
Culvert #27 Headwall

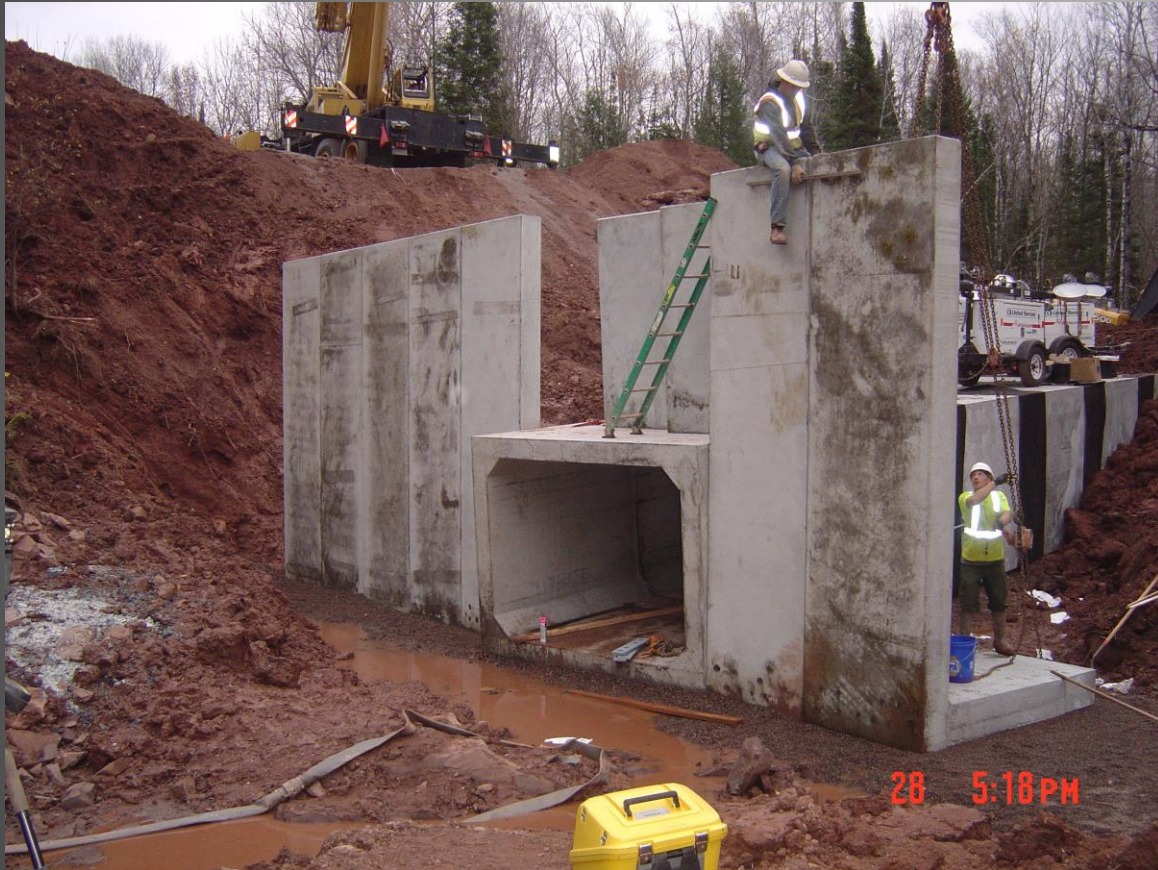
Culvert #27 Outlet

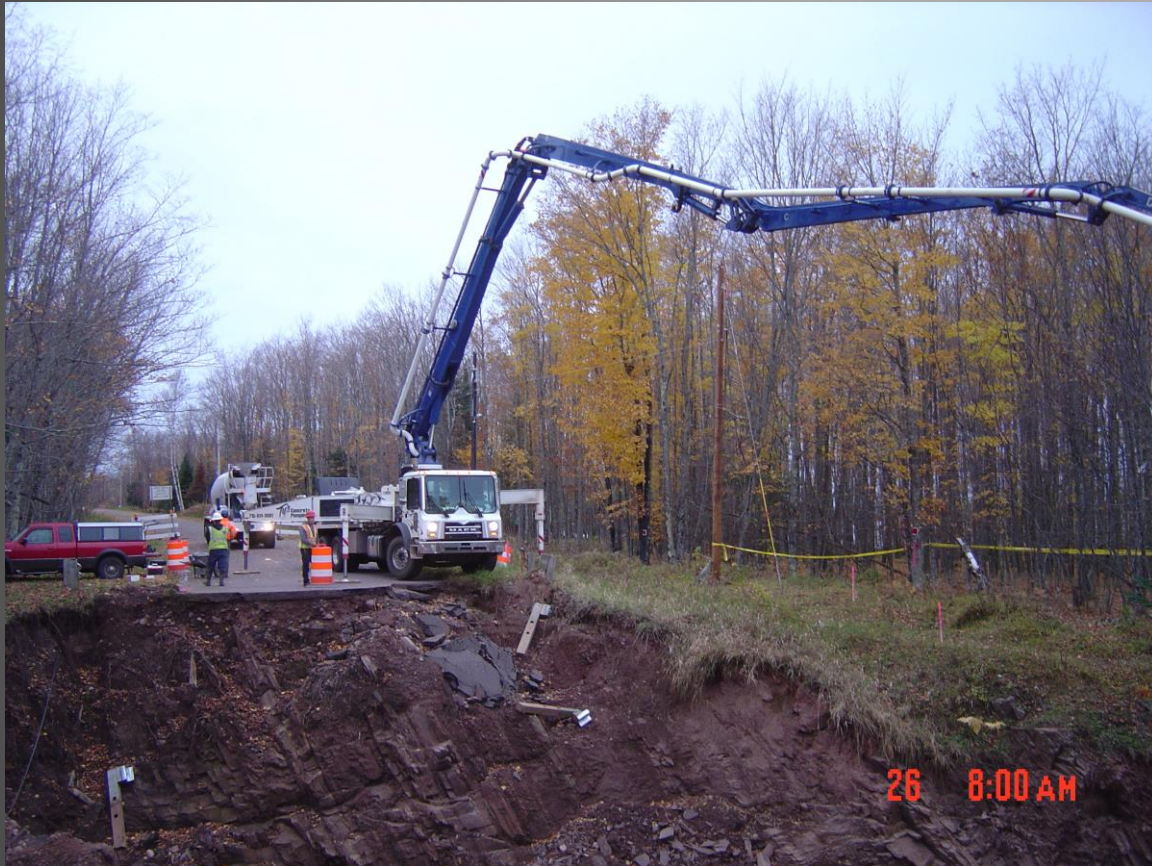
Culvert #13 Concrete Pump Truck

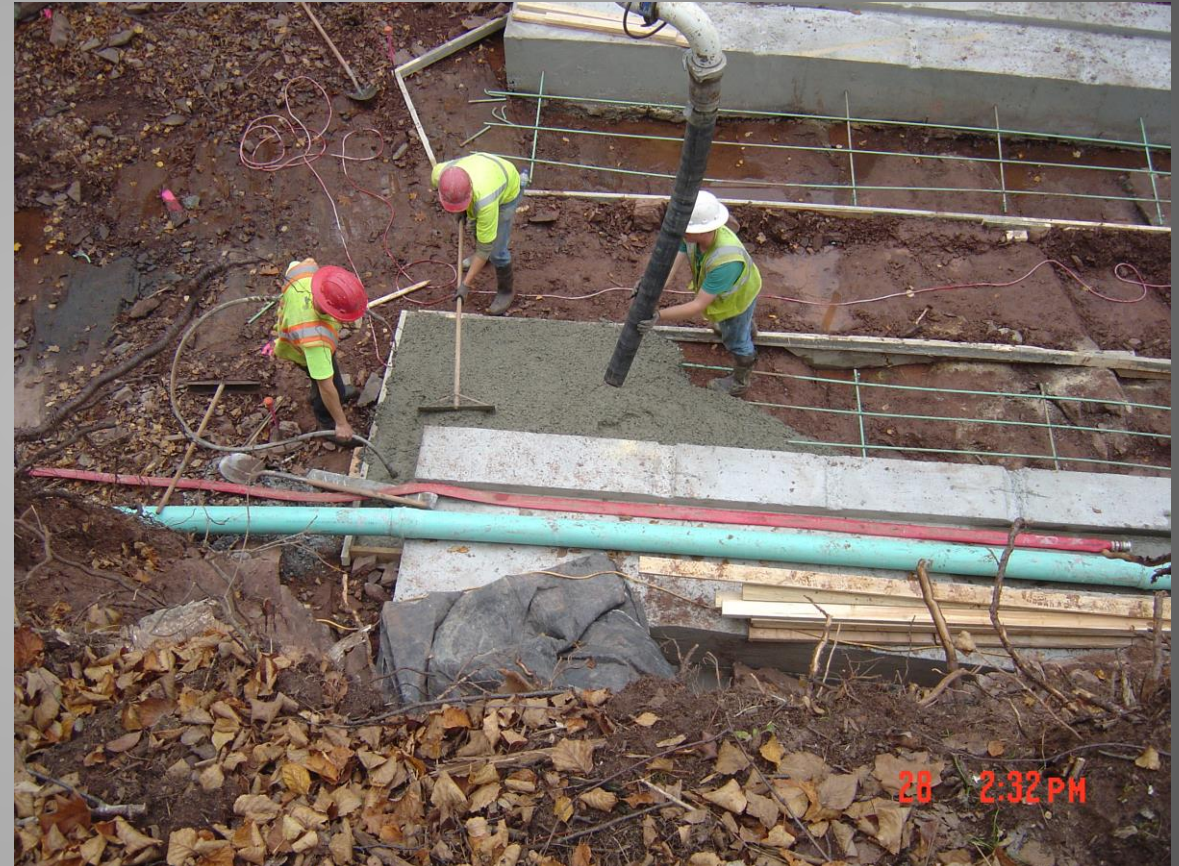
Pouring Sloped Channel

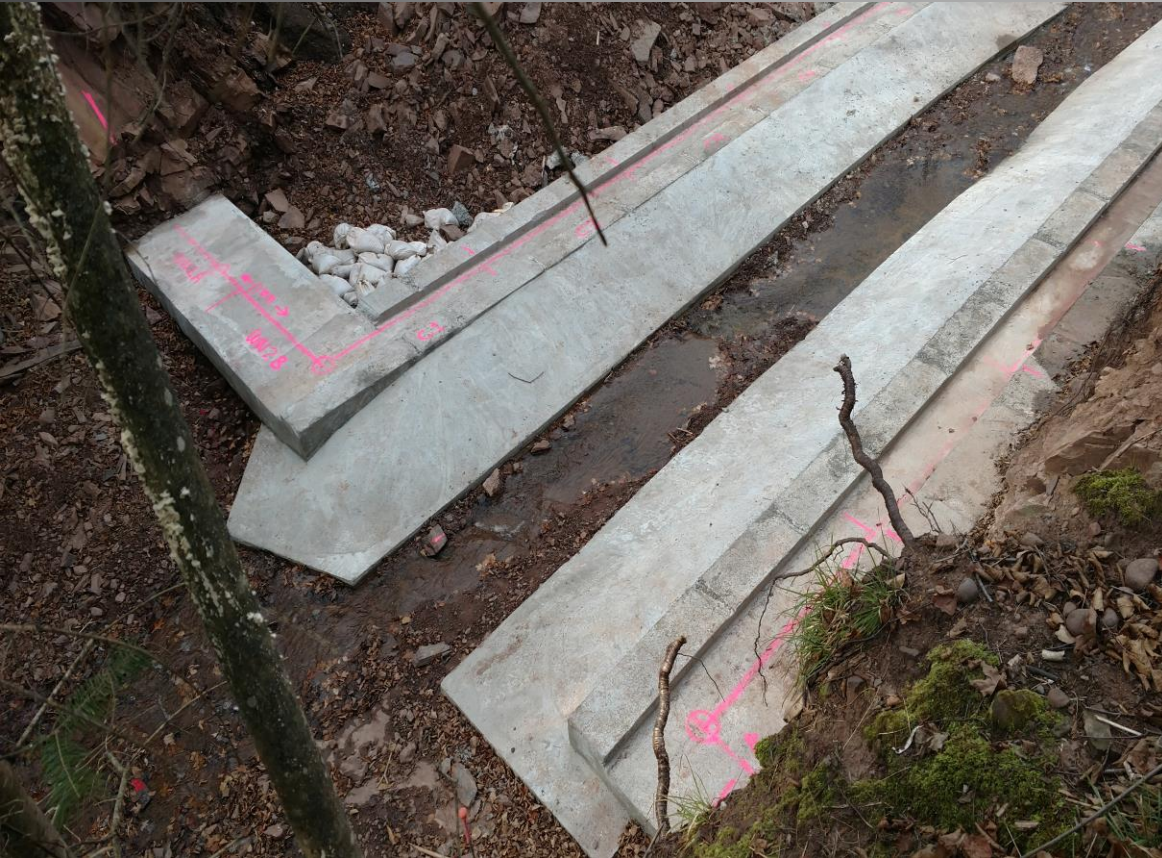
Foundation turned into rock cliffs

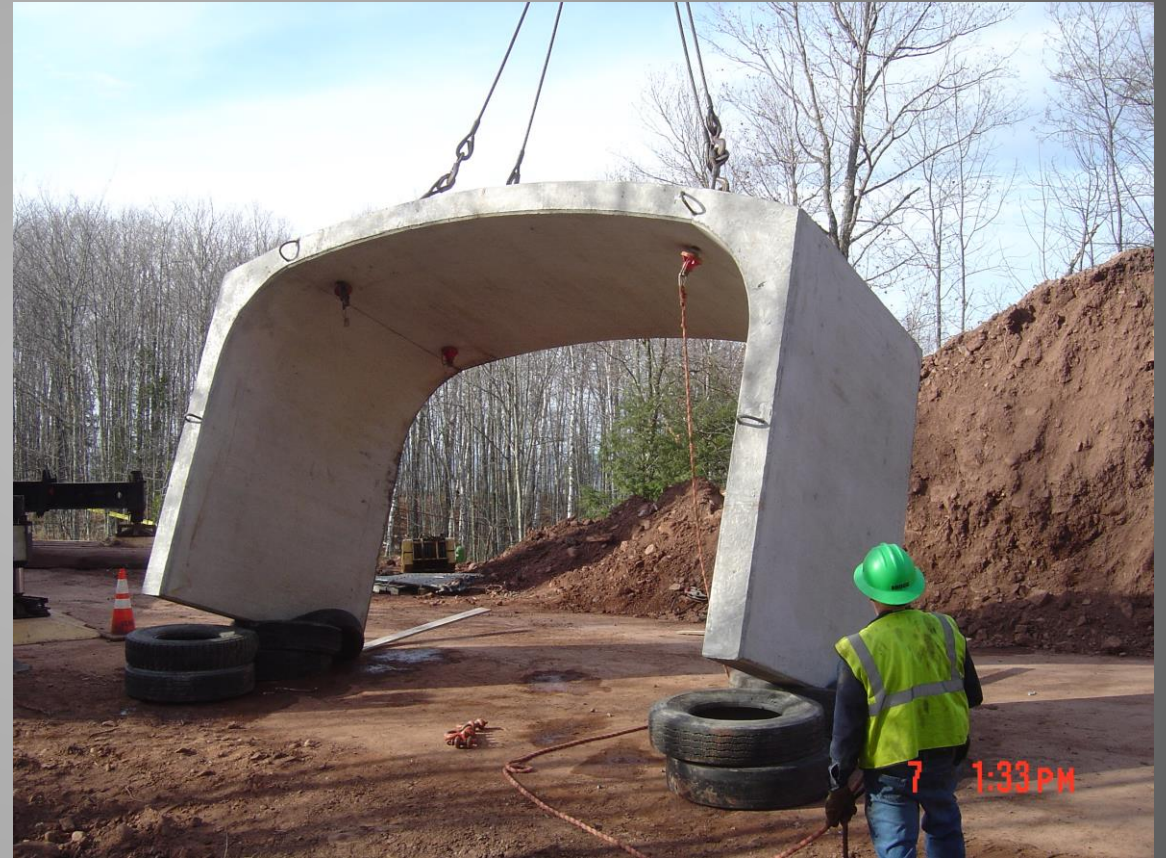
Culvert #13 Con Span Sections

- Topo Survey, Drainage Areas, Concept Designs
- Coleman Engineering (9 sites)
- AECOM - Con Span Structure

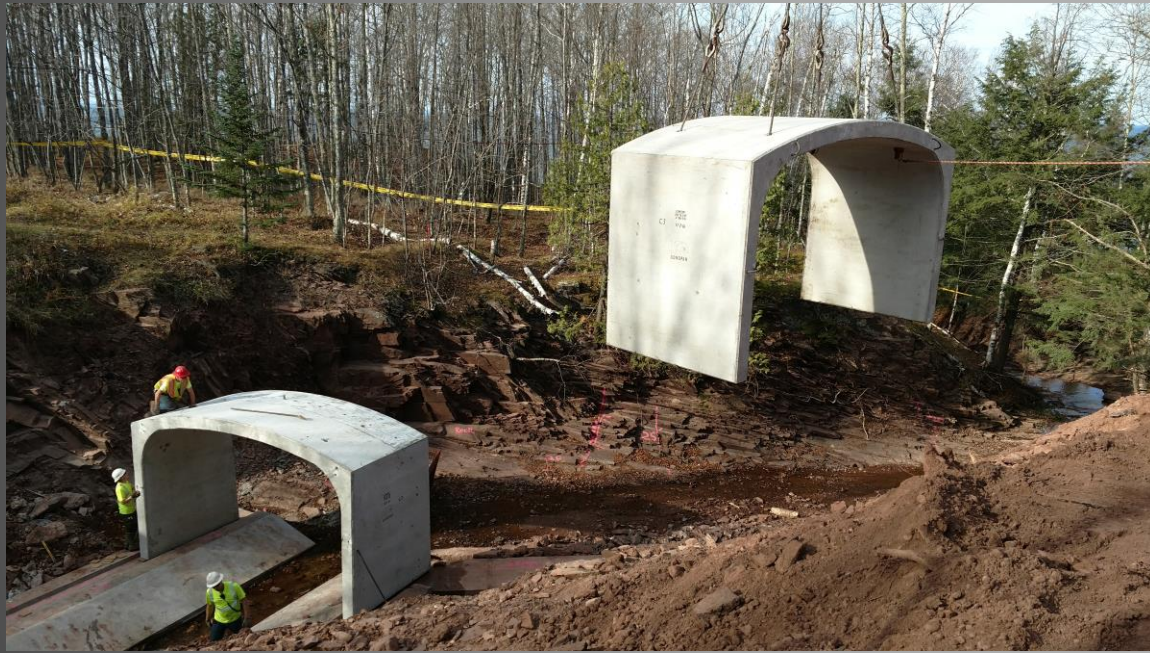
Setting Con Span

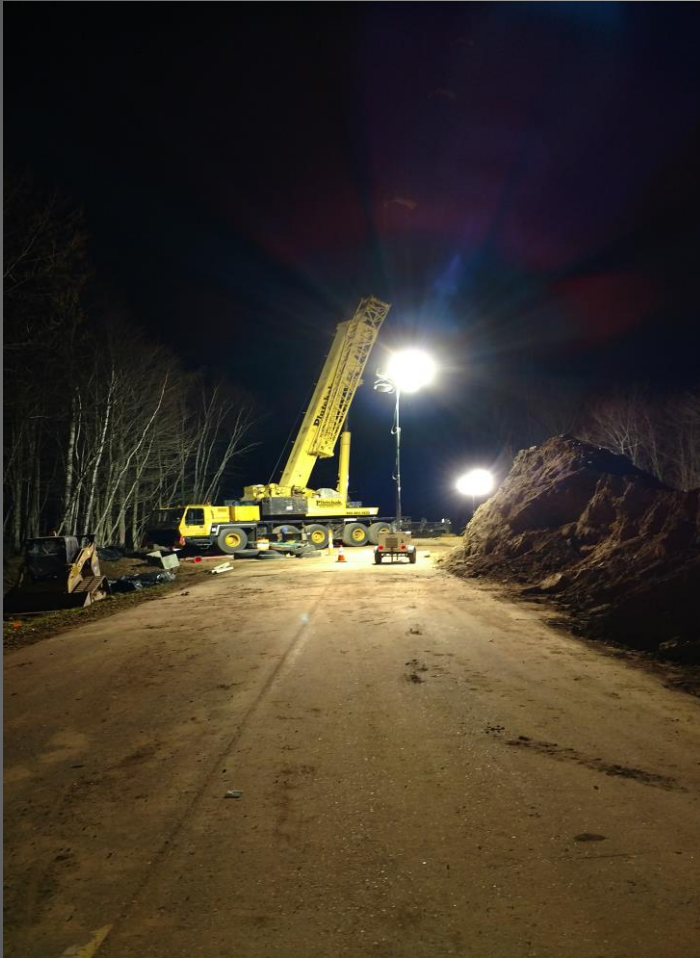
Project set up for Night Work

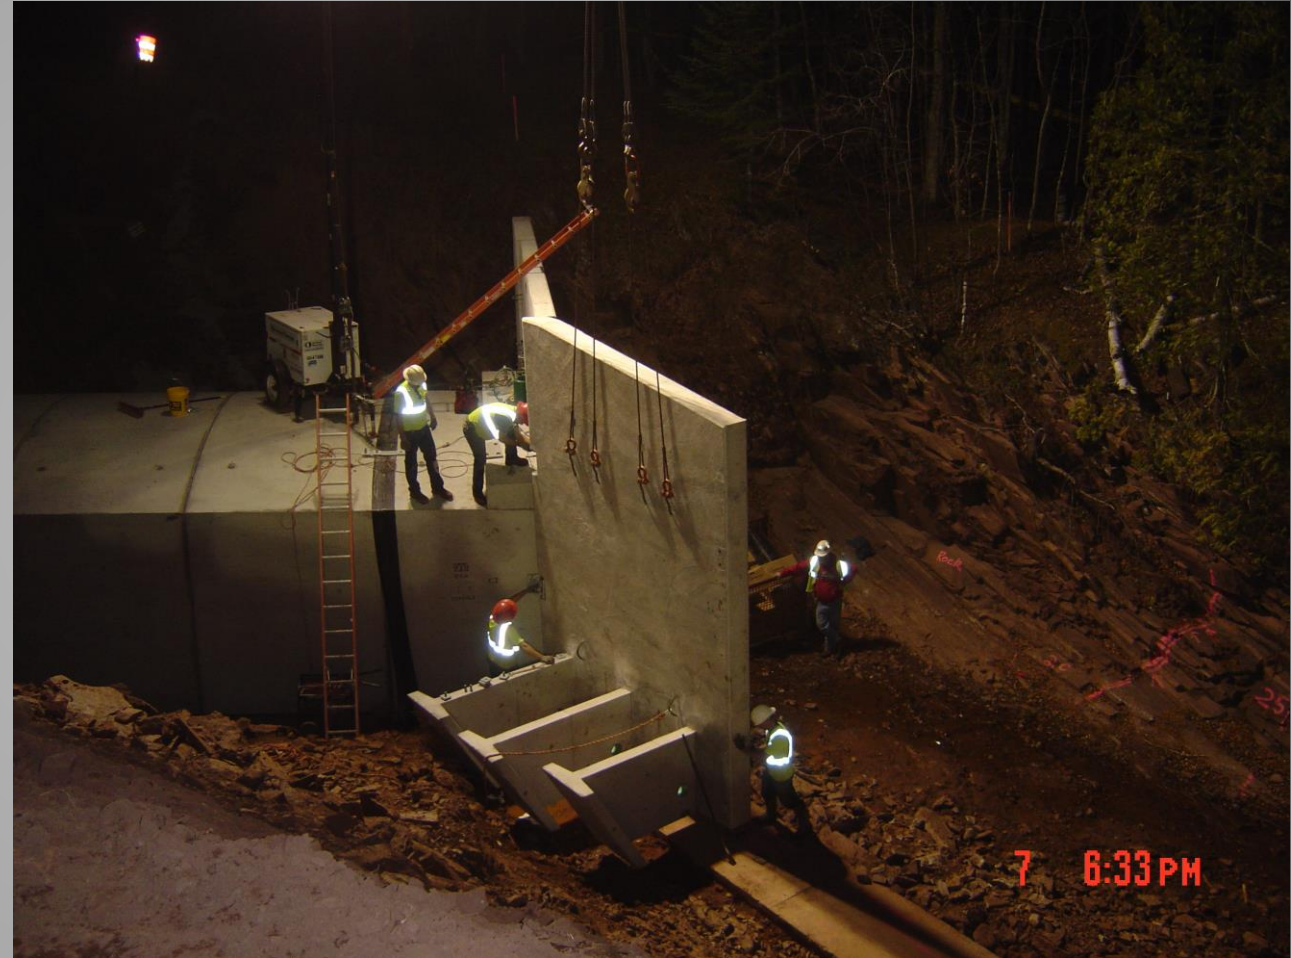
Retaining Wall Sections

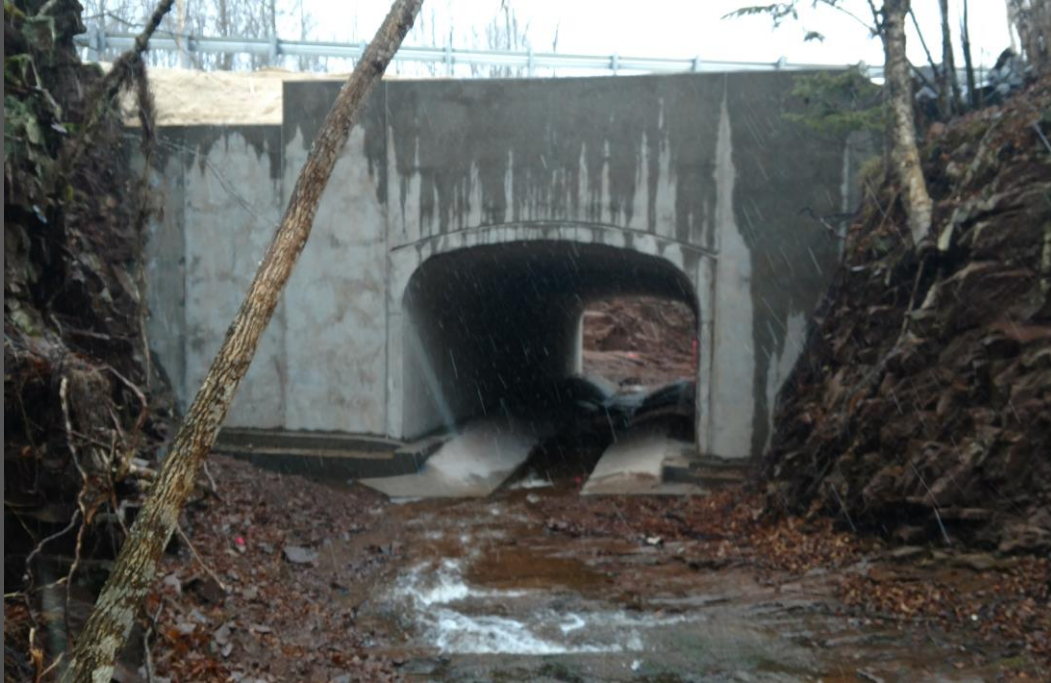
Inlet of Culvert 13 – Flink Creek

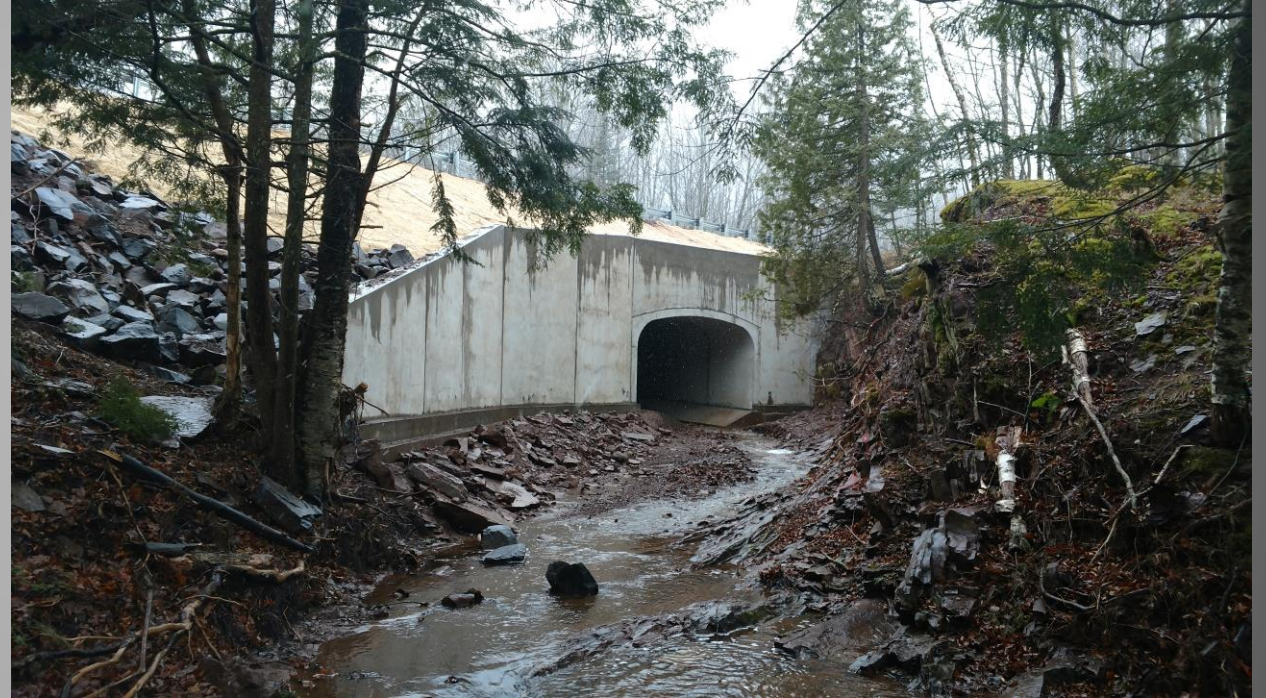
Outlet – Flink Creek
