Evaluation of Centerline Rumble Strip Impacts on Short-Term Pavement Performance

Peter Savolainen, Ph.D., P.E.

October 11, 2018

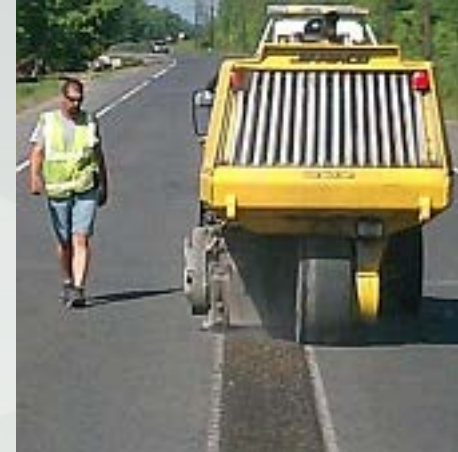
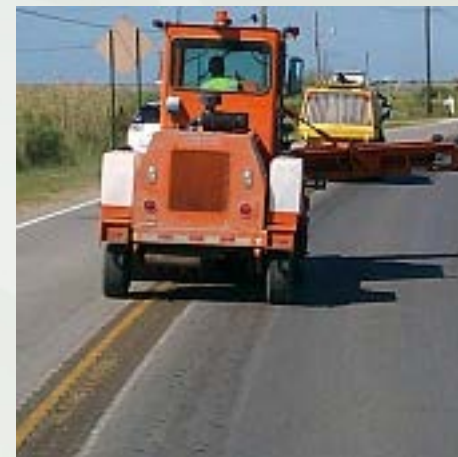
- Rumble strips are generally milled into existing pavement surface
- Milling process may cause several detrimental conditions:
 - effective pavement surface thickness is reduced in the milled areas
 - milled areas may allow moisture to infiltrate the pavement surface
 - milled indentation may allow for water to pool and freeze
- Little published research exists pertaining to pavement deterioration associated with rumble strips

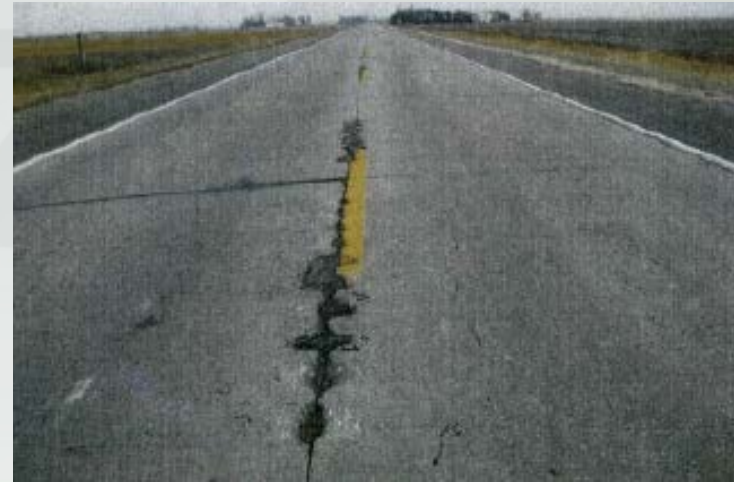
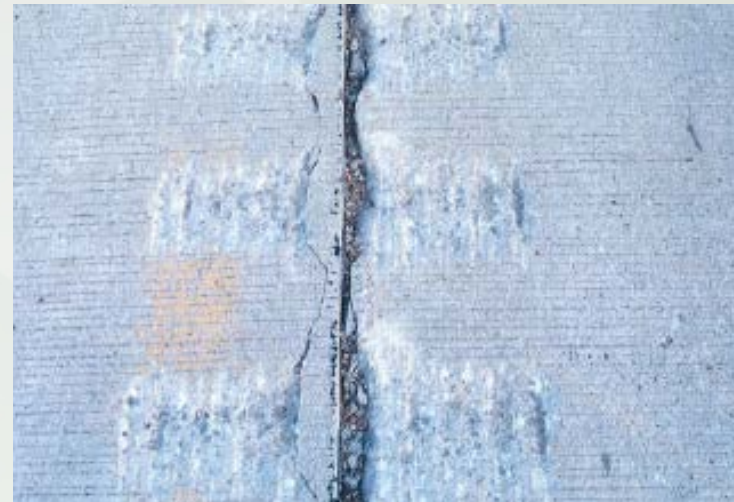
- Pavement distress quantified using metrics such as:
 - Quantity (i.e., frequency)
 - Extent (i.e., length)
 - Severity (i.e., width/size)

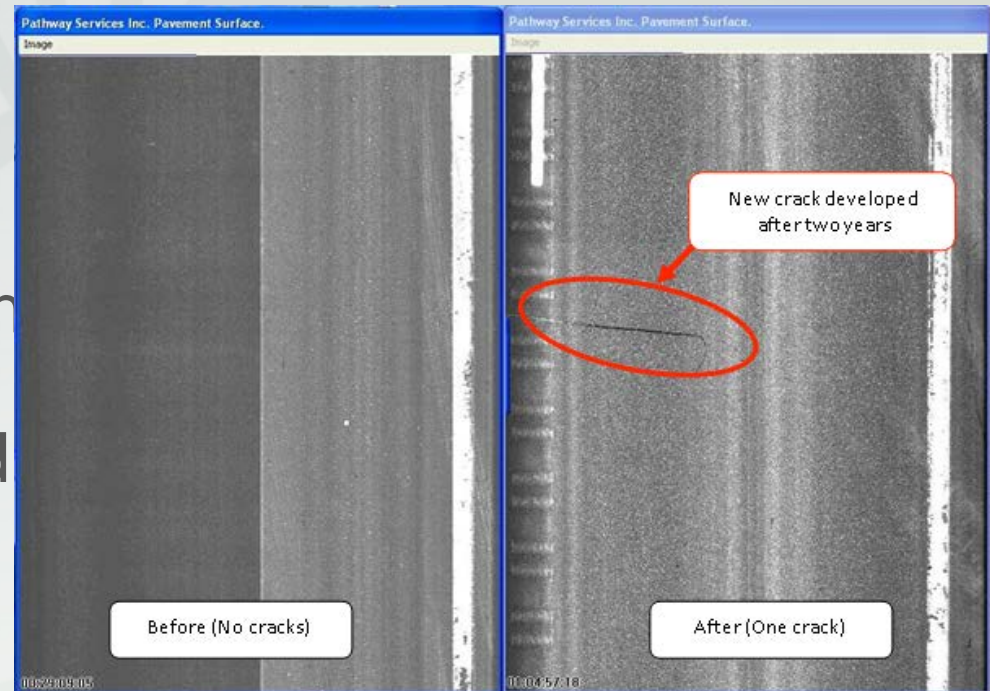
- Changes in number of cracks intersecting centerline compared before and after rumble strip installation
- Rate of crack propagation compared between segments where rumble strips were installed and comparable control segments

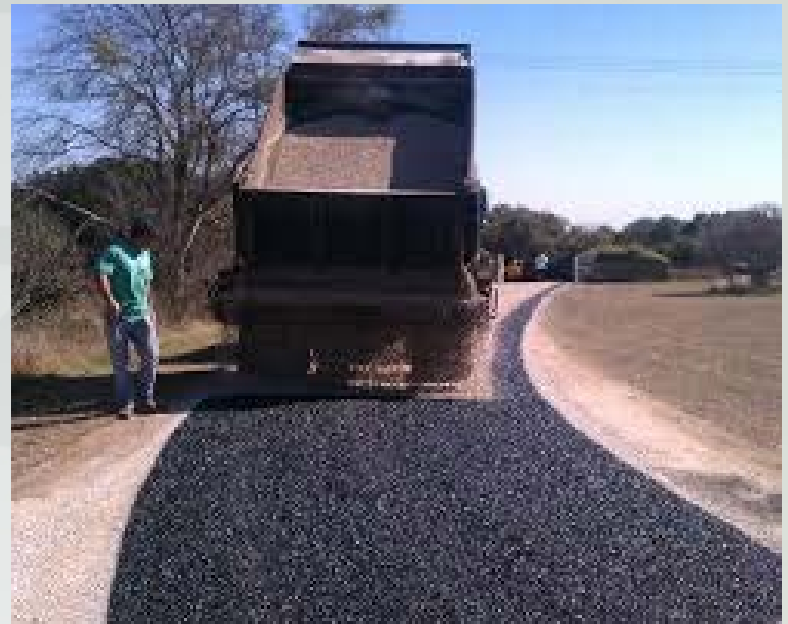
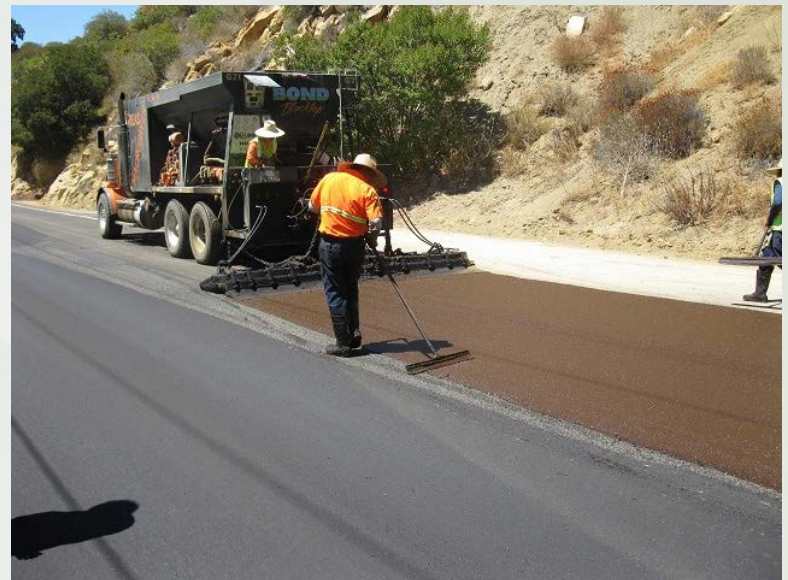
- Cutting into an asphalt joint could expedite deterioration
 - MDOT adopted joint density specification to ensure soundness of centerline pavement
- Chip seal
 - Rumble strips maintain functionality w/single chip seal
 - Double chip seal reduced effectiveness
 - MDOT updated Special Provisions, for double chip seal only top layer crosses the rumble strips
- Microsurfacing treatments found to nullify rumble strips
 - MDOT updated Special Provision, rumble strips should be filled in prior to surface treatment

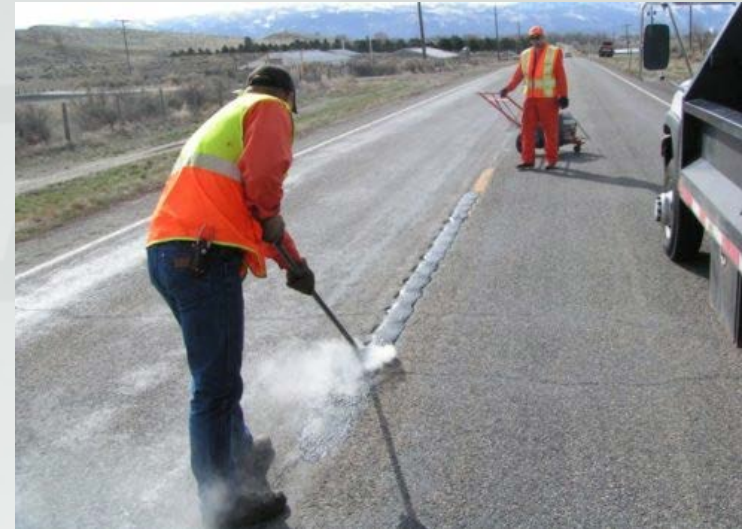
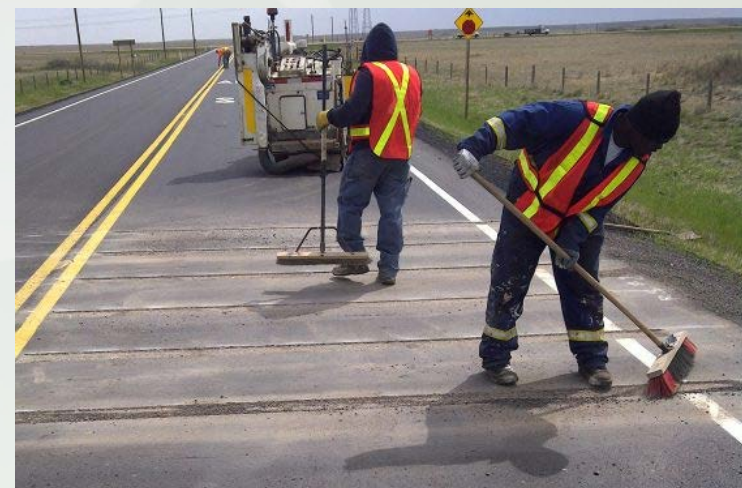
- Crack treatments for longitudinal joints
- Various types of sealants (e.g., fog seal) and rejuvenators.
