HIGH WATER / EROSION ON COUNTY ROADS

Wayne A. Schoonover, P.E.

Operations Response to High Water

Lifting Longbridge &
Erosion Control on Scenic
Drive at Stony Lake

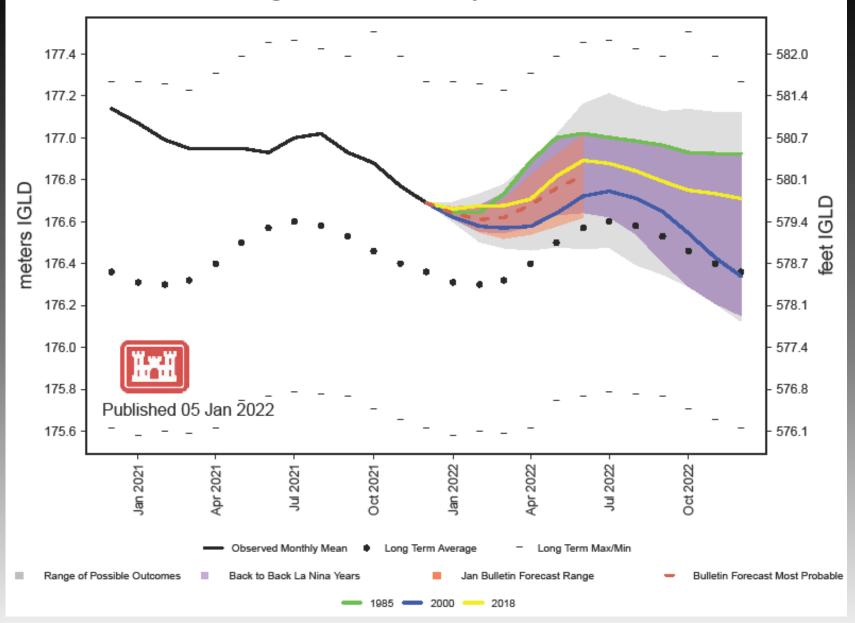
Lake Michigan-Huron Monthly Mean Water Levels

Water levels in the Great Lakes are projected to be higher at the start of 2022's boating season than their averages last year, according to the latest six-month forecast by the U.S. Army Corps of Engineers.

The forecast, the first that encompasses June, the start of the boating months, suggests the levels of Lakes Huron, Michigan, Erie and Ontario will be higher than average. Lake Superior appears it will be right around average, with a possibility of being slightly higher or lower in the forecast.

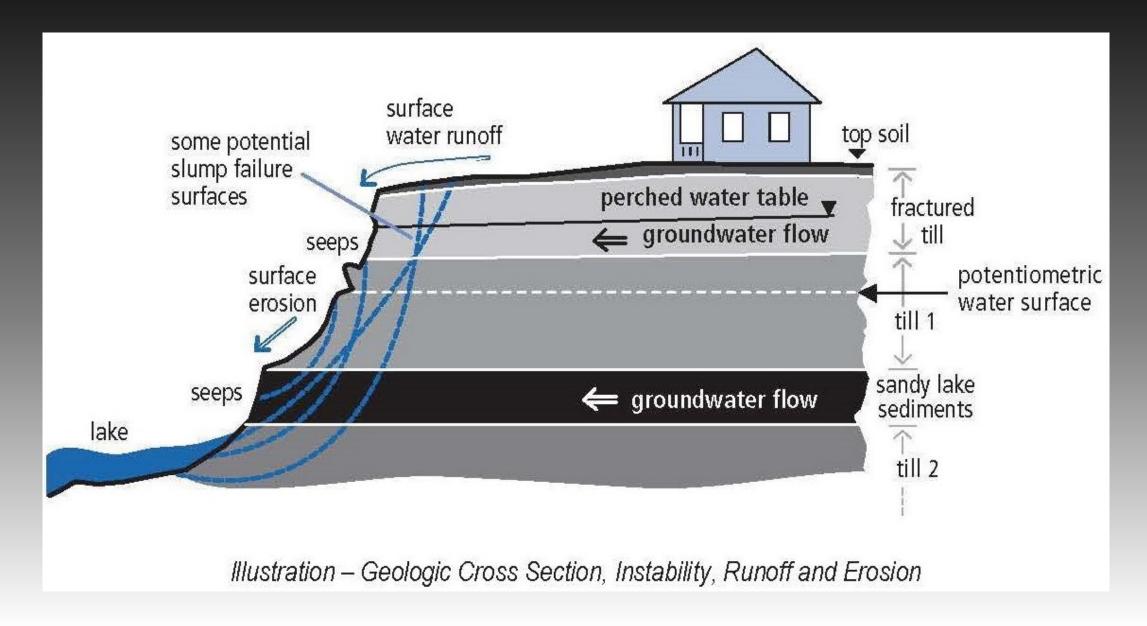
Bluff Rd at C-C'

Contours at C-C'

CONTRIBUTING FACTORS – TALL BLUFF

- HIGH PRECIPITATION
- PERCHED GROUNDWATER
- HIGH WATER TABLE
- AQUITARD / SILT-CLAY LAYER
- SURFACE EROSION –
 HARD SURFACE RUN OFF, STAIRWAYS
- SLOPE SLUMPING
- WAVE EROSION
- GROINS

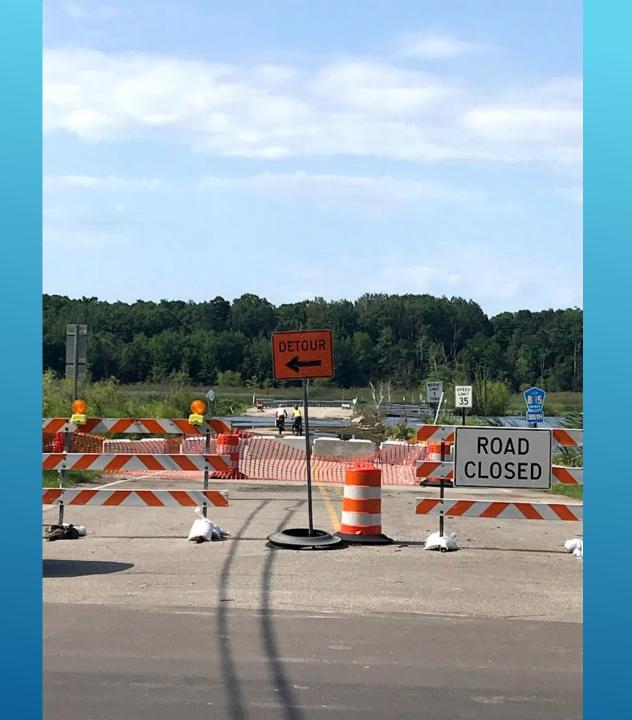
View from Northeast side of Longbridge

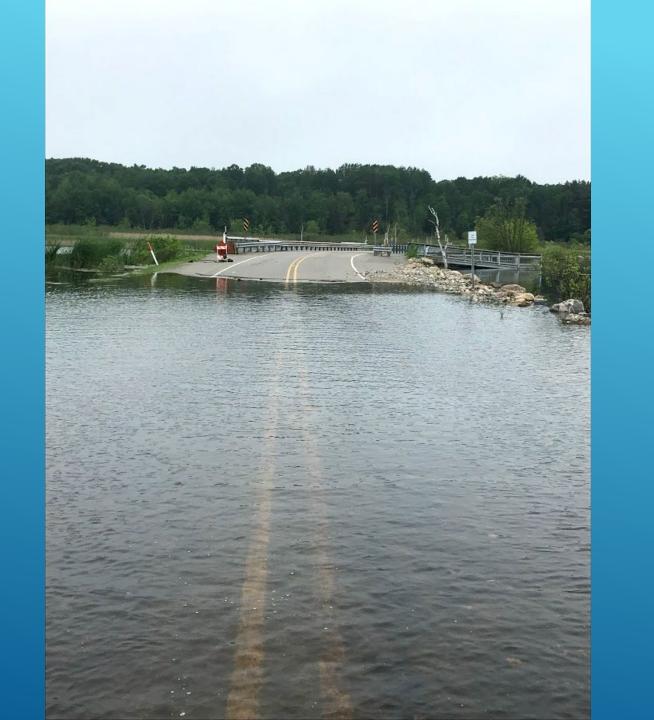
Concrete barrier blocks were placed as residents continued to pull barricades and snow fence aside and drive over road

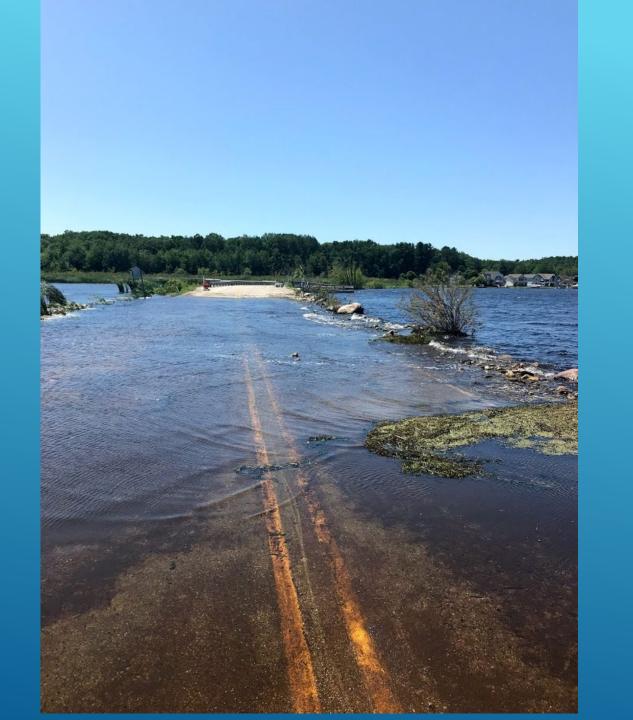
WALKING
ACROSS
ROAD
NOW
REQUIRED
WADERS

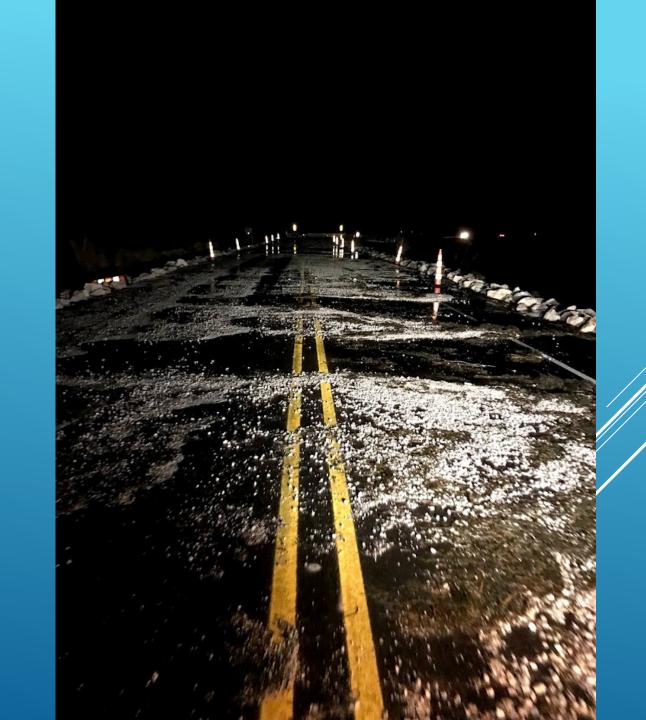
WASHED OUT
21 AA LIMESTONE
FROM SHOULDERS

AFTERMATH OF STORM

ORIGNIALLY WE PLACED 21AA LIMESTONE ON **SHOULDERS BUT WAVE** ACTION **WASHED IT** OUT

We then used vac truck to remove remaining limestone

WE THEN **POURED** CONCRETE BETWEEN **ASPHALT** SHOULDER AND RIP RAP

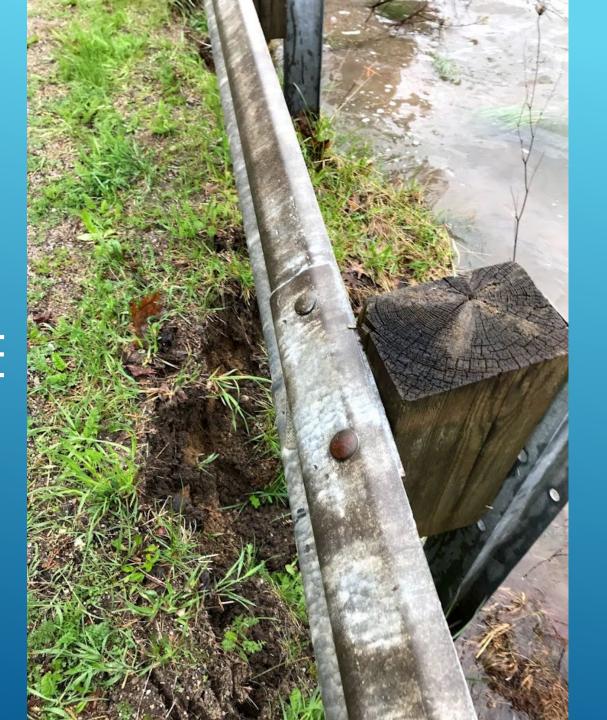
MAY 2020
EROSION DUE
TO HIGH
LAKE
MICHIGAN
WATER LEVEL

EROSION MODERATE AT FIRST

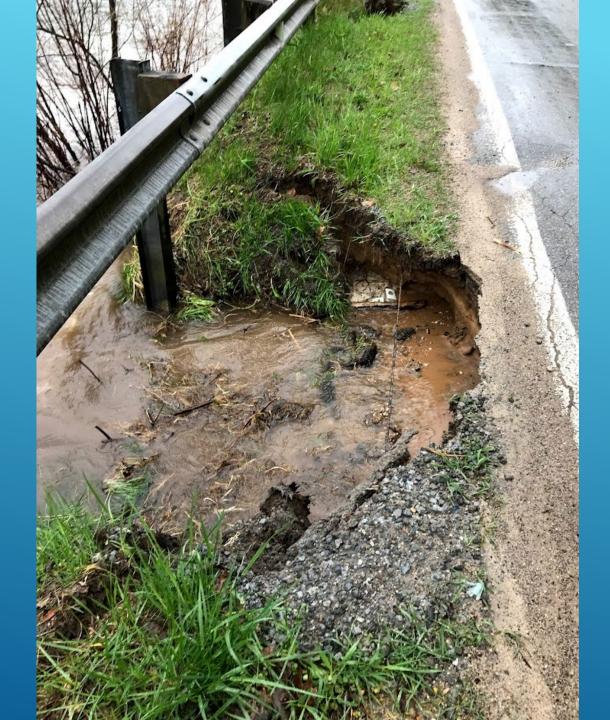
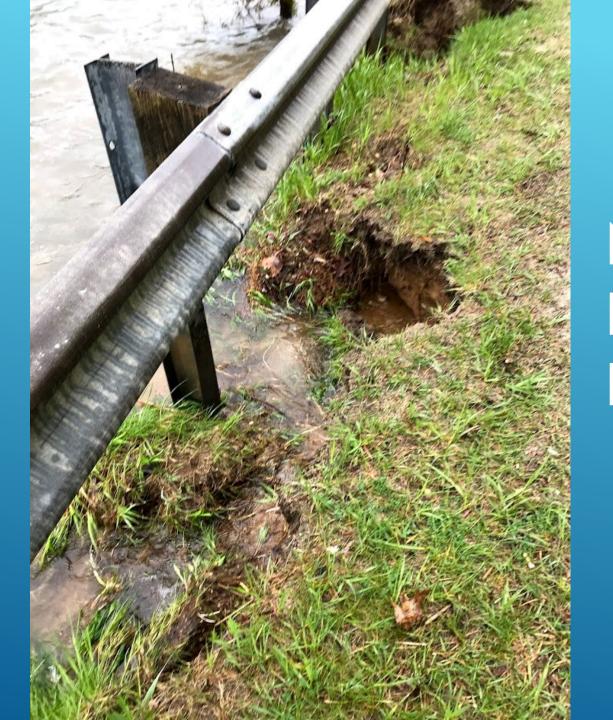
STORM FROM EAST CAUSED **EROSION** THAT THREATENED TO WASH OUT ROAD

NUMEROUS ERODED LOCATIONS

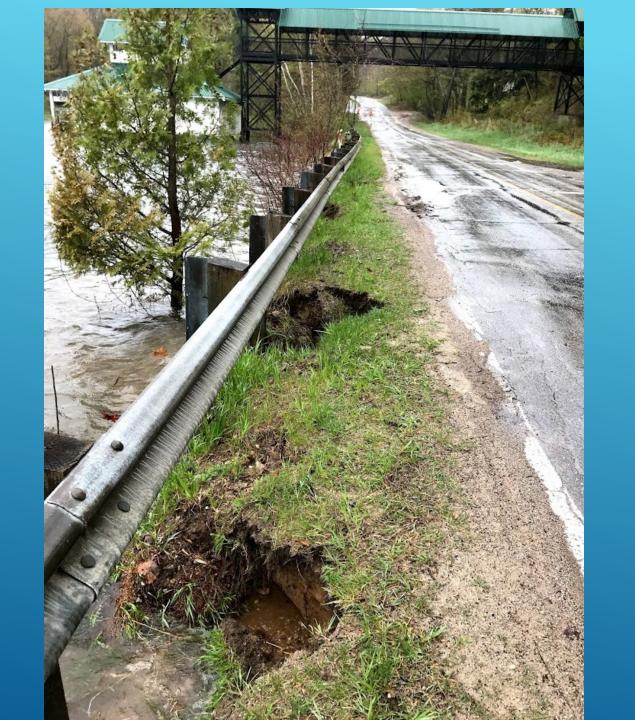
EROSION PAST GUARDRAIL
