# Michigan CEW 2026 MIRAFI<sup>®</sup> H<sub>2</sub>Ri

The Road to 100-Year Pavement  
Foundations

3 February 2026  
Santino S. Piccoli  
Engineering Business Manager  
(m) 216.408.8059  
[spiccoli@solmax.com](mailto:spiccoli@solmax.com)

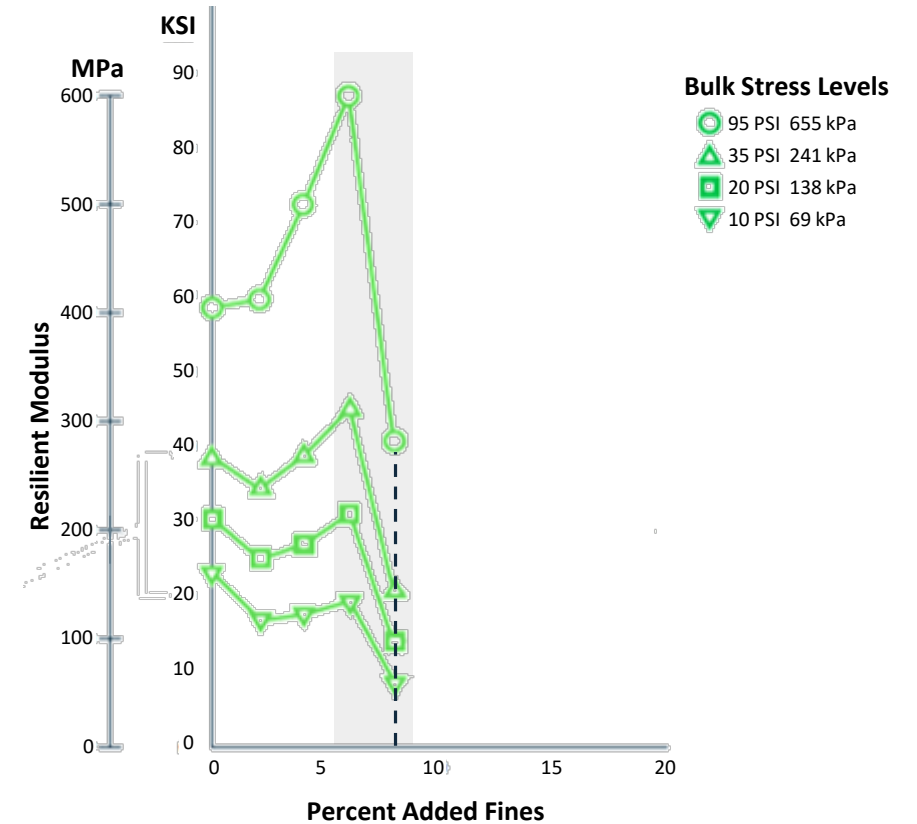
Gravel road without separation geotextile

**Less than 10% fines contamination** of the unbound aggregate base can **lower its effective strength by as much as 50%**

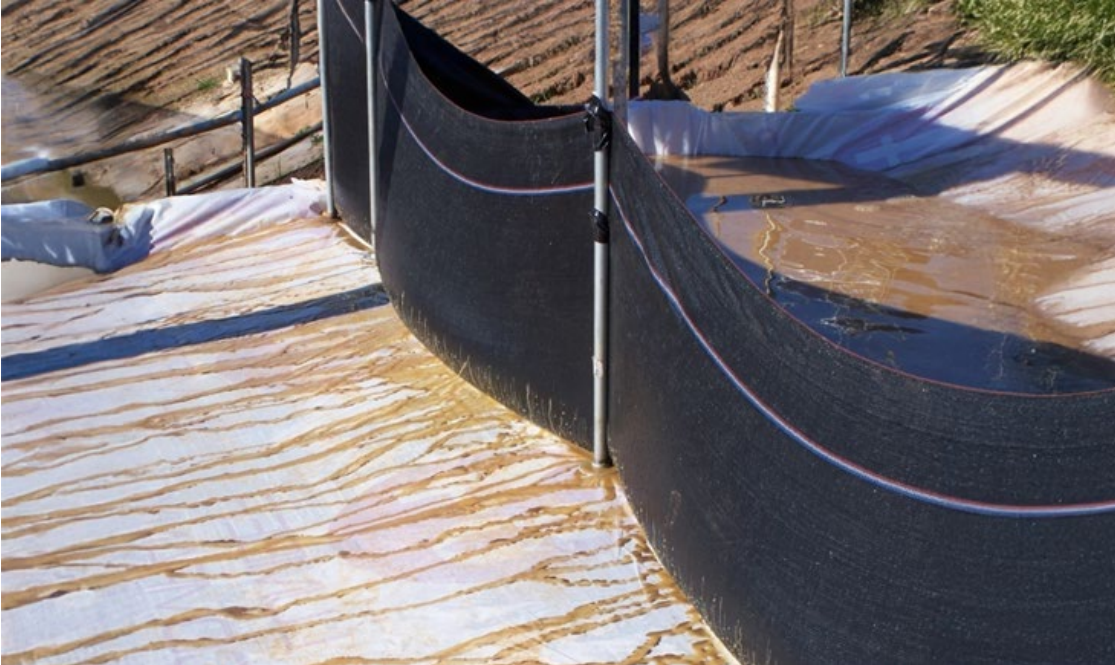
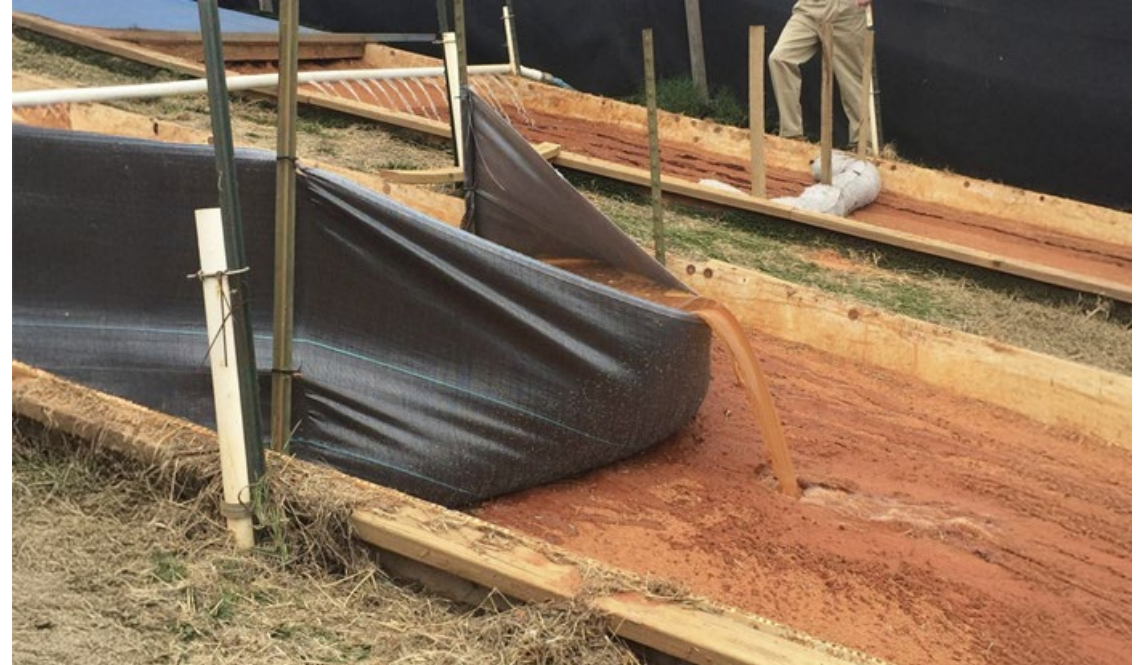
# Slit tapes have poor water flow characteristics

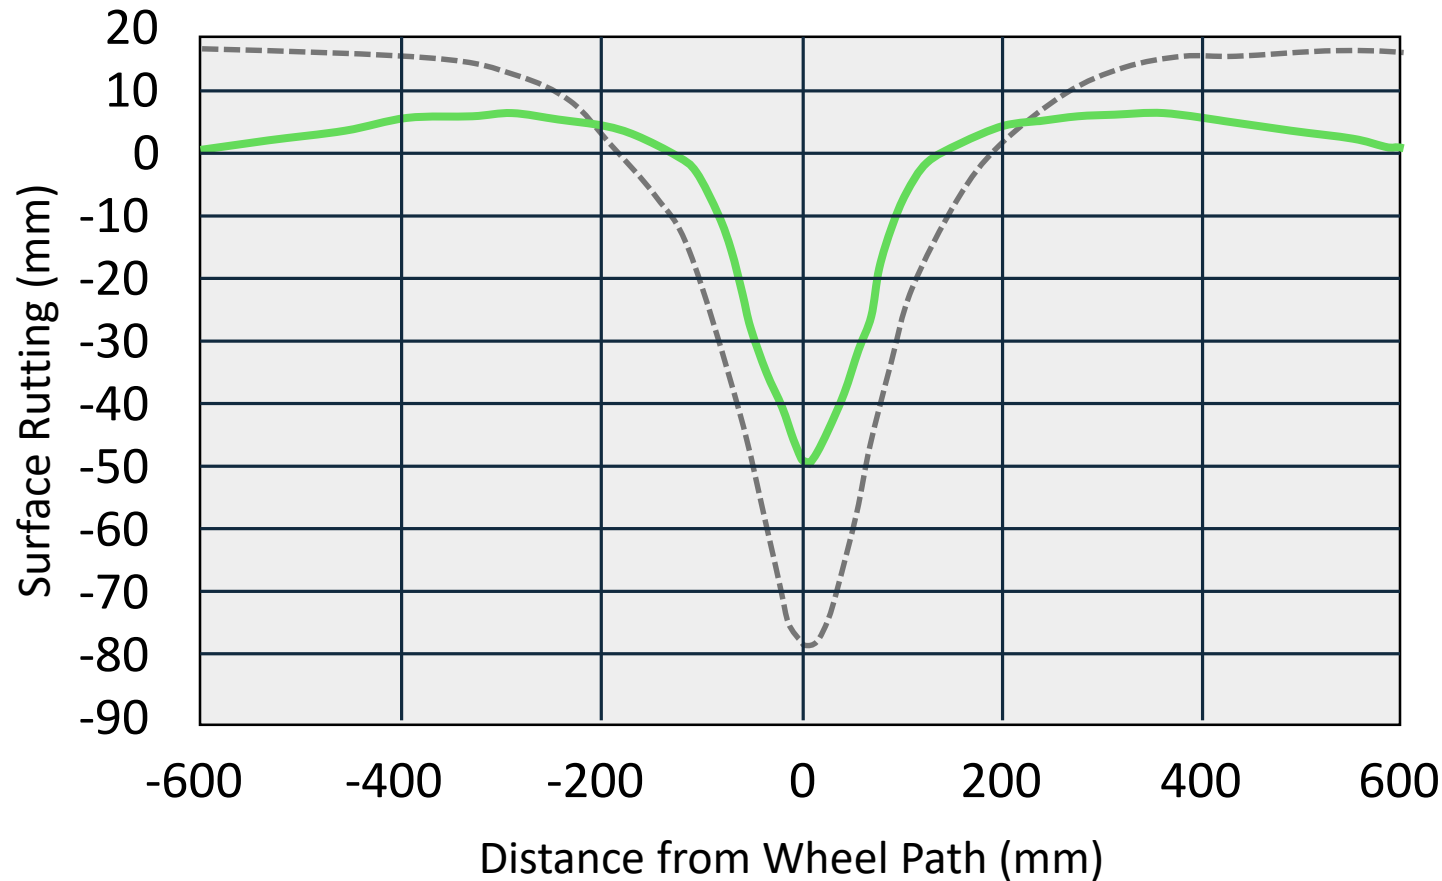
Control Section @ 700 cycles

Separation @ 1185 cycles

**35% less rutting**  
**70% more axle passes**

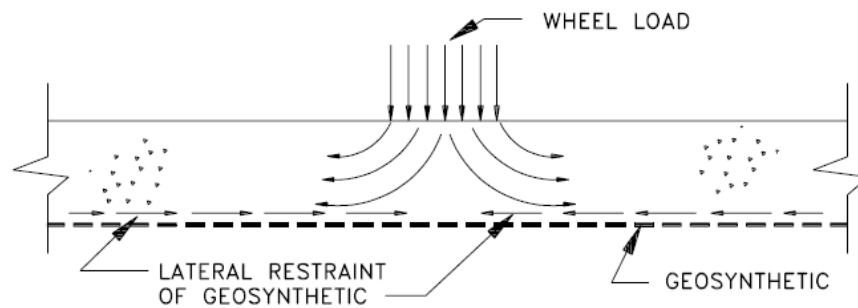
**Lateral restraint  
(Confinement)**

**Increased bearing capacity  
(Tensile modulus)**

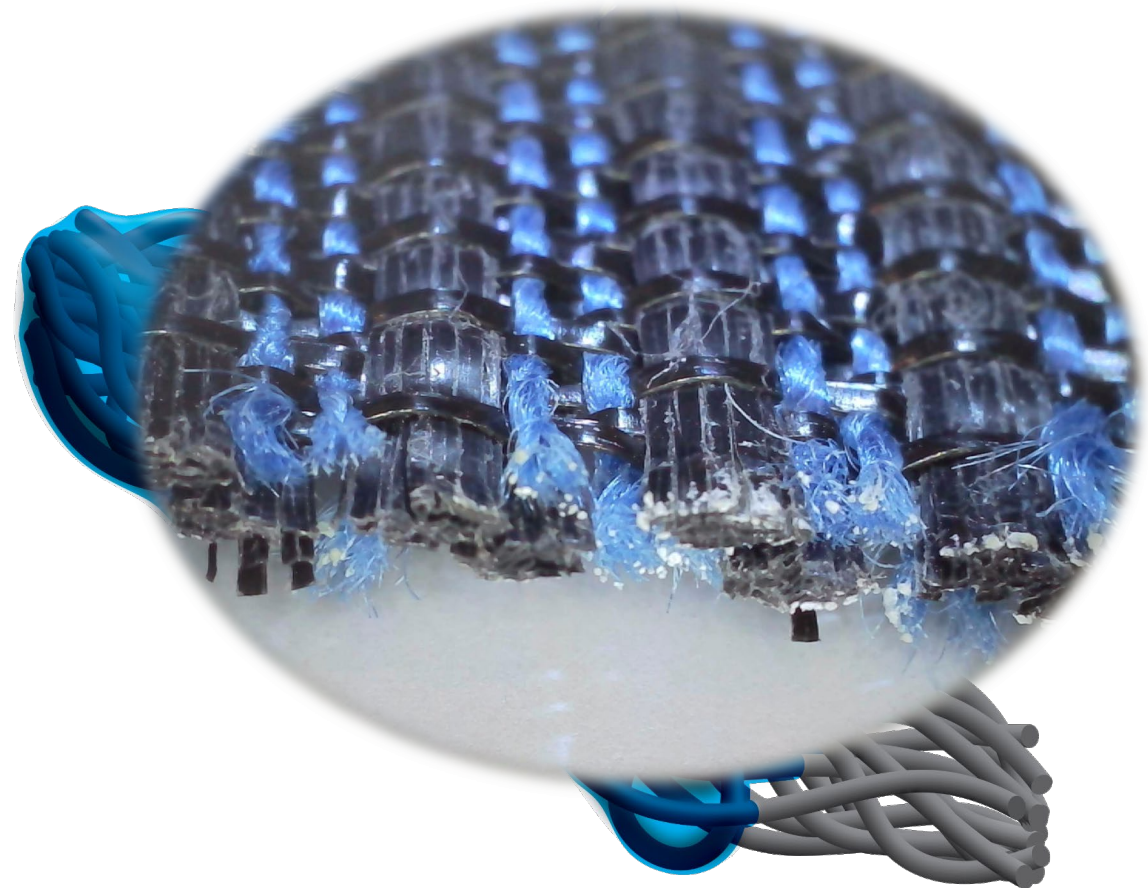
- Two components
  - Black **high-modulus** reinforcement yarns
  - Blue engineered **moisture management** yarns: ~10 million filaments in every 15' x 300' roll
- Each filament is the size of a human hair

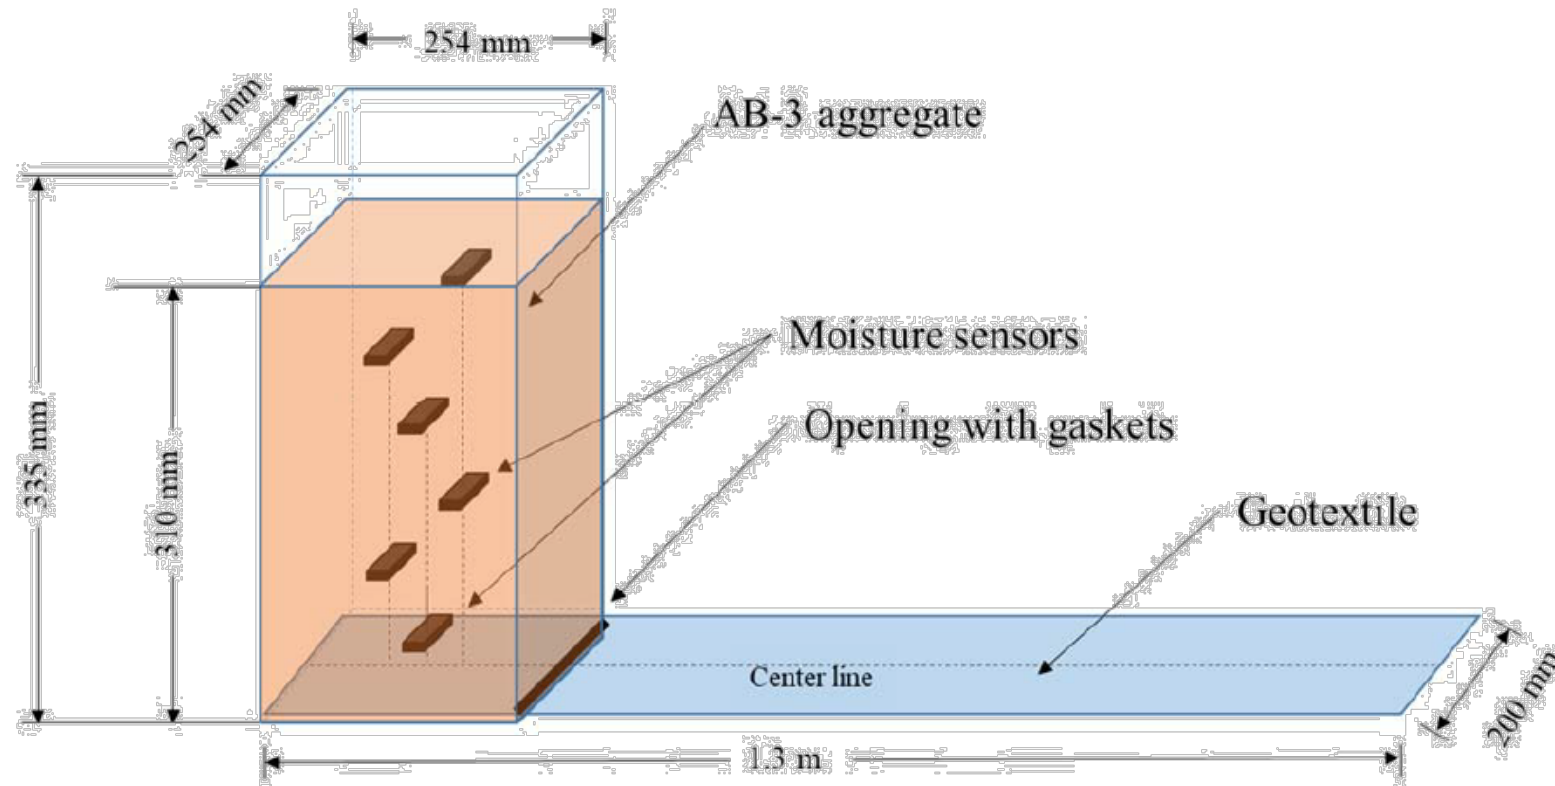
# Evaluation and Design of Wicking Geotextile for Pavement Applications

***Zone of influence in base course up to 10"***

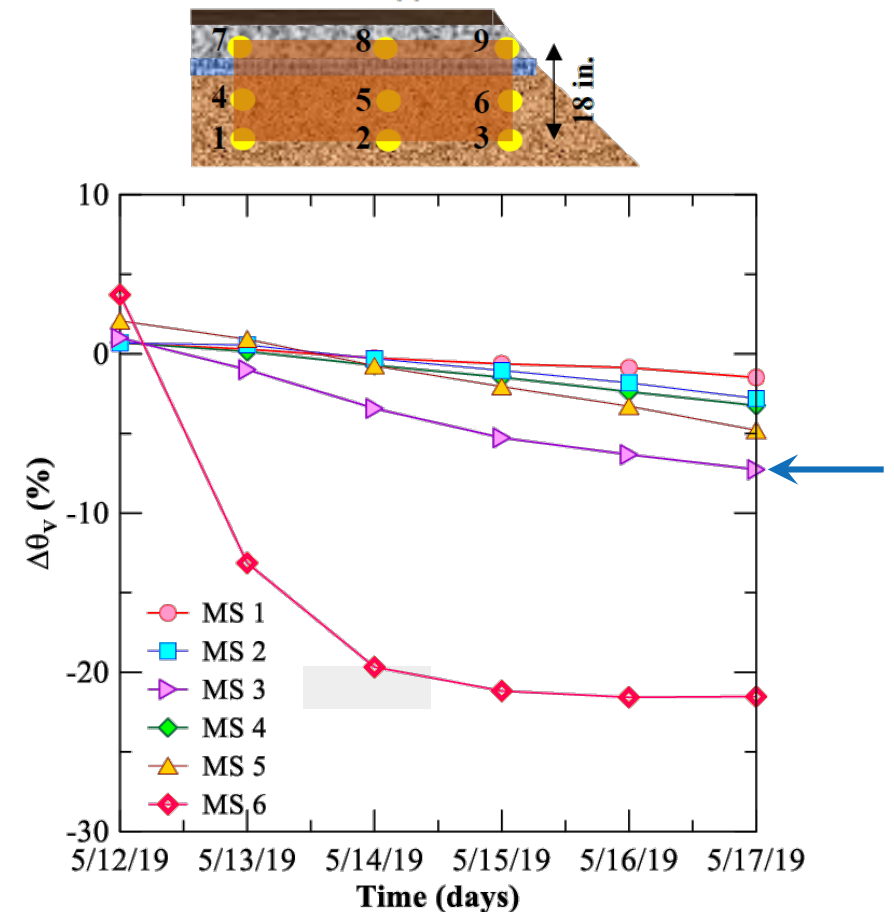
# Depth of Influence of a Wicking Geotextile Below the Flexible Pavement Constructed Over Expansive Subgrade

- Percentage reduction in  $\theta_v$  at different depths
- Remember: CH soil
- MS 3 located 12" below MIRAFI H<sub>2</sub>Ri

*Zone of influence in  
CH subgrade up to 12"*

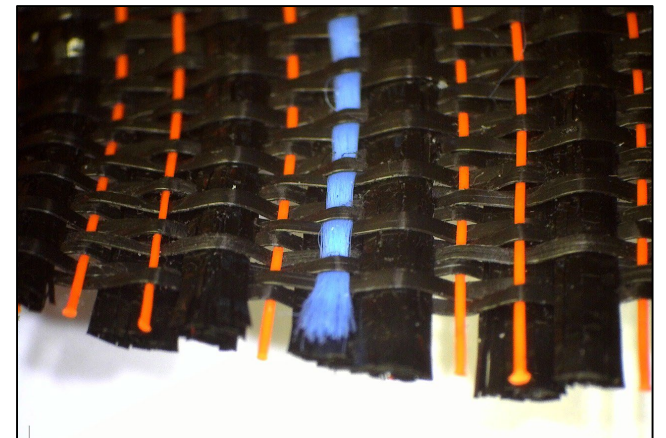
MIRAfi RS580i – Side View

Same mechanical reinforcement

1/10th the wicking of **MIRAfi H<sub>2</sub>Ri**

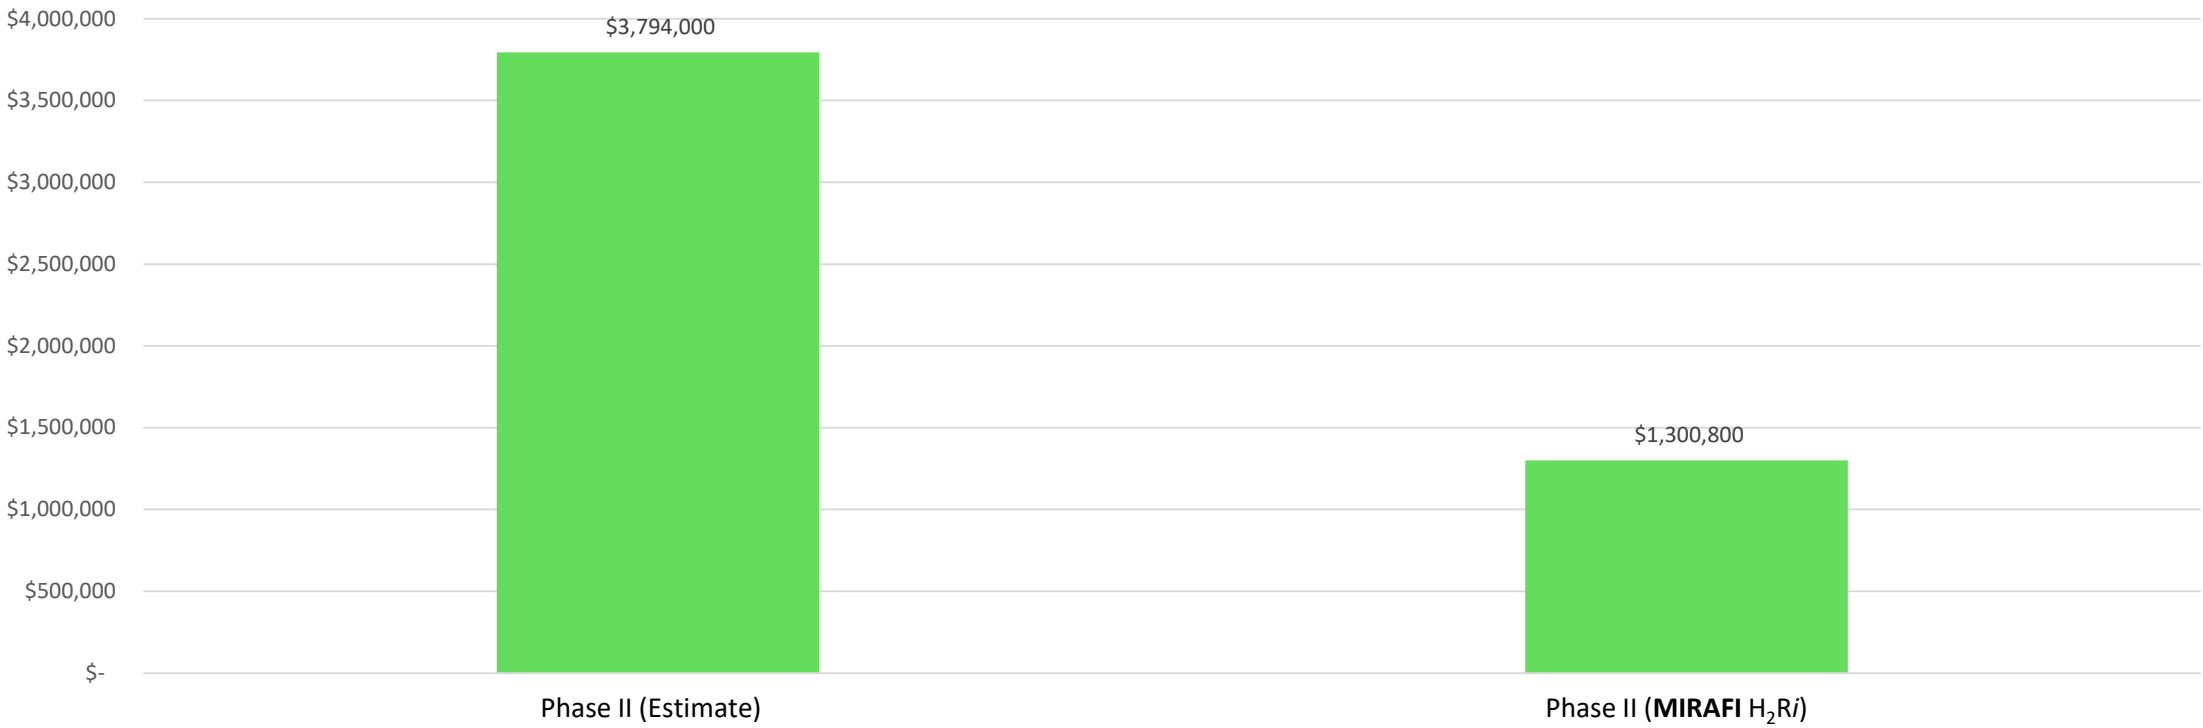
# Dalton highway MP197-209 rehabilitation project

***Total savings was \$2.5 million in construction costs alone***

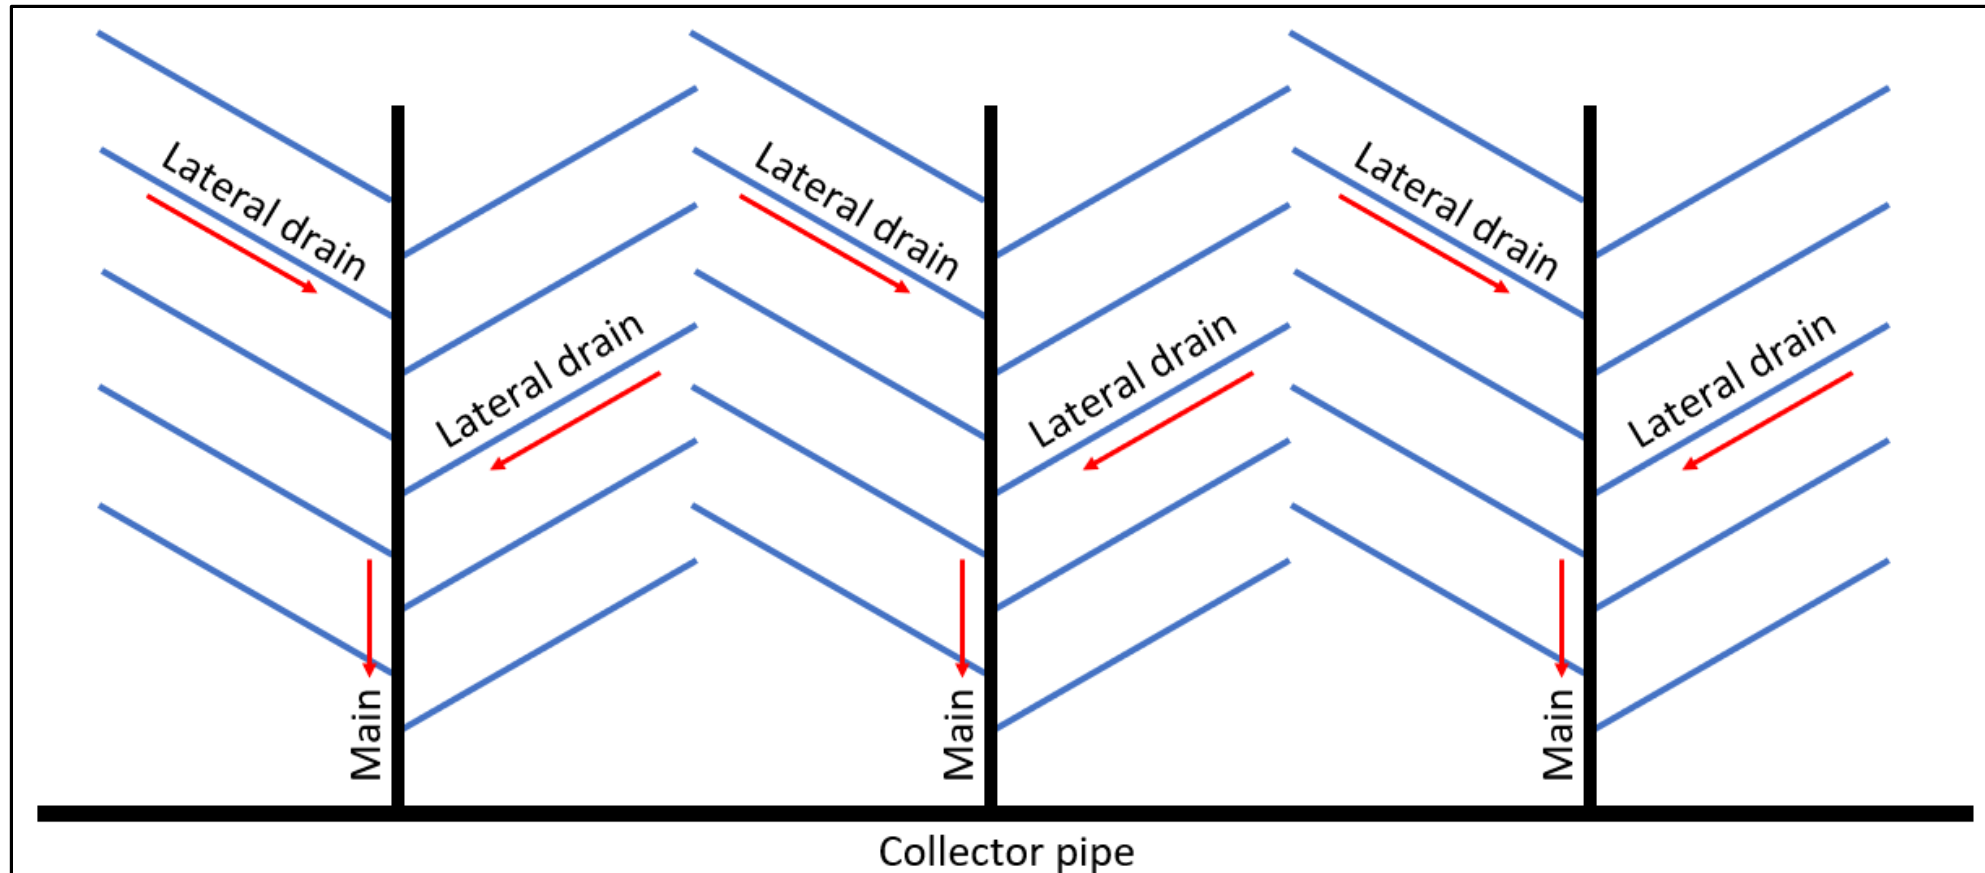
## Typical Herringbone Drain Layout – Plan View

- 72-acre Container Yard (~ 350,000 yd<sup>2</sup>)
- Reconfigure layout to add capacity
- Tear out and replace pavement and rail (in 4 phases over 3 years)
- High water table, concern with water intruding into new pavement system
  - Herringbone drainage system beneath the pavement system

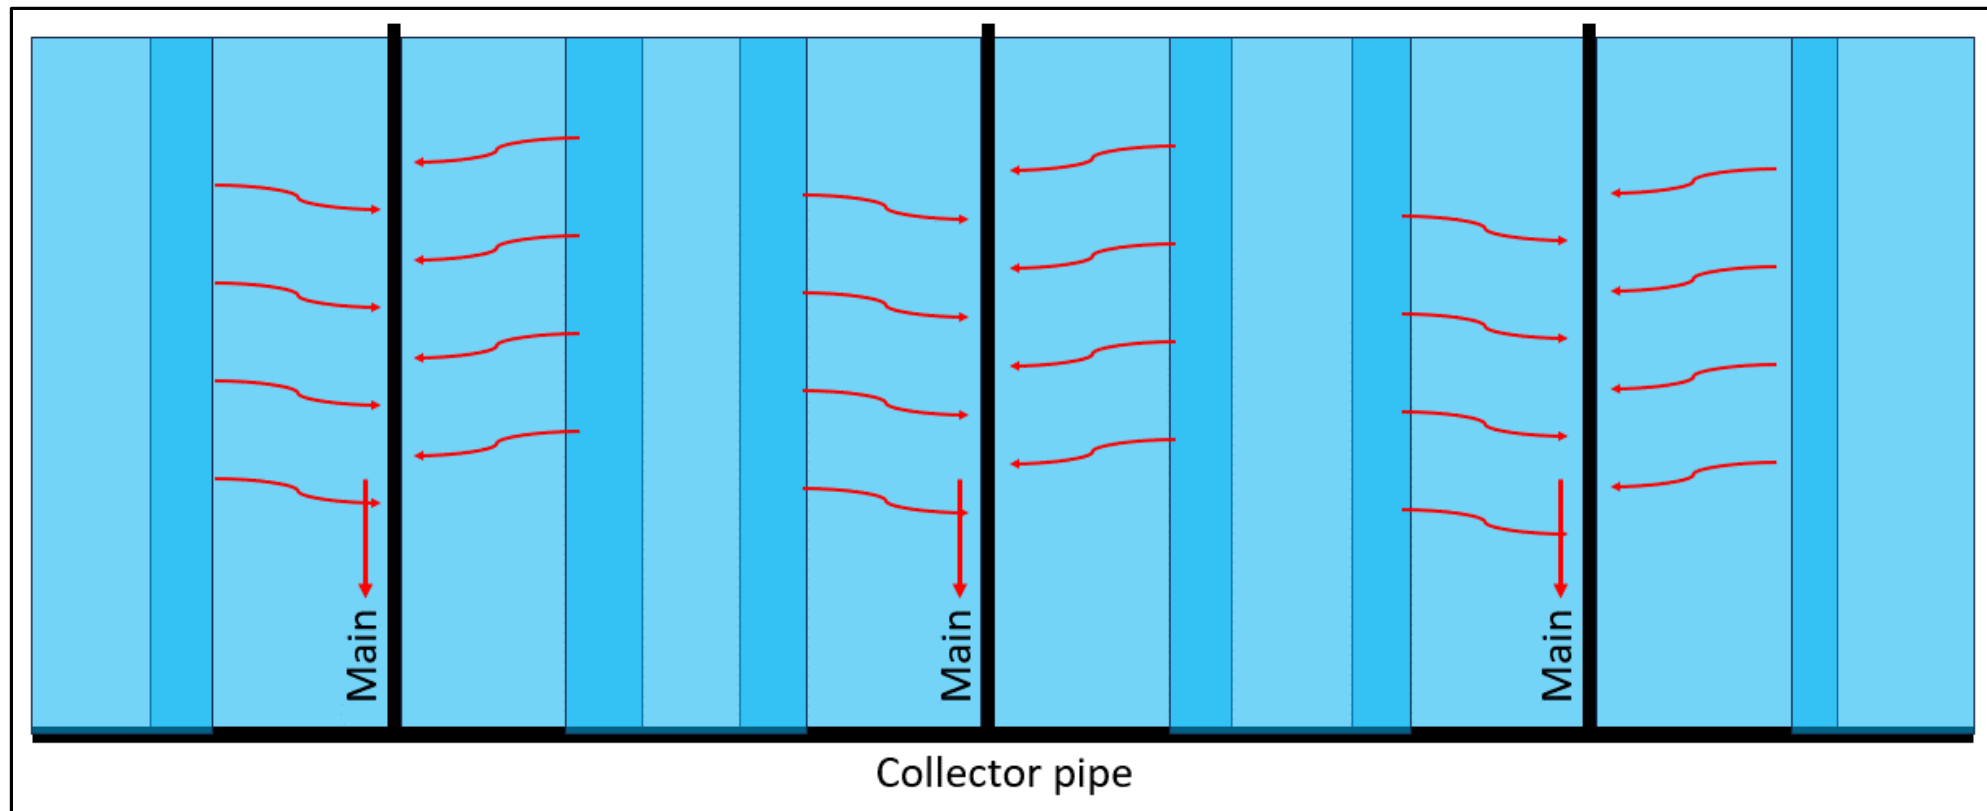
## MIRAFI H<sub>2</sub>Ri Layout – Plan View

- Eliminated the 4-inch aggregate drainage layer
  - 77,364 tons aggregate
  - 3,095 truckloads of aggregate (25 tons per truck)
- Non-performed the nonwoven geotextile separation fabric
- Eliminated the lateral drains of the herringbone system
  - Trench excavation, aggregate and pipe
