Importance of Substructure Evaluation

Wiss, Janney, Elstner Associates, Inc.

Inspection Case Studies and Techniques

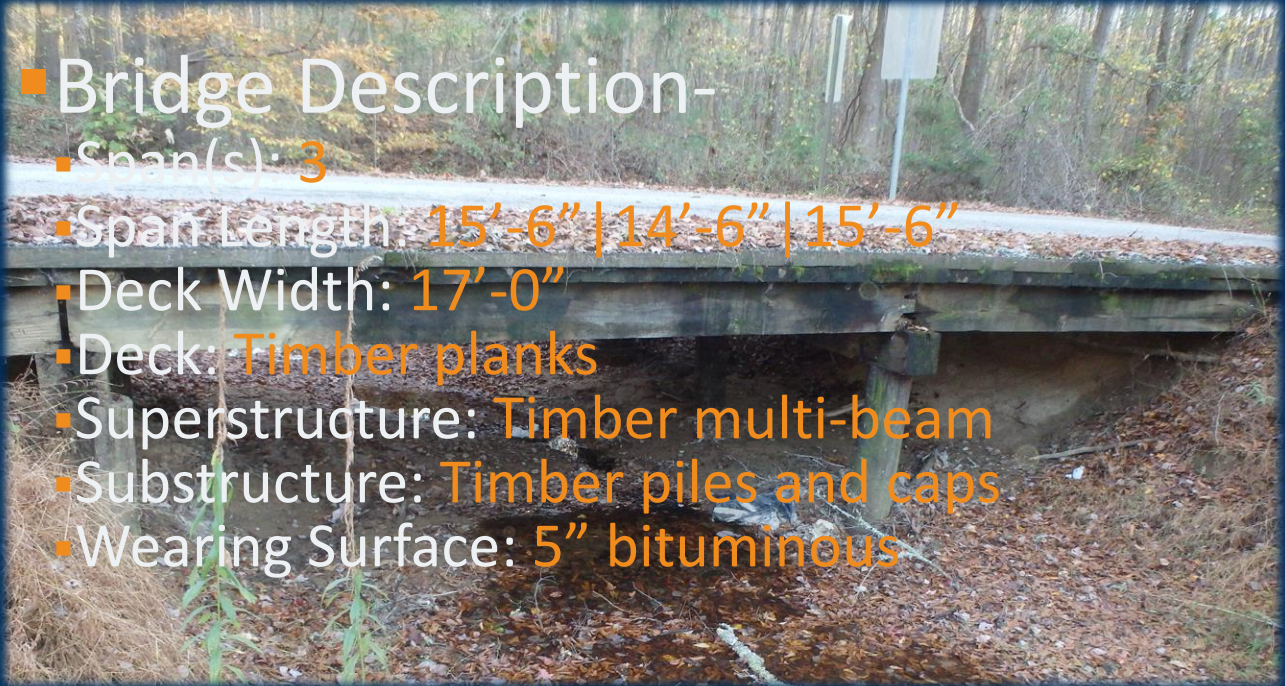
- Span(s): 3
- Span Length: 15'-6" | 14'-6" | 15'-6"
- Deck Width: 17'-0"
- Deck: Timber planks
- Superstructure: Timber multi-beam
- Substructure: Timber piles and caps
- Wearing Surface: 5" bituminous

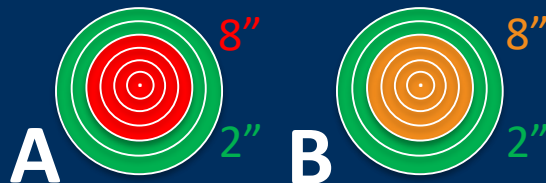
→ 45% loss in capacity

- No decay
- Moderate
- Advanced
- Severe

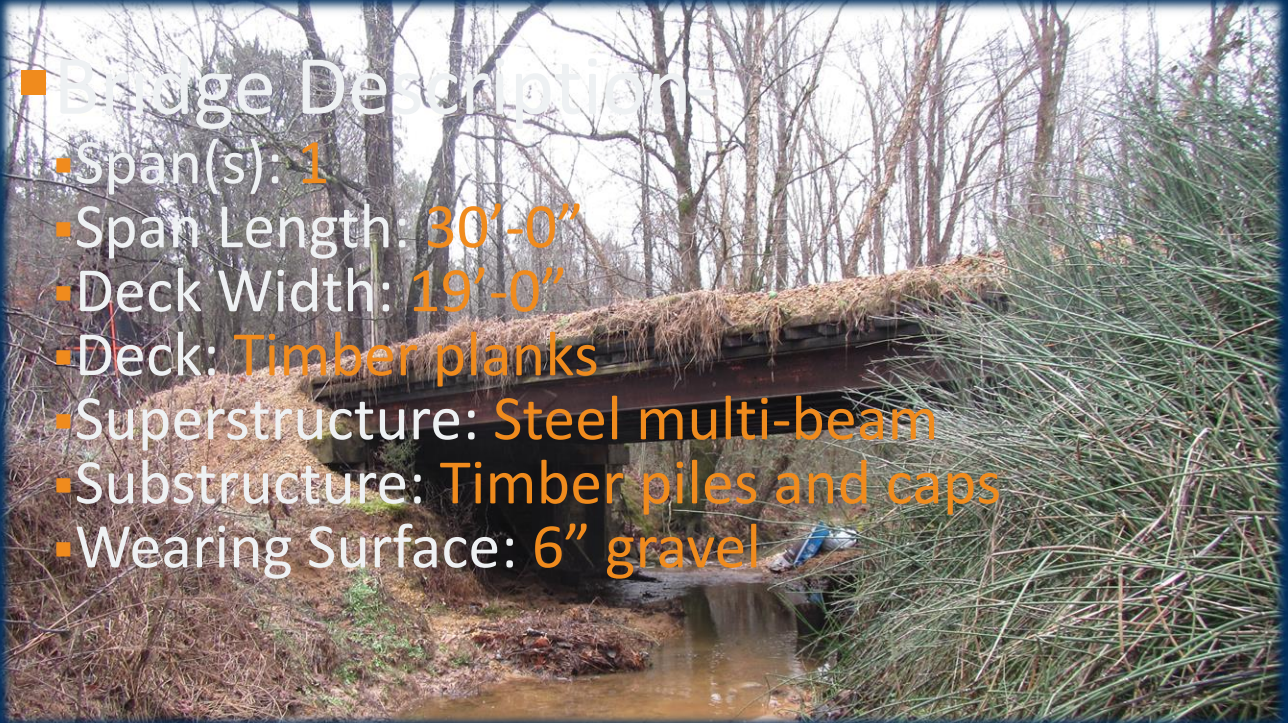
- Span(s): 1
- Span Length: 30'-0"
- Deck Width: 19'-0"
- Deck: Timber planks
- Superstructure: Steel multi-beam
- Substructure: Timber piles and caps
- Wearing Surface: 6" gravel

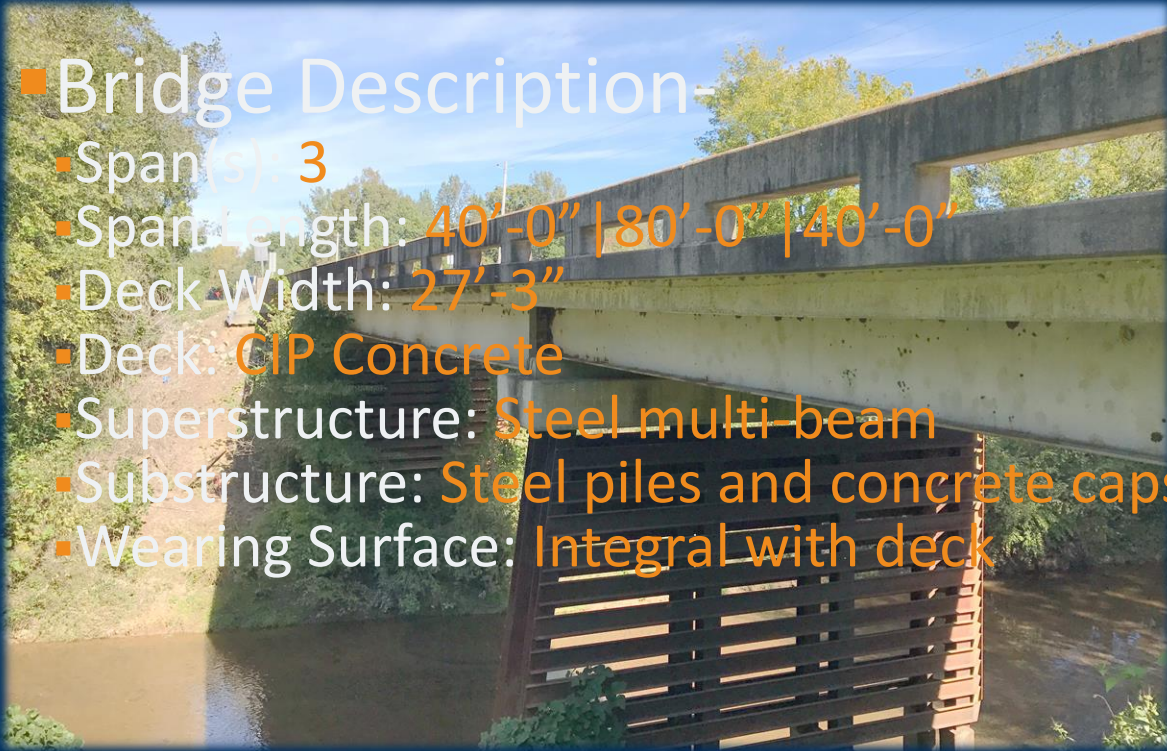
- Span(s): 3
- Span Length: 40'-0" | 80'-0" | 40'-0"
- Deck Width: 27'-3"
- Deck: CIP Concrete
- Superstructure: Steel multi-beam
- Substructure: Steel piles and concrete caps
- Wearing Surface: Integral with deck
