Culvert Inspection Program and Replacement Projects Case Studies

Washtenaw County Road Commission Presenters

Halbert Road Culvert Replacement

2021 COUNTY ENGINEERS WORKSHOP

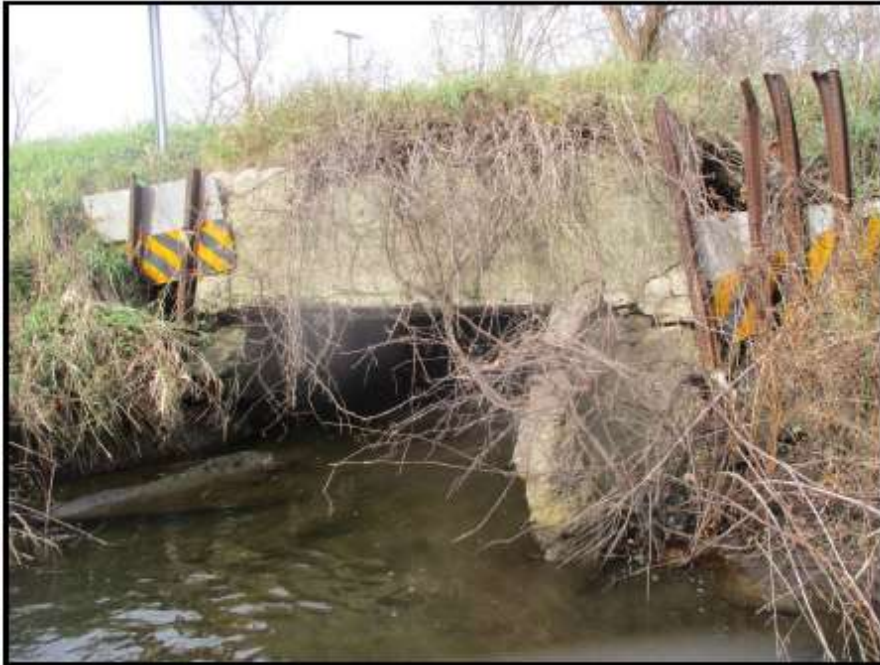
Old US 12 Road Culvert

Unconventional Fixes

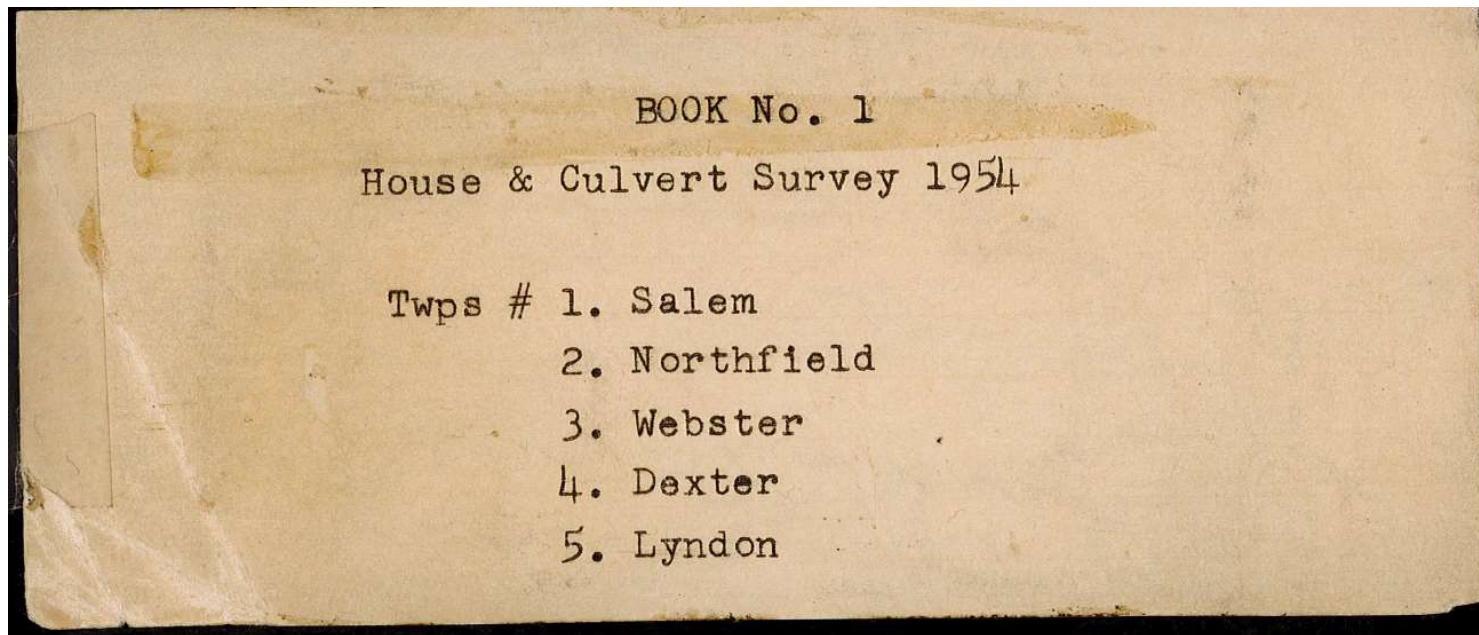
Culvert Book - 1954

REMARKS: 9 I beams - 9" beams - 2 1/2' c. to c.
Wooden hand rail on west, pipe handrail on East
S abut needs painting this summer.
Jack arch is weakening - ✓

Note: Recent replacement of similar structure
150' to south = 1952? Multiple plate - channel box.
Channel to this structure needs good cleanout
heavy brush + small trees -

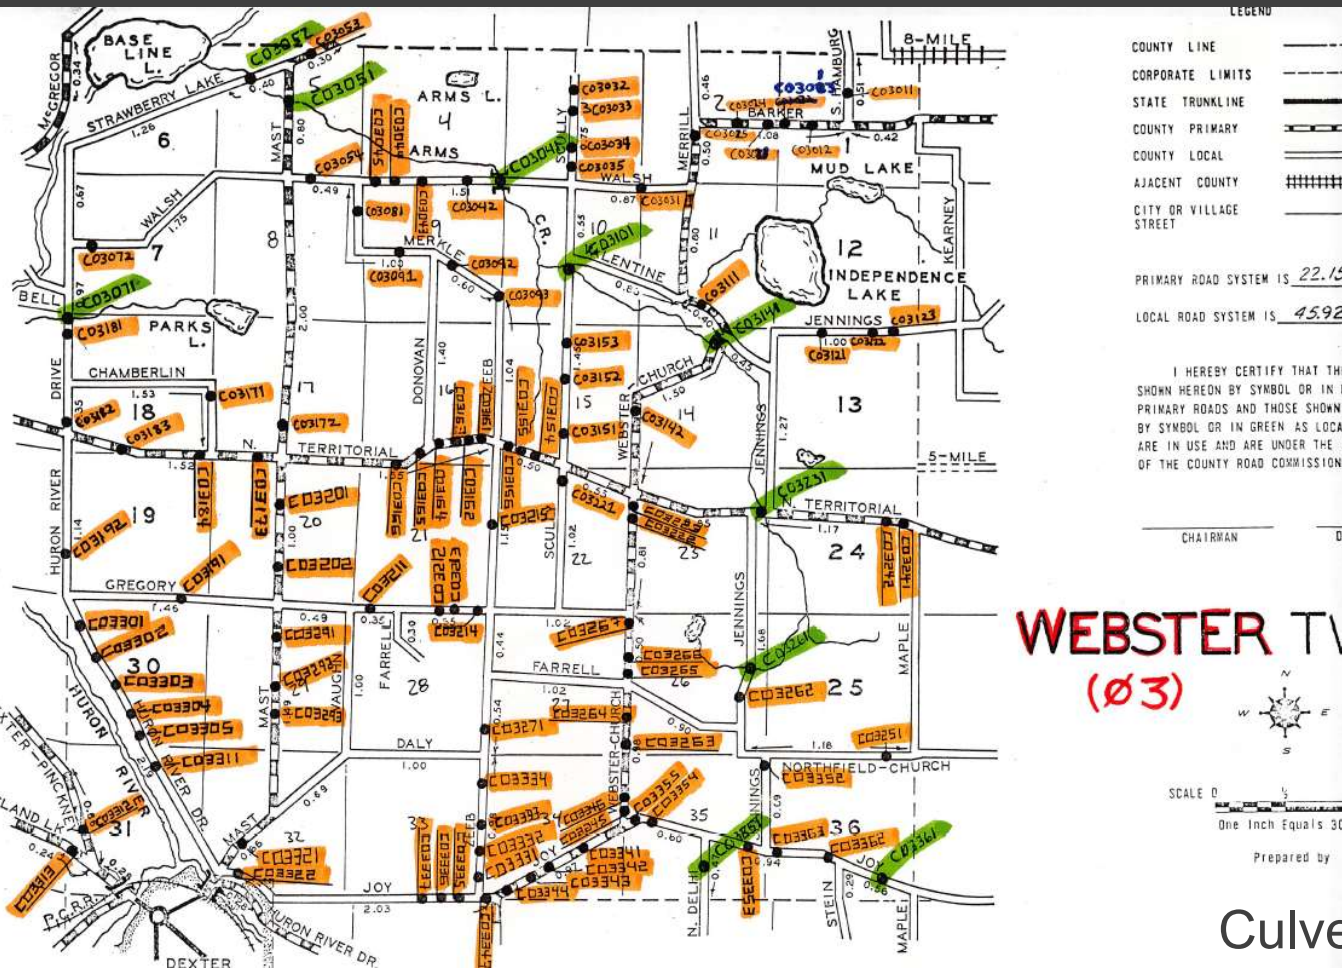
Culvert Book - 1996

2. DECK		WEST END 18" CMP -> 1/2 FULL OF DIRT.					
3. EXPANSION JOINTS		EAST END 24" CMP -> 1/2 FULL OF DIRT.					
4. OTHER JOINTS		24" BEAT -> CULVERT STILL APPEARS TO WORK.

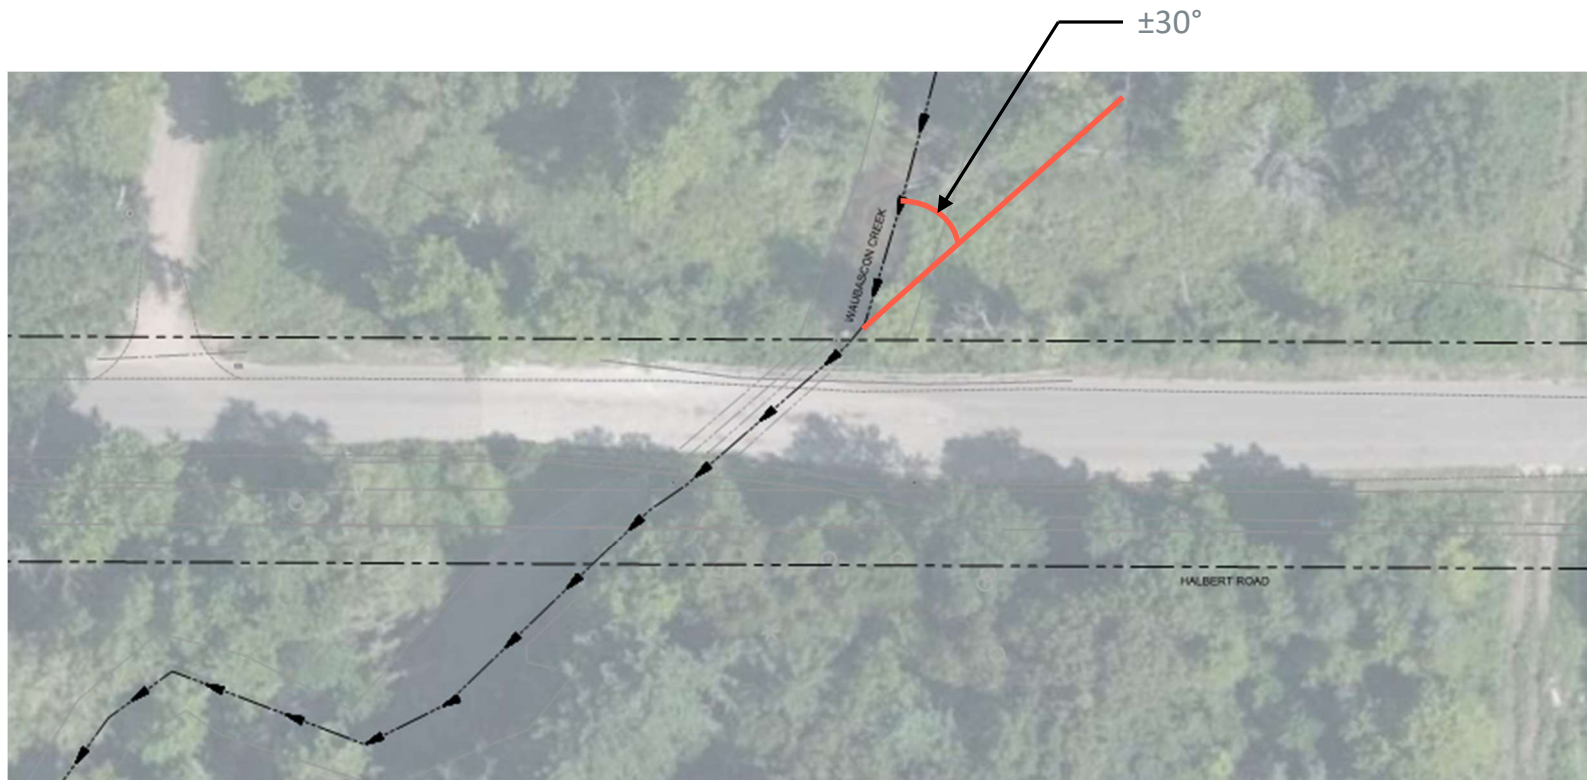
ORIGINAL ALIGNMENT

PROJECT NEED

- + ONE OF THE CULVERTS HAD FAILED
- + BACKFILL WAS CONTINUOUSLY FALLING INTO THE CULVERT CAUSING PAVEMENT FAILURE
- + REQUIRED ROUTINE HMA PATCHING
- + EROSION UPSTREAM OF CULVERTS
