Concrete Overlay Lessons Learned

County Engineers' Workshop February 10, 2022

ANN ARBOR-SALINE RD PROJECT

Getting out of a sticky situation A fog seal story

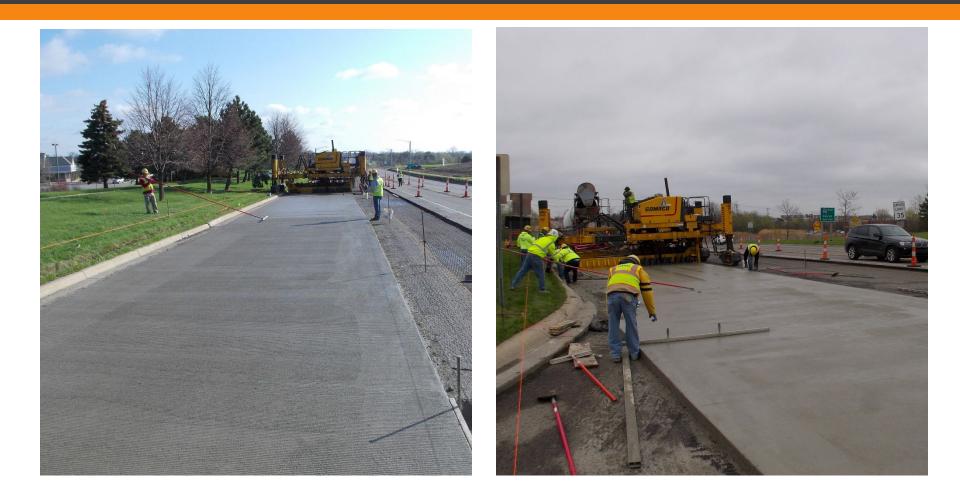
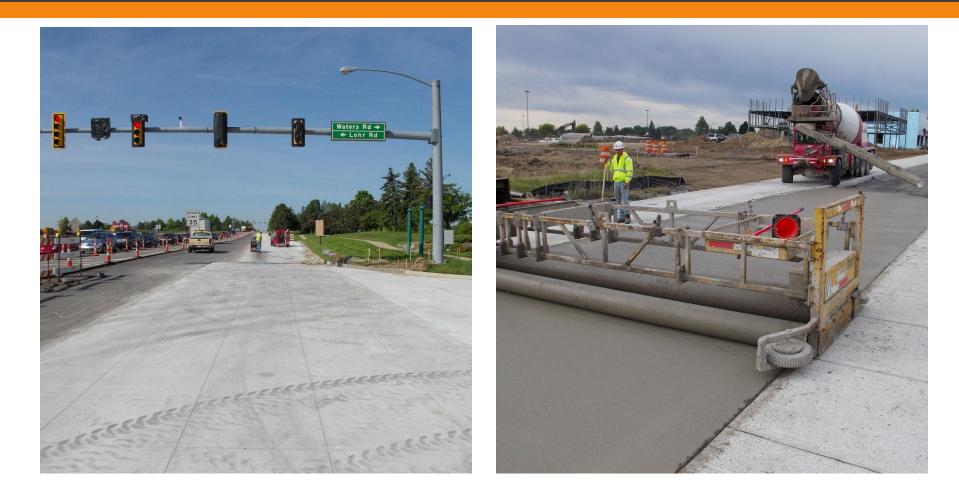
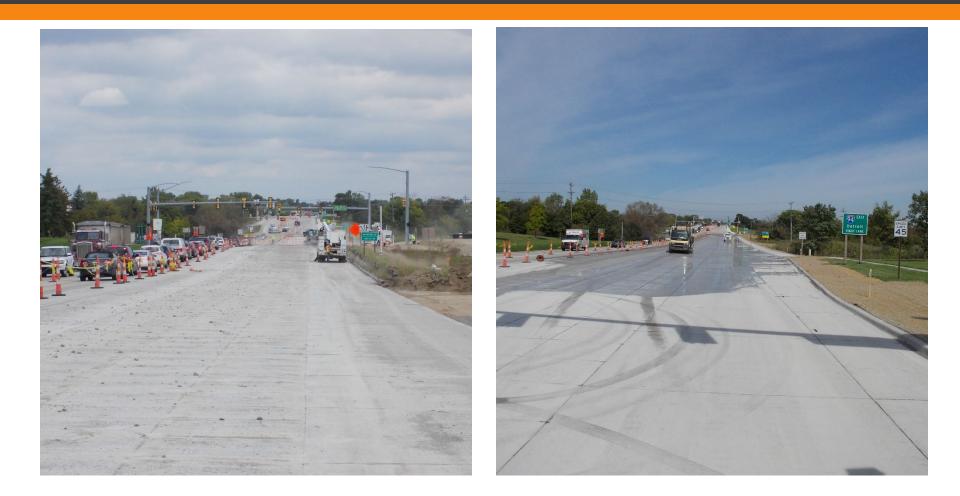
Conc Overlay Construction

By 2019, thinned concrete overlay failed in traveled lanes.

• Determination made to replace with full depth concrete pavement.

- Conc Pavt, Nonreinf, 9 inch
 - -4,490 SYD at \$51.50 per SYD
 - Approximately \$400,000 fix for a 20-year pavement

• 5" minimum thickness for a concrete overlay.

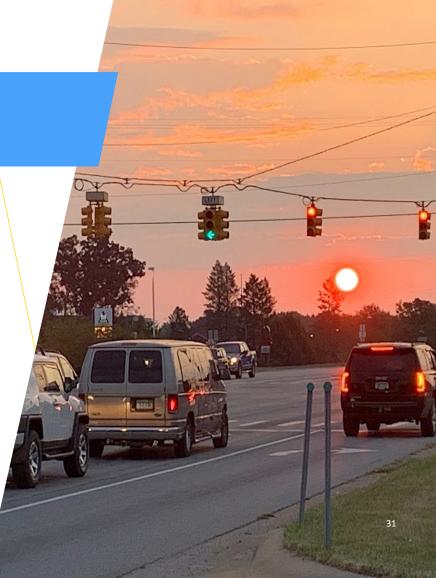
And then the trouble begins...

- RCKC crews apply fog seal material to 3 lanes
- They notice the dry time is taking longer than normal
 - Clearly there is a problem
 - Supervisors called to site
- After an investigation and phone calls, it is determined that Cationic Asphalt Emulsion (CRS-2M) has been applied over the chip seal and not the CSS-1H.

Temporary Solution

- Road must re-open
- Use chip spreader to sand the road
- Road can open to traffic as permanent solution is sought

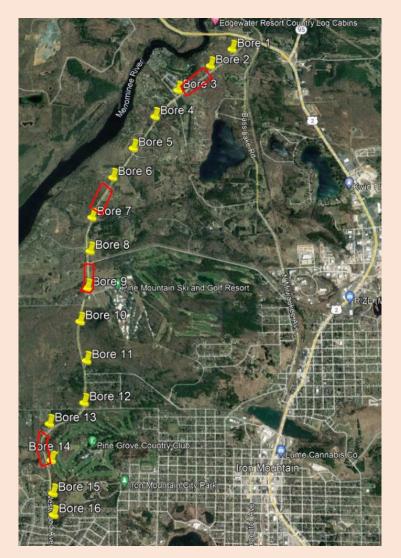
- Road not breaking up. Actually it was pretty good.
- No heaving or rutting
- Crowns and super elevations true
- Uniform spaced transverse cracks in areas.
 - ► Most road at about 110-120 ft
 - but 40-50 ft spacing in some areas
- Other random transverse cracks elsewhere in the project.

=BAD CRACK AREA

= Pre-design road bore (approximately 1500 Ft spacing)

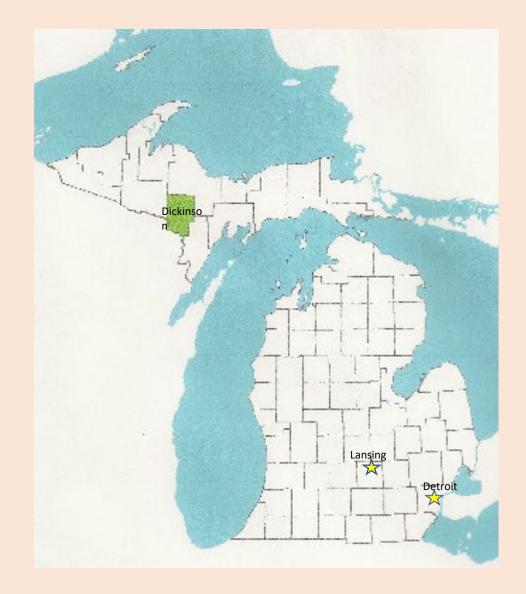
- Talked to the contactor's lab, they used "Michigan Oil" as the rejuvenation fluid. They have done other jobs in Michigan, and this was the same as they used elsewhere in the state in last couple of years.
 - The "Michigan Oil" is an emulsion, so it had no performance grade.
 - It's properties were based on the Detroit area.
 - It was recently successfully used in Lansing.
 - They never did a job this far north.

- Closer soil borings
- Emulsions don't have PG. Use proper penetration / viscosity.
- Interview maintenance workers & old people who were there
