Raymond Road Bridge Rehabilitation

Calhoun County Road Department

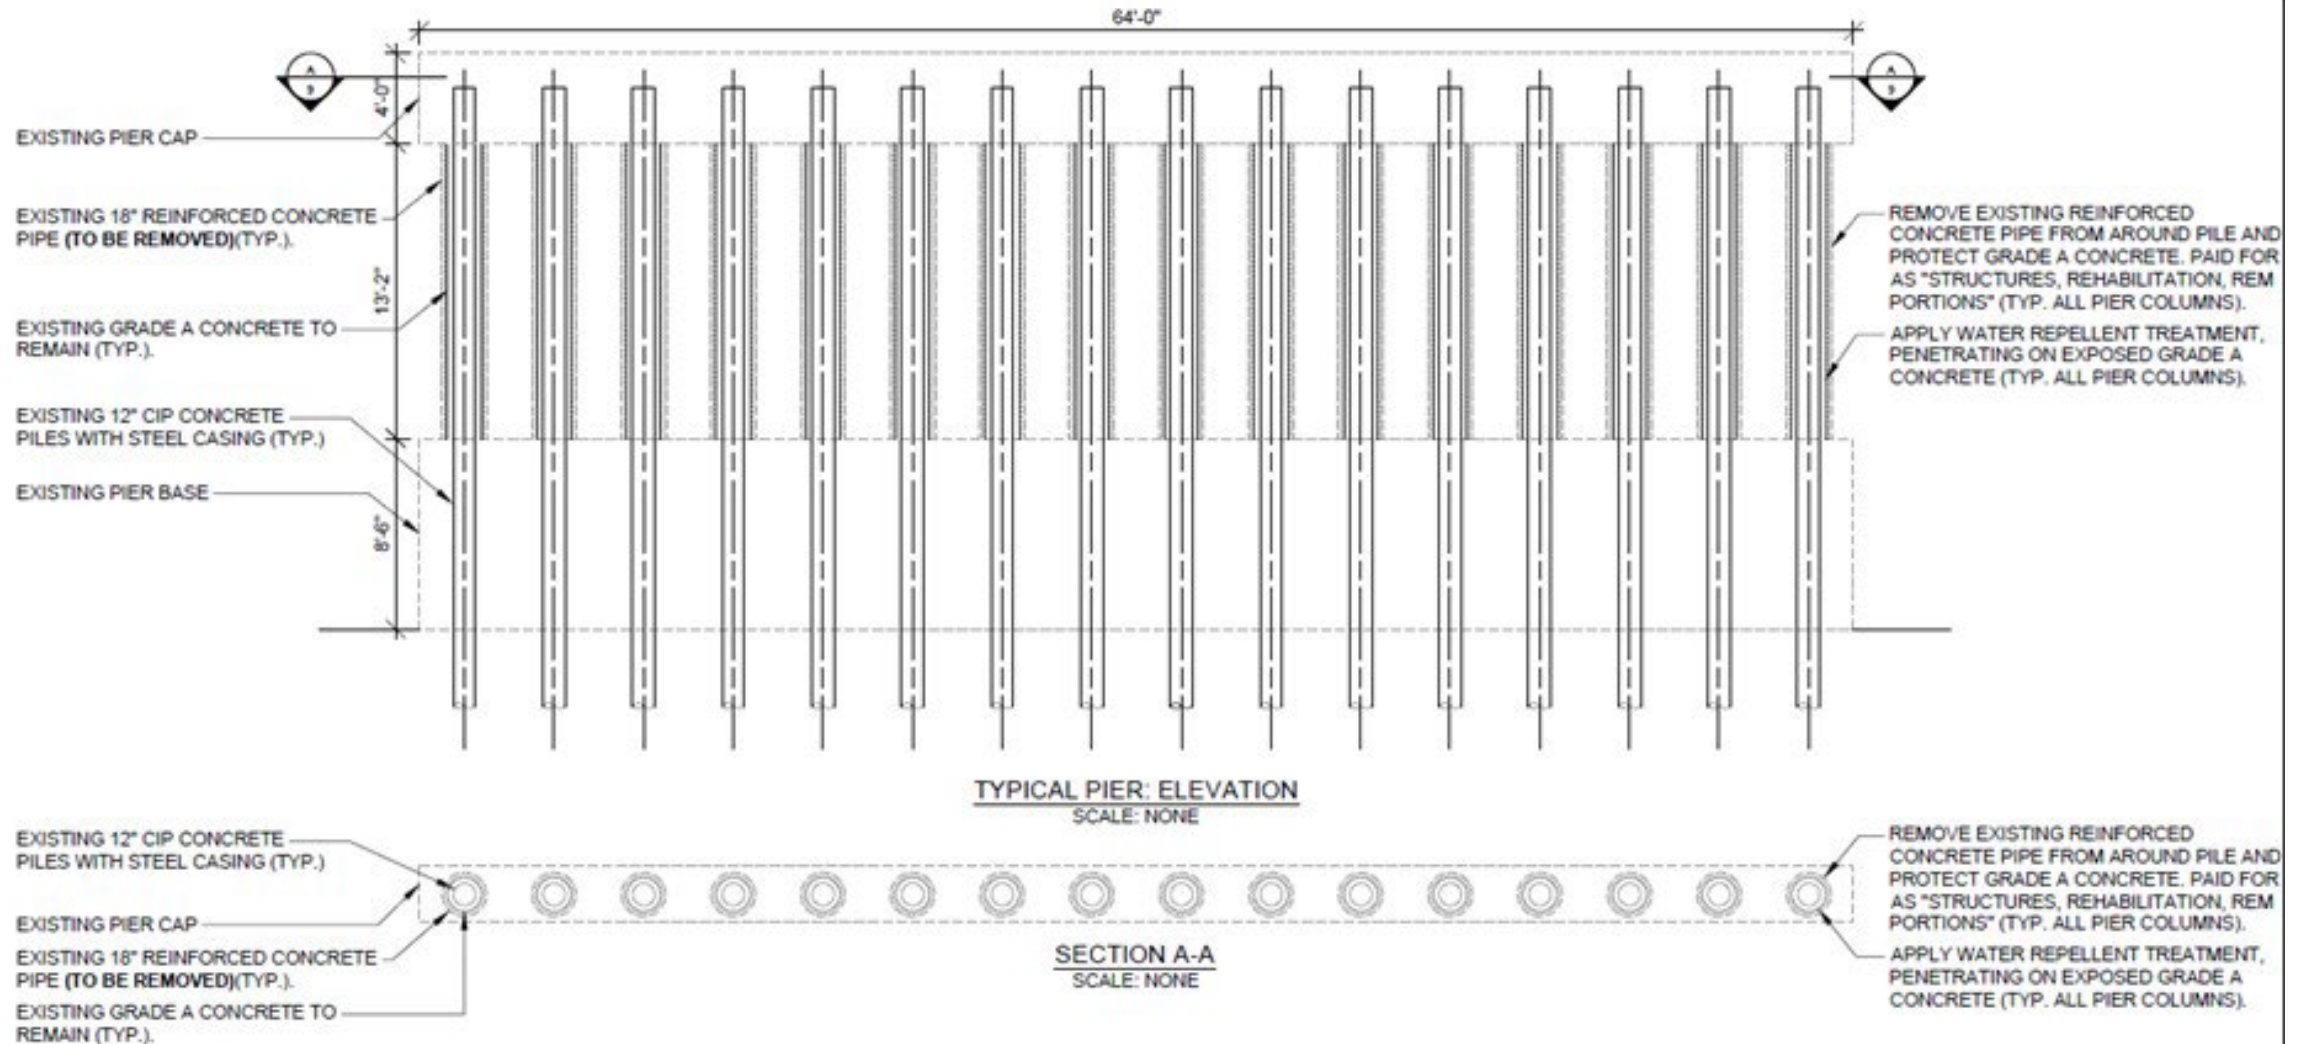
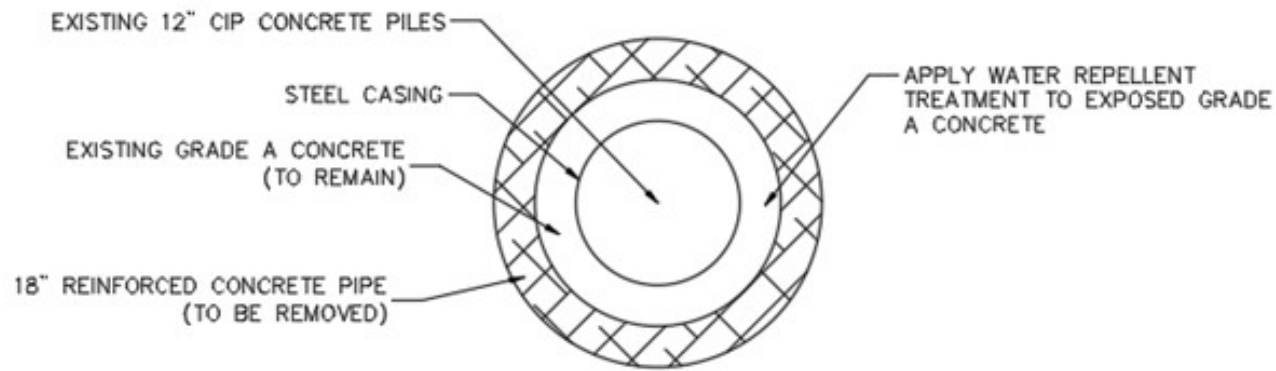
Initial Substructure Plans

- It was assumed that the columns were concrete piles, surrounded by steel casing, and Grade A concrete, and that the columns were enclosed in reinforced concrete pipe.
- The plans were to remove the concrete pipe, exposing the Grade A concrete.
- The Grade A concrete would then be finished with a water repellent treatment.

- Upon starting construction, it was discovered that design assumptions were incorrect.
- Failed exterior concrete was not RCP and there was only one layer of concrete outside of the steel casing.
- Some of the columns were too deteriorated to be rehabilitated and would need to be replaced.
- Forced to develop an alternative design

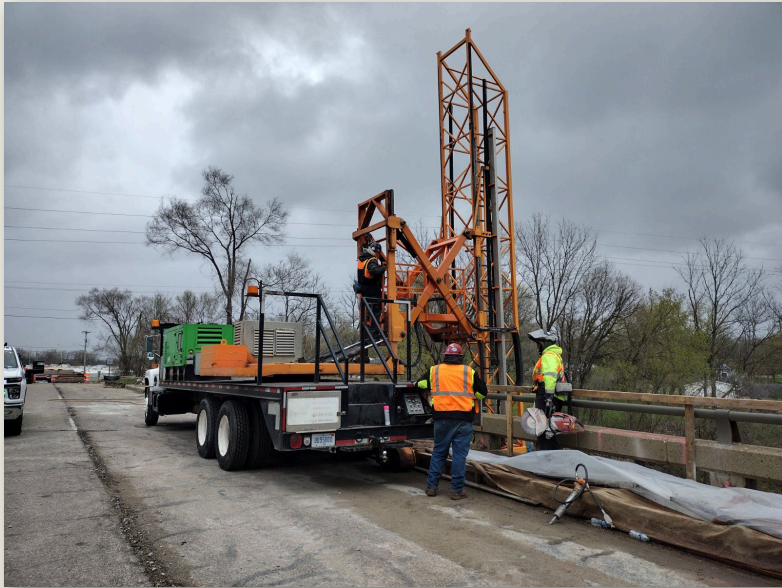
- An under-bridge truck was used for ease of access to the columns, while keeping equipment near the tracks to a minimum.

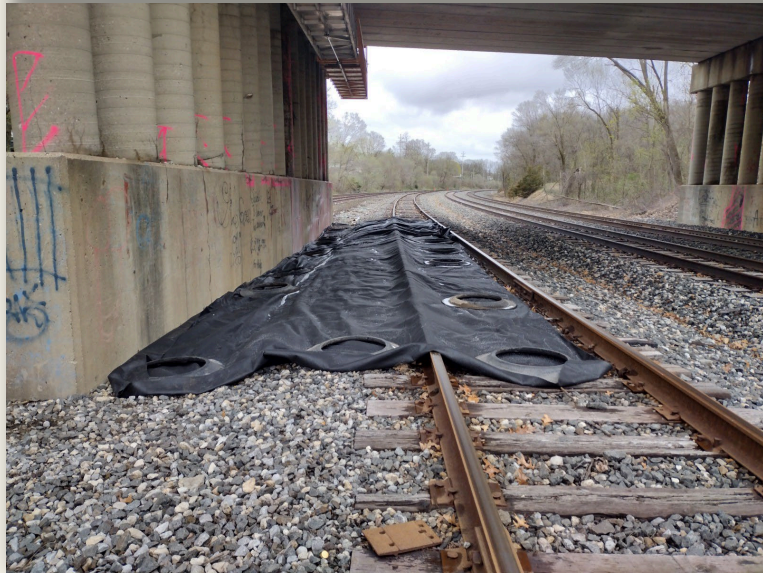
- Tarps were placed over the tracks to keep them free of debris while chipping concrete
