# Culvert Assessment Program

Clinton County Road Commission  
County Engineers Workshop 2026

**Date:** May 30, 2025  
**To:** Marc Trotter – Clinton County Road Commission (CCRC)  
**From:** Kyle Patrick P.E. – Land & Resource Engineering (LRE)  
**Re:** Clinton County Culvert Assessments – Bengal Township

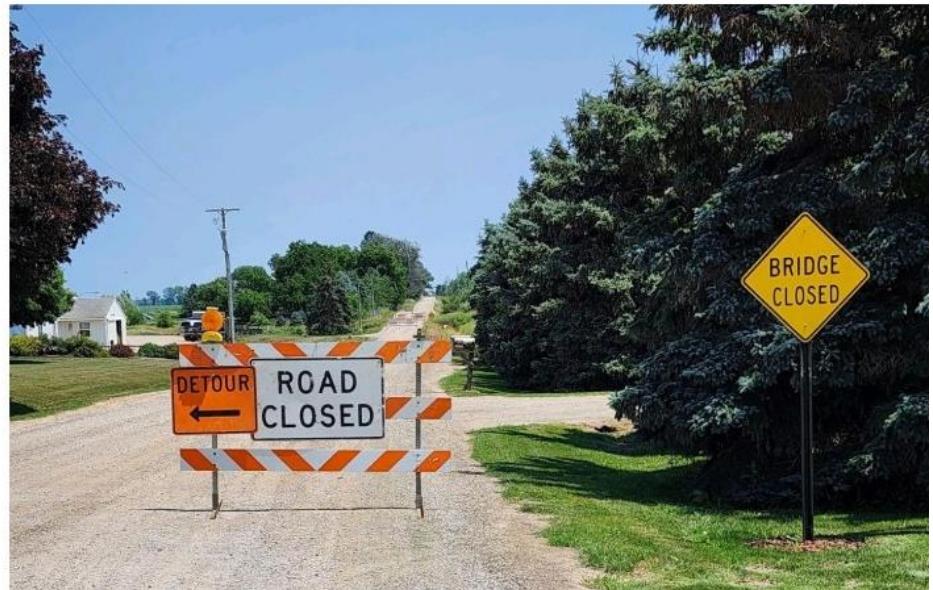
- Three large CMP culverts closed in 2023
- No warning to townships; no time to budget
- Questions raised:
  - What else is approaching failure?
  - How can we avoid reactive closures?

<b>Owner</b>	County: Clinton(19)	<b>Operational Status</b>
TSC	Lansing(17)	K Closed to all traffic(K)
<b>Last NBI Inspection</b>	10/13/2022 / J5BJ	<b>Scour Evaluation</b>
		5 Stable w/in footing

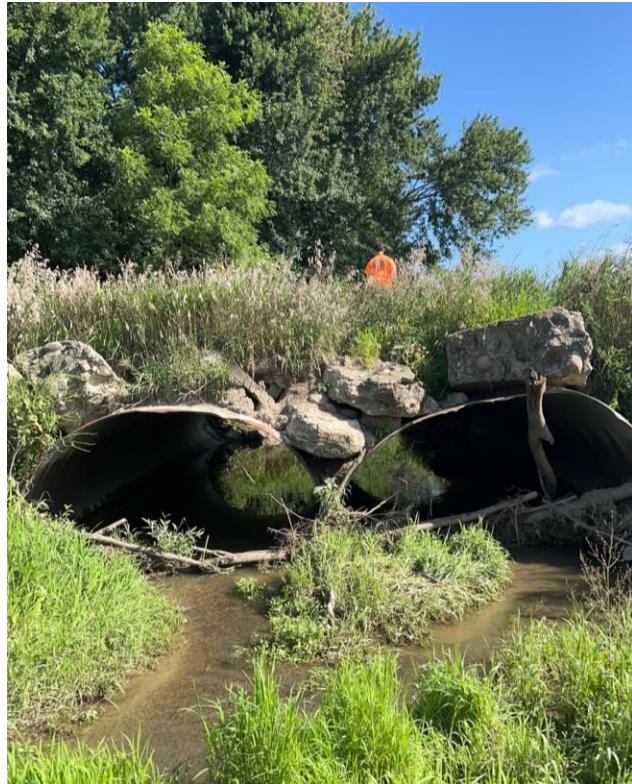
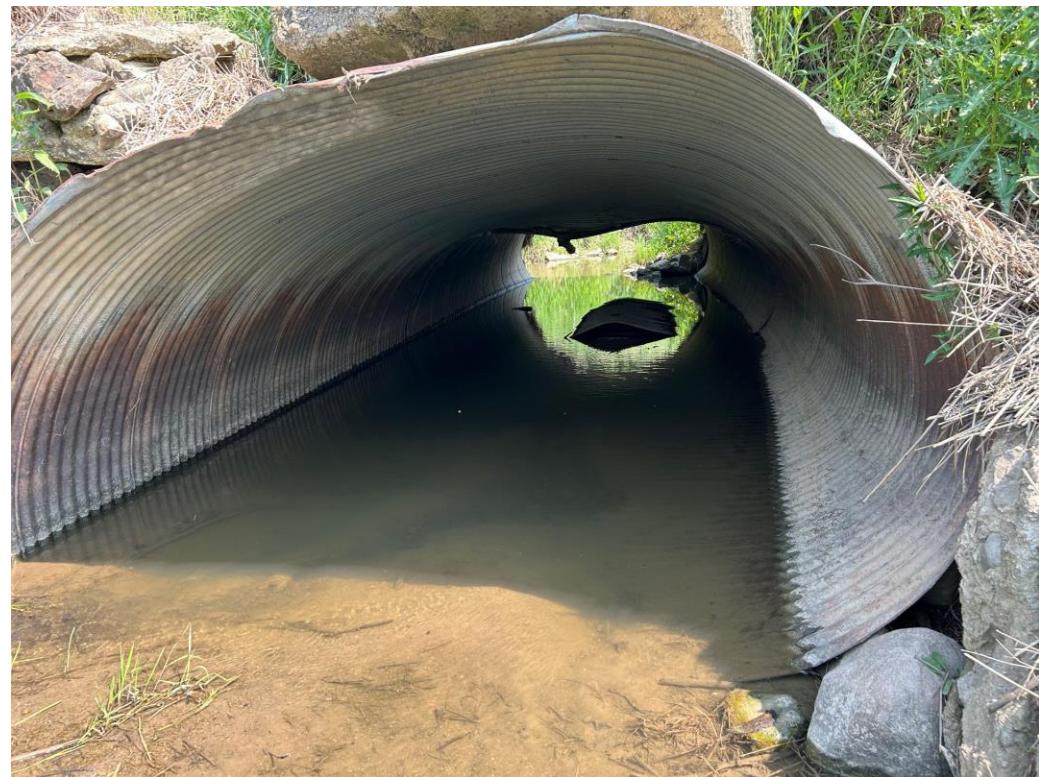
# Inventory data directly supported real-world decisions
