A TALE OF TWO BRIDGES

Au Train Bridge

**PROPOSED AU TRAIN
BRIDGE REHABILITATION**
MDNR - DTMB
ALGER COUNTY, MICHIGAN

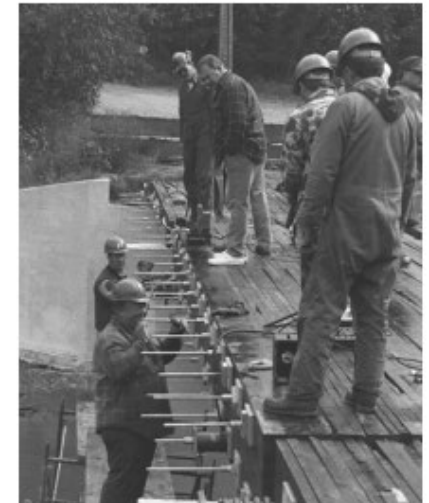
Figure 11—Two sets of deck stressing equipment were used to tension the stressing bars after deck placement.

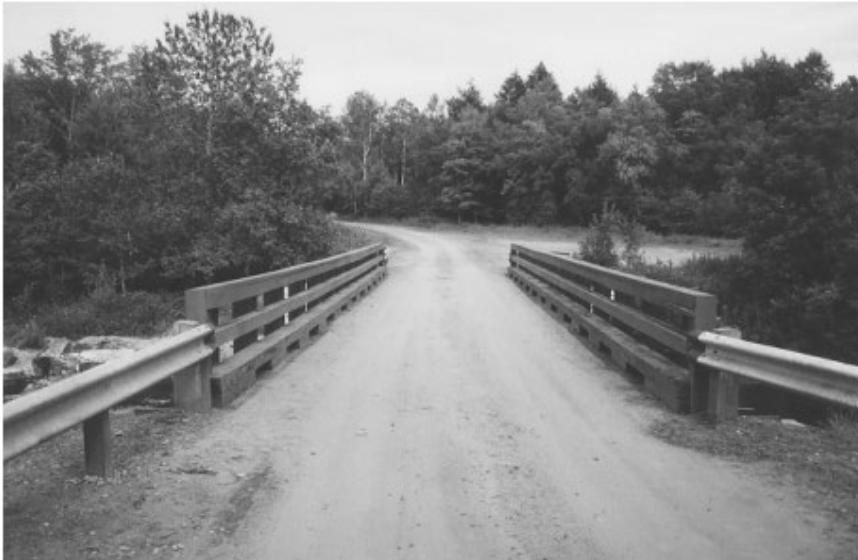
Figure 12—Completed Big Erick's bridge: side view (top), end view (bottom).

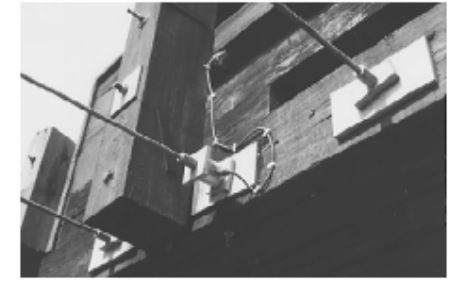
Figure 13—One of six load cells installed on stressing bars to measure changes in bar force.
