Using UAV Collected Bridge Condition Data for a Rating Exercise

Intro to UAV-enabled methods to collect & process bridge condition data

Michigan Bridge Conference, 3/21/2017

Routine Surface Visual Inspection of a Bridge Deck Exercise

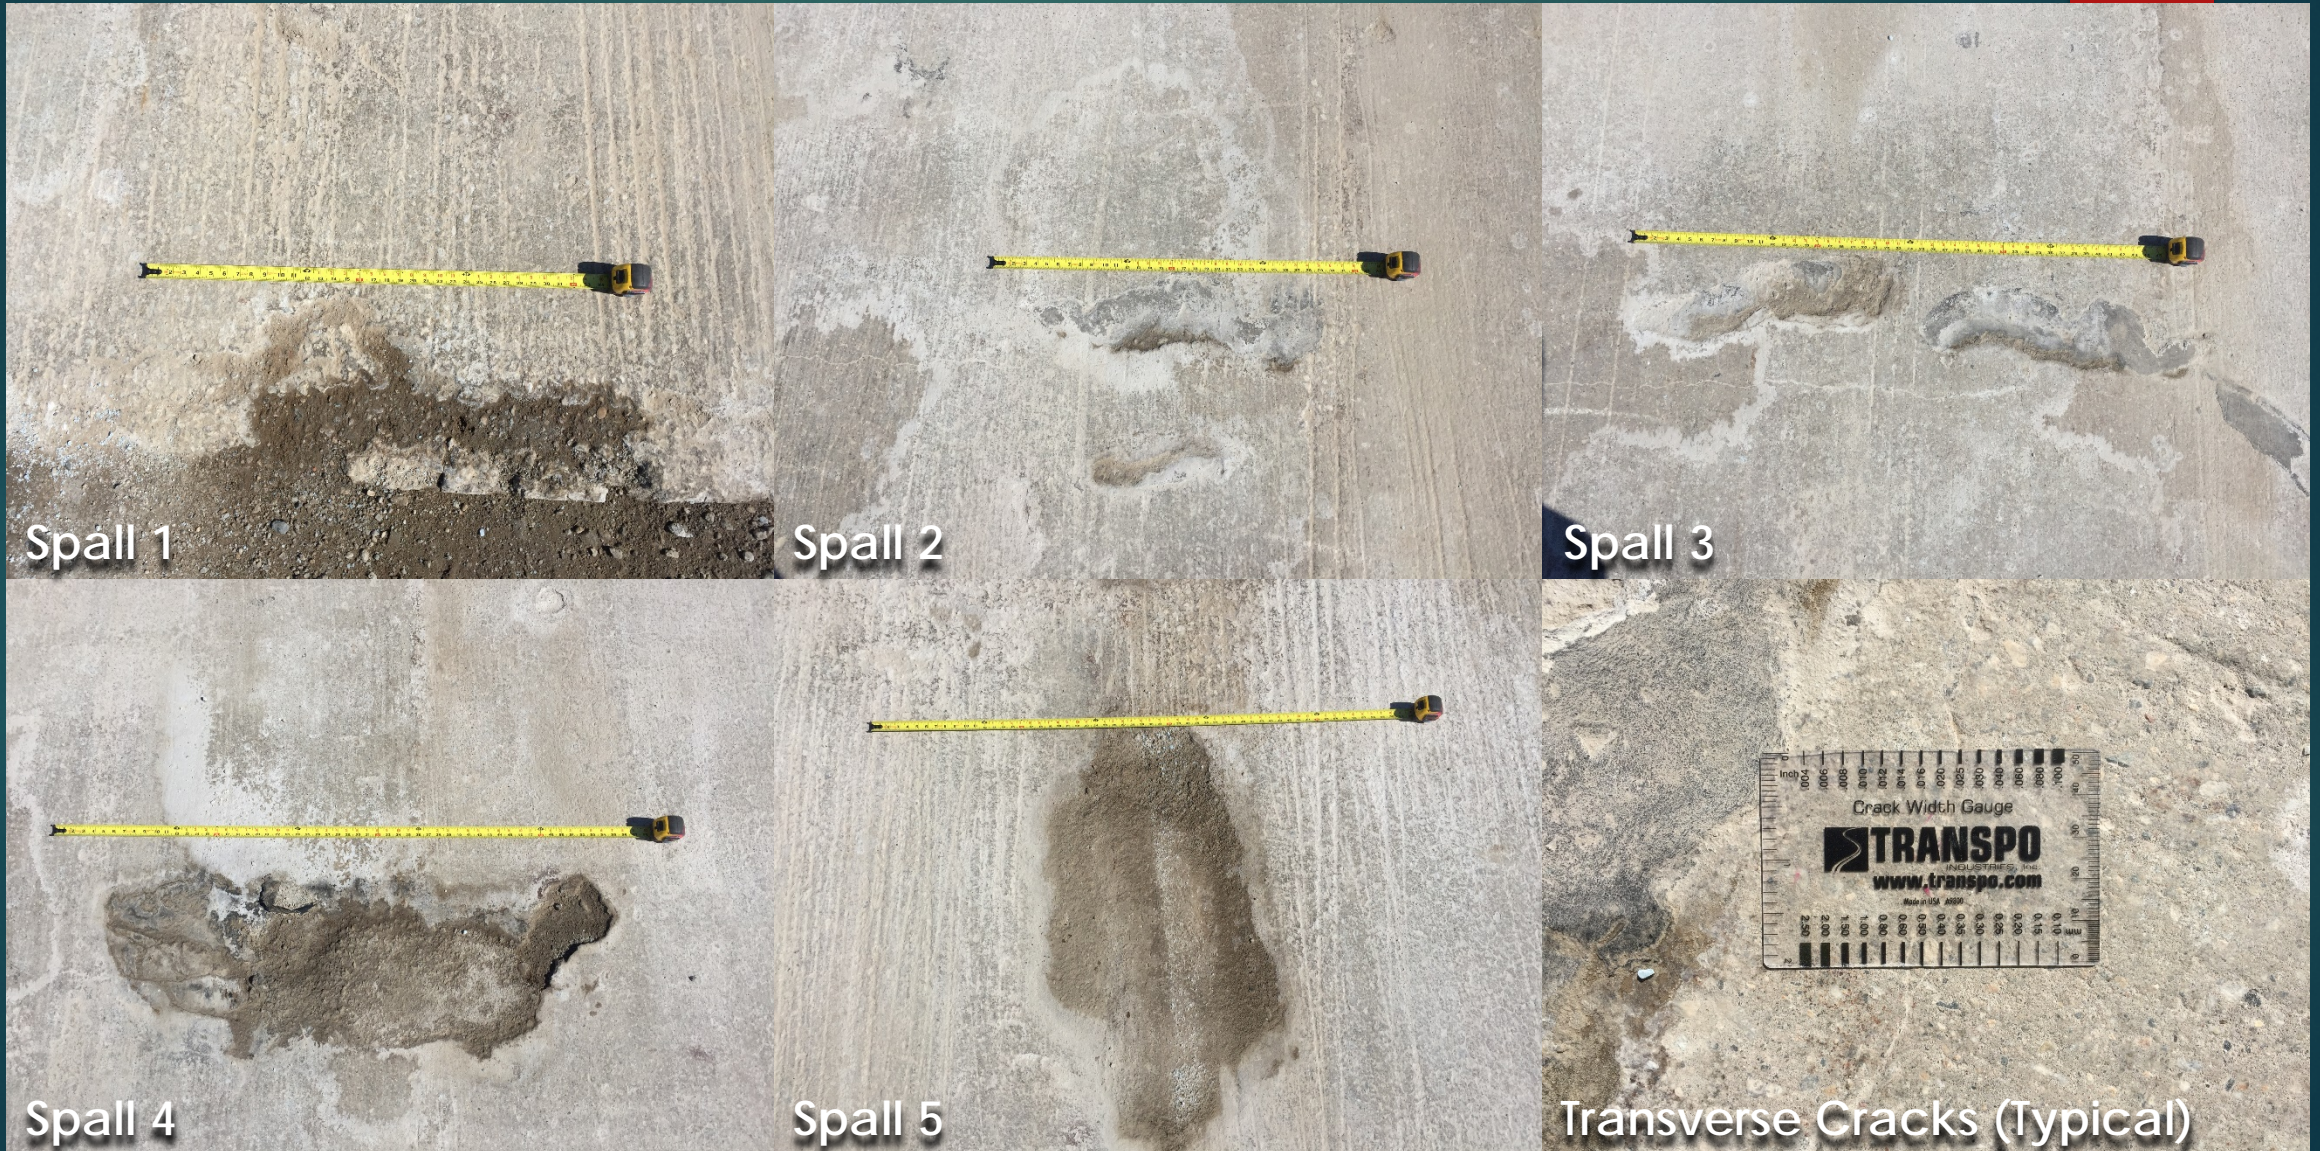
Concrete deck has scattered gravel. There is approximately 12 sft of spalls in 5 locations and approximately 15 sft of delamination in 5 locations. Largest spall at midspan centerline. Block cracking in the southeast corner in a 6'x6' area. Moderate map cracking in south lane. There are 6 transverse half width cracks. There is a monument in the deck near west abutment. There is debris along brush blocks. (10/16)

Conditions had minimal change over the last three inspections of the surface.

Roughly 4% of the deck has spalls, delaminations and heavy block cracking.

Moderate map cracking in left lane. Moderate crack thickness ranges from 0.012 to 0.05 inches.

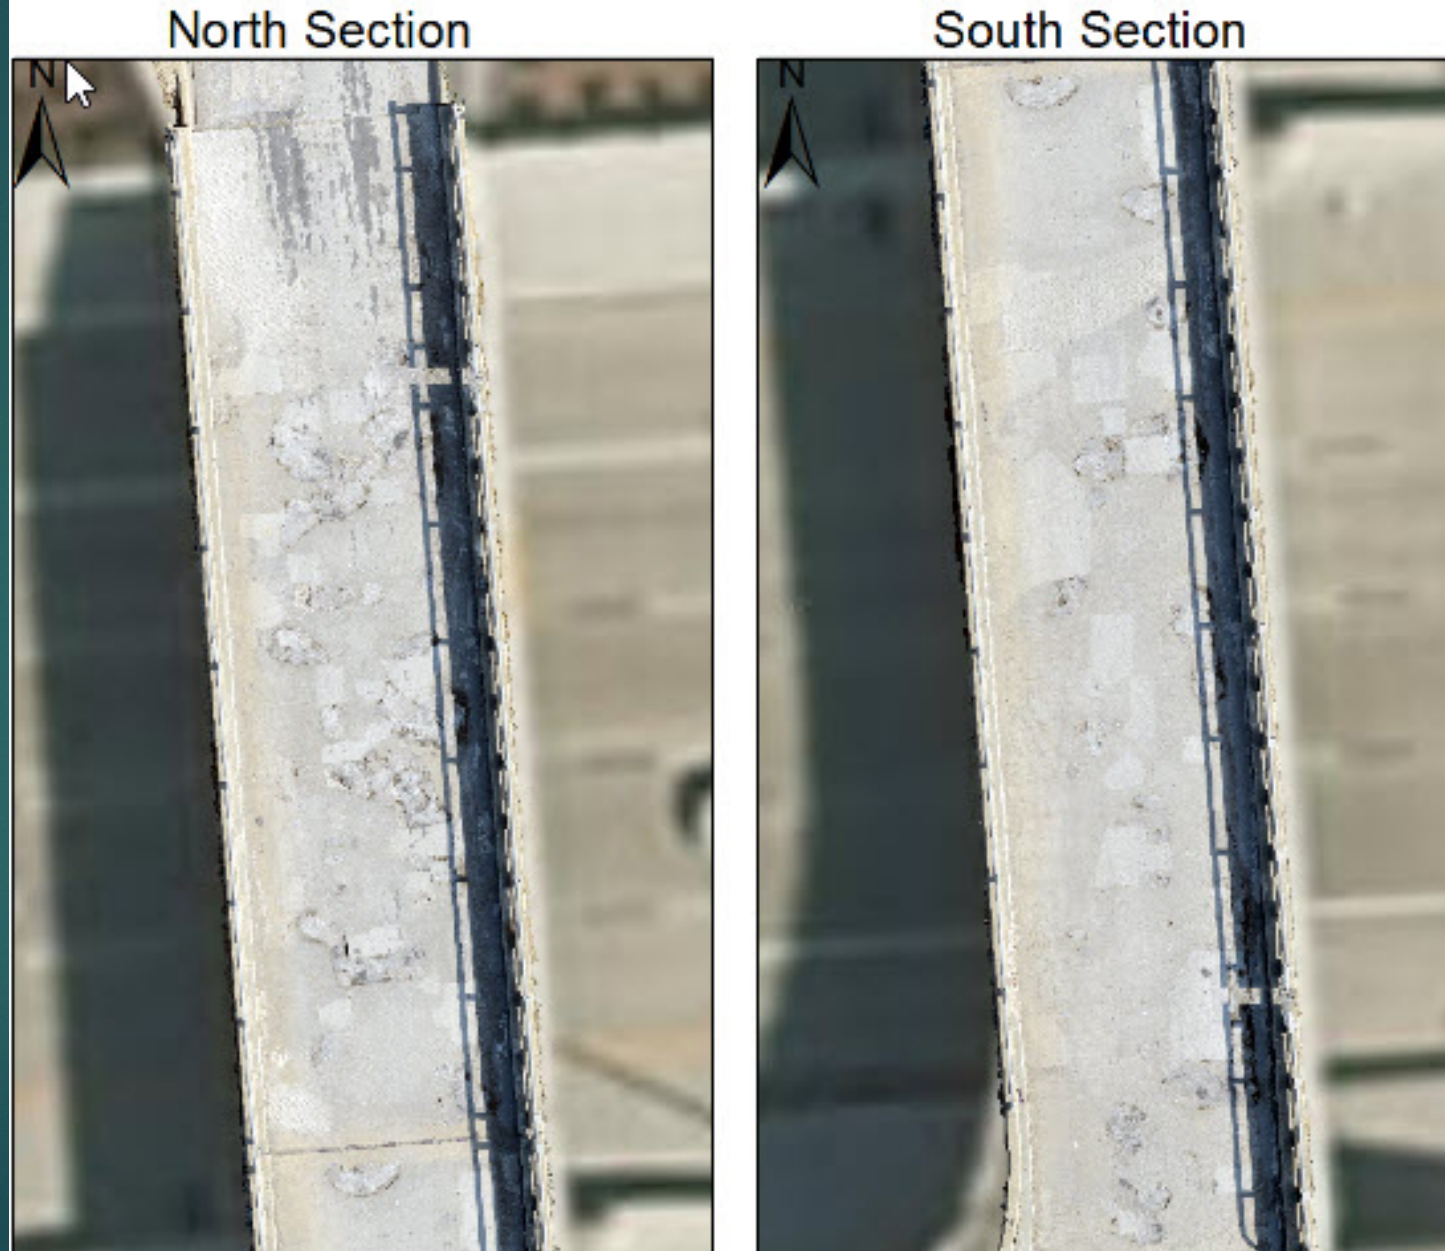
Typical Spalls, HMA patching, concrete patches

Inspection notes noted numerous open spalls, bit filled spalls, and concrete patches throughout the entire deck. Most concrete patches were in good condition.

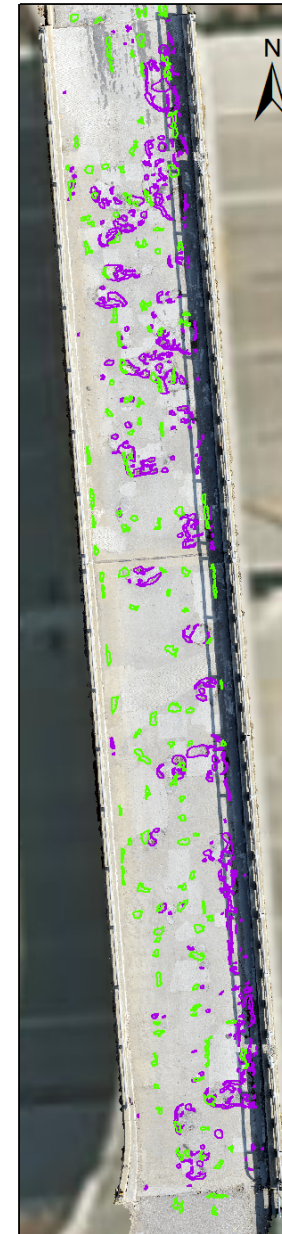
UAV Data
Merriman Rd East Bridge
Thermal-Optical Algorithm
Derived Delaminations
Application Detected Spalls
STR# 11516

- Thermal - Optical
Algorithm Delaminations
- Application Detected Spalls

Total Detected Spall
Polygon Area = 150.44 sq ft
Total Area of Optical - Thermal
Polygons = 92.79 sq ft

UAV detected 243 sft of delamination and spalls

Roughly 6+% of the deck surface has spalls, delaminations, from UAV data

Results do not account for moderate to heavy cracks.

Deficiencies could not be picked up in the shaded areas
