MDOT
Michigan Department of Transportation

Michigan DOT Best Practices

Identifying Maintenance Needs & Properly Addressing

2017 CTT Michigan Bridge Workshop

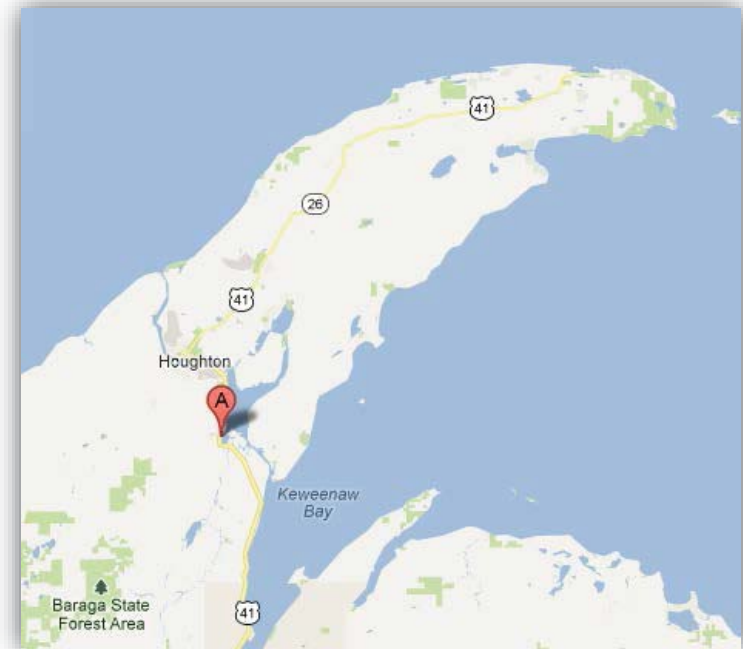
- BO4-31051: US-41 over Sturgeon River
- 1.8 Miles SE of Chassel

- North Abutment
- Spalls to Steel
 - Beams 7W and 8W

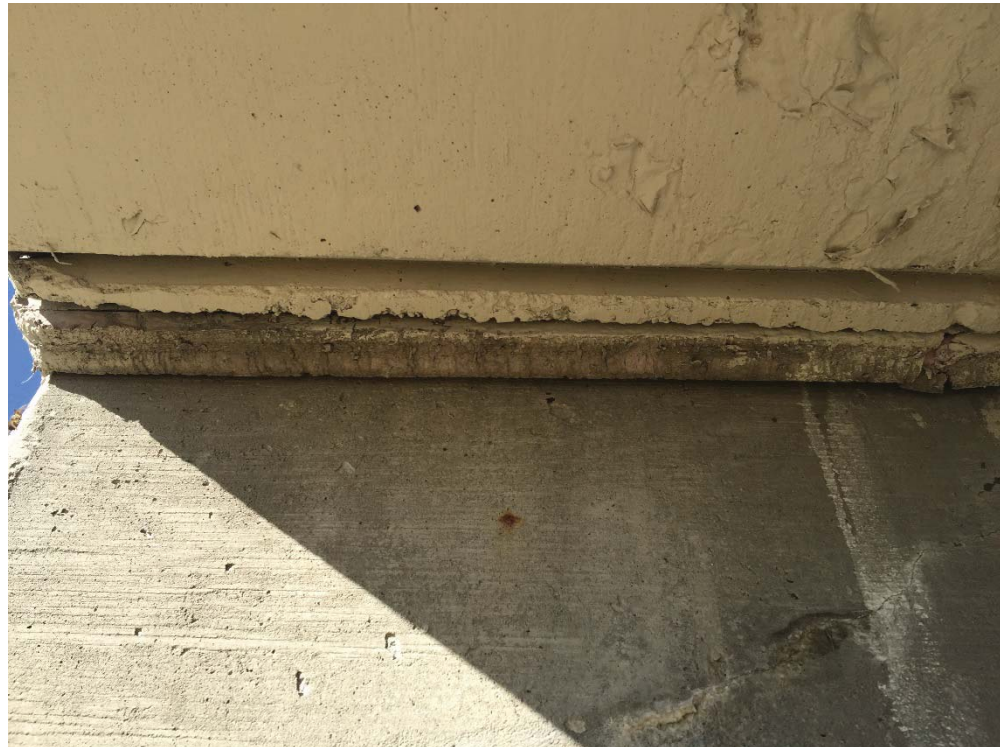
Bad Joint Details

- 4" Expansion Joint
 - Off Bridge and On Sleeper Slab
 - Deck Slides over Back Wall
 - 1/2" Gap Between Deck Fascia and Return Wall

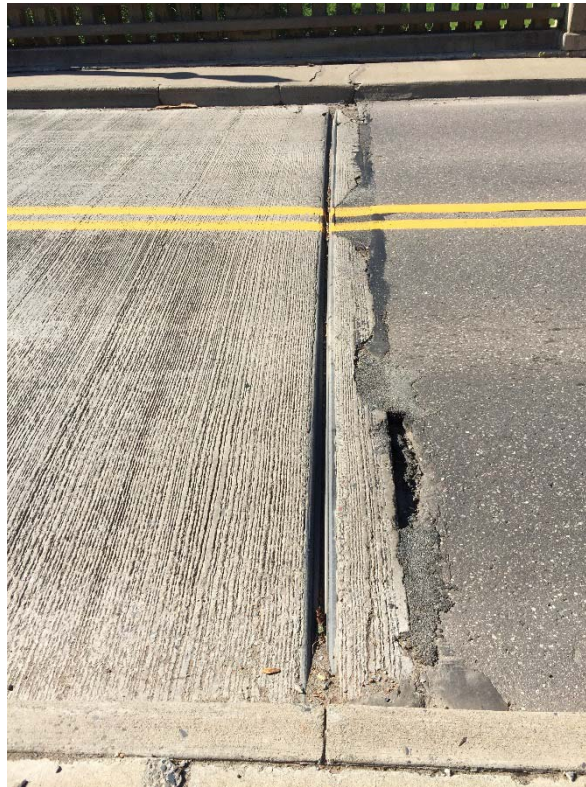
Bad Joint Details

- 2" Expansion Joint
 - Off Bridge and On Sleeper Slab
 - Deck Slides over Back Wall
 - 0" Gap Between Deck Fascia and Return Wall

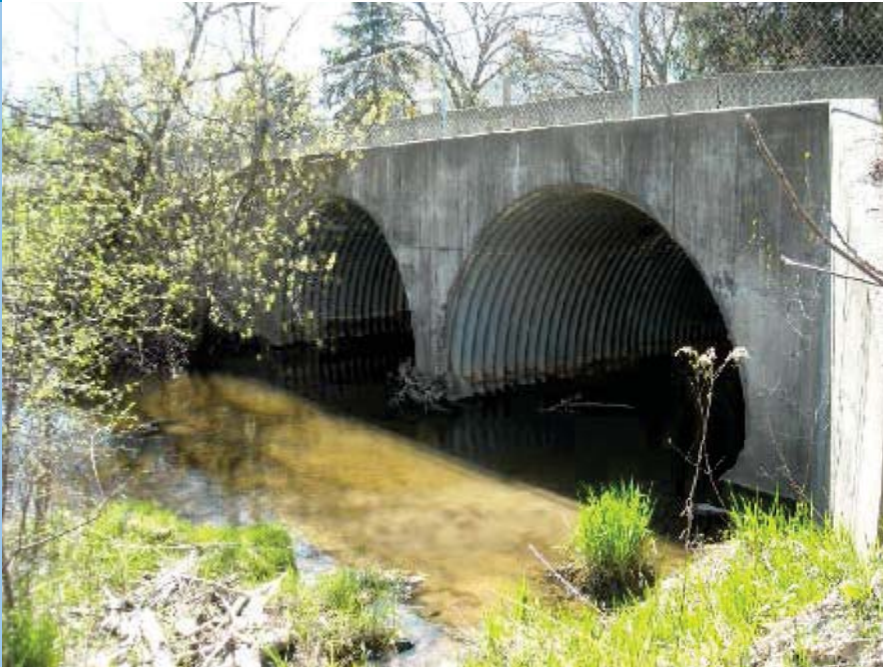
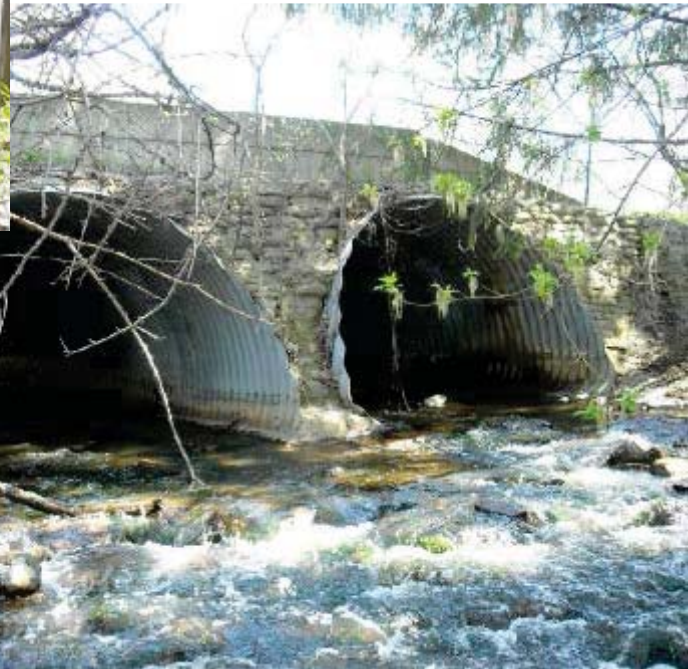
Wattles Rd Culverts at the Rough River

- Twin Multi-Plate Pipe Arch
- Originally Constructed in 1967 and extended in 1983
- Severe Corrosion at Invert and Haunch
- 170 Linear Feet of CMP
- 12 ft 10 inches Wide
- 8 ft 4 inches Tall
- 2.5 Inch Thick Geospray Mortar
- 3 Weeks

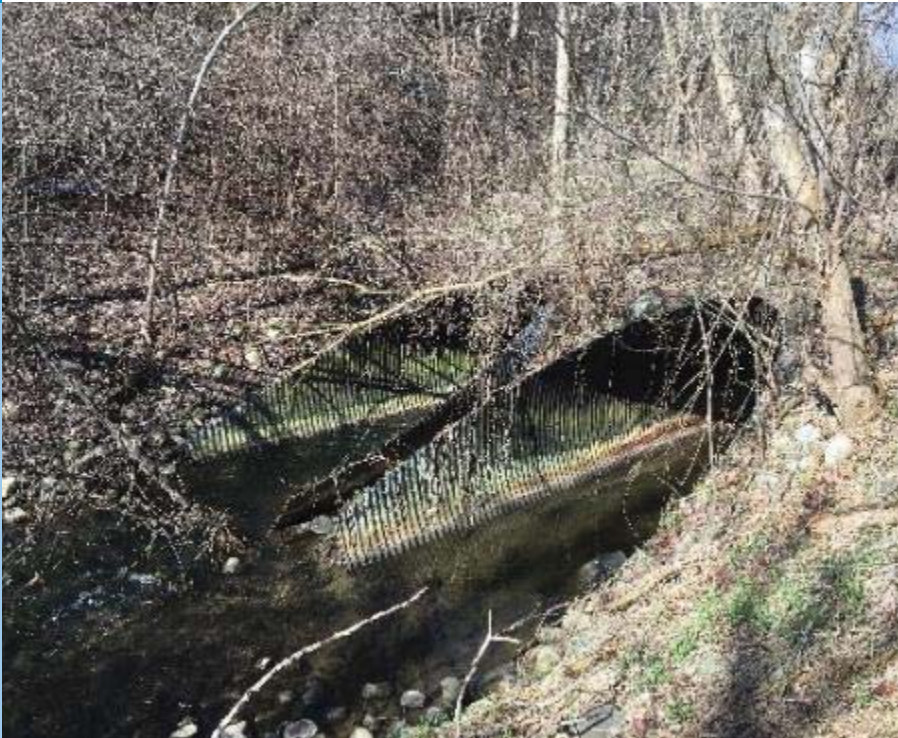
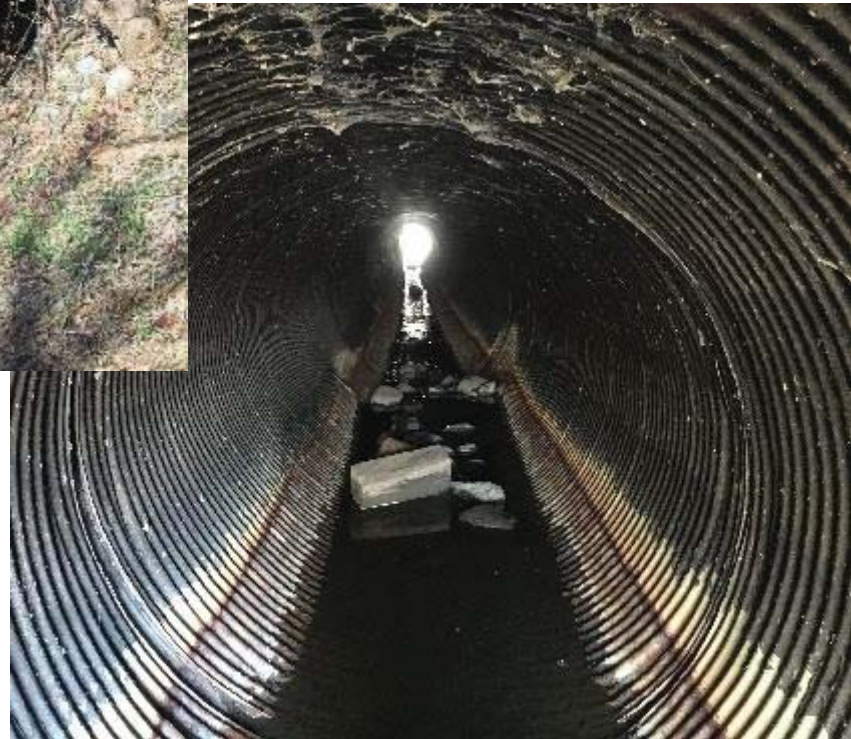
- Corroded Twin Structural Plate Culverts under 13 Mile Road in Farmington Hills, MI
- Culverts originally constructed in 1987
- 78" Diameter
- 200 linear Ft each
- 1.5 Inch Thick Geospray Mortar
- 2 Weeks

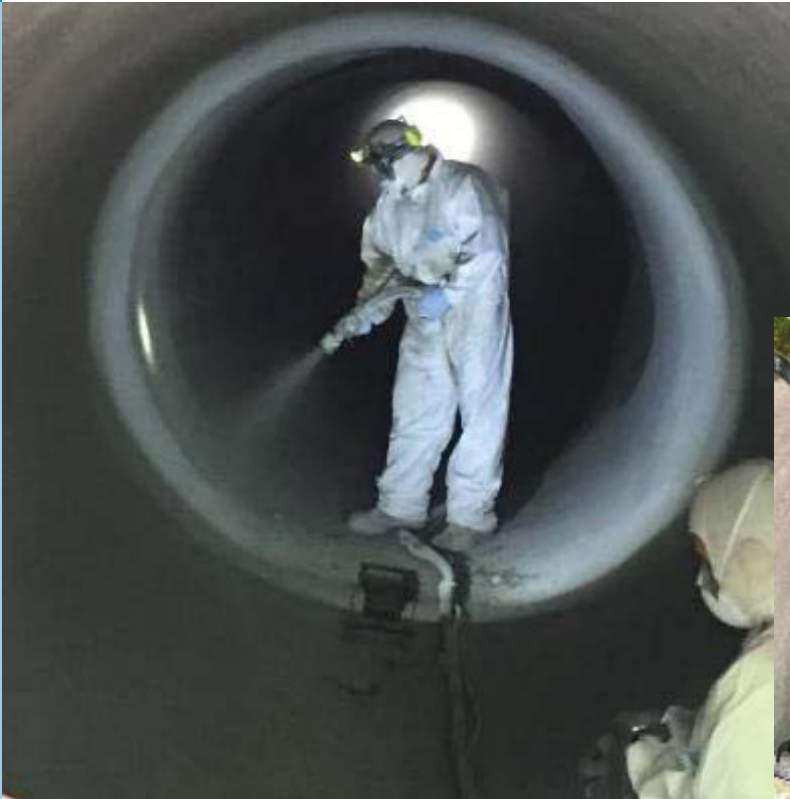
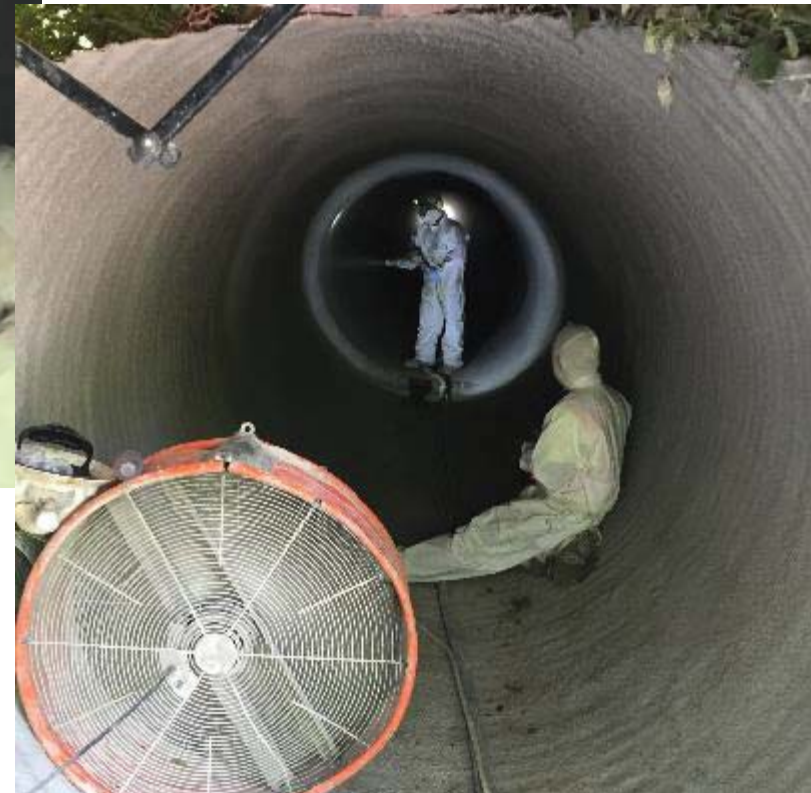
Culverts

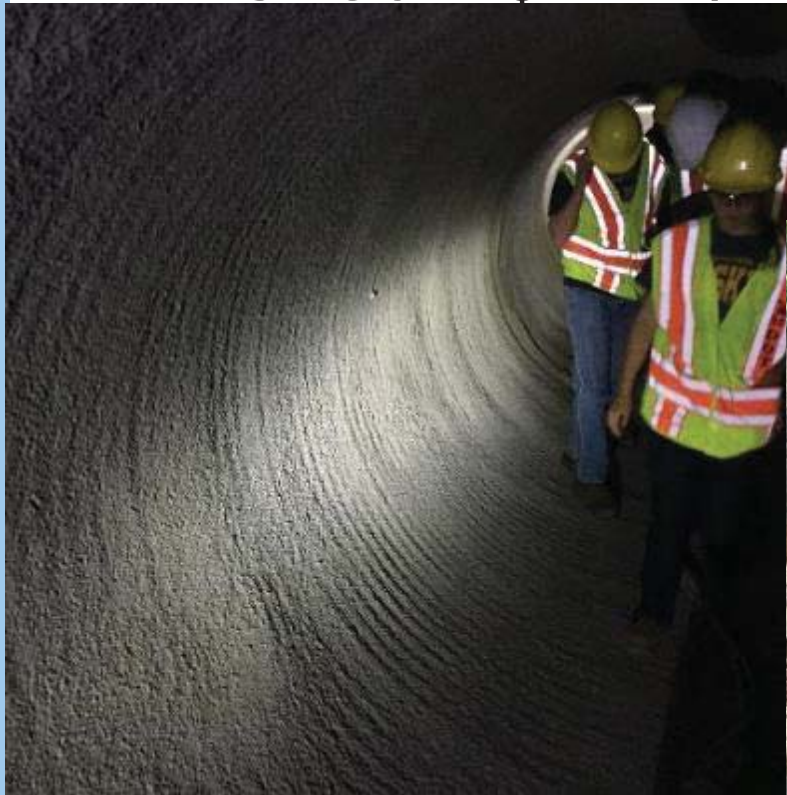
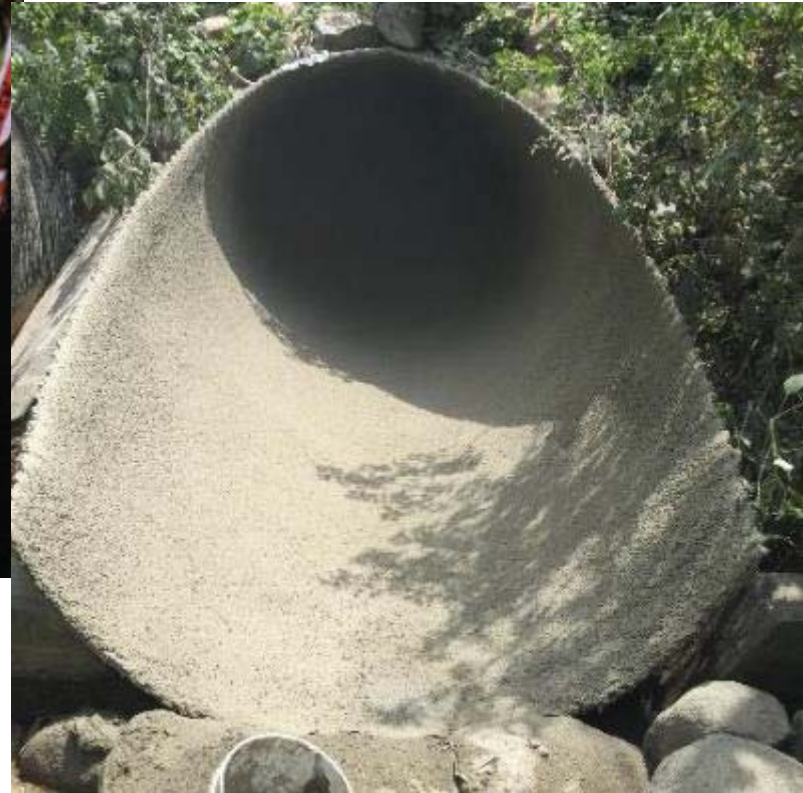
- Finished - \$427 / Lineal Foot

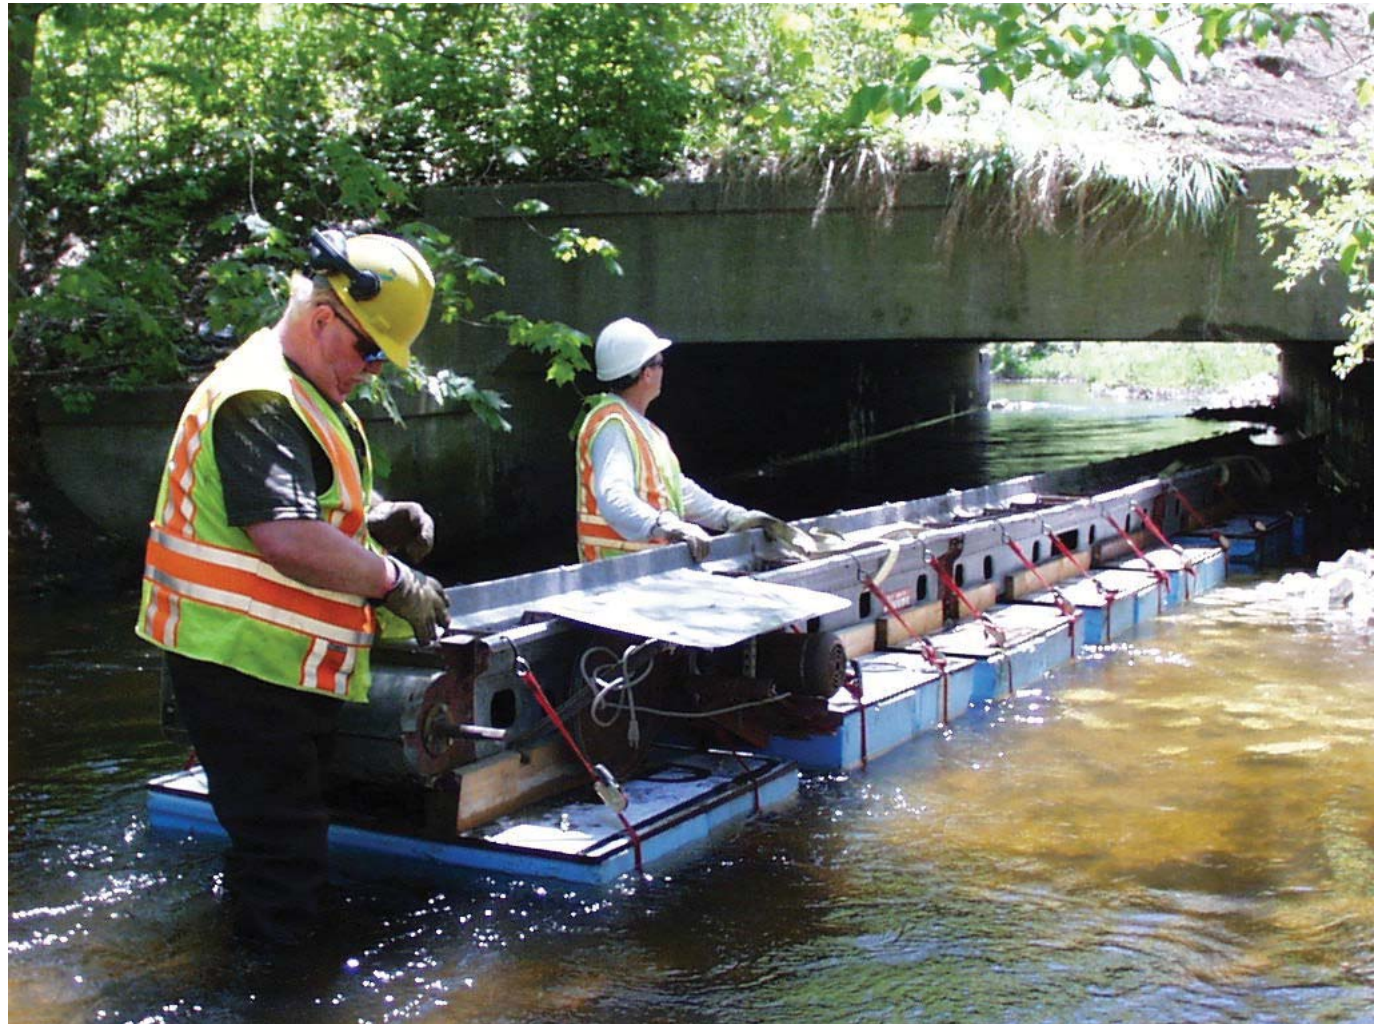
Culverts - Scour

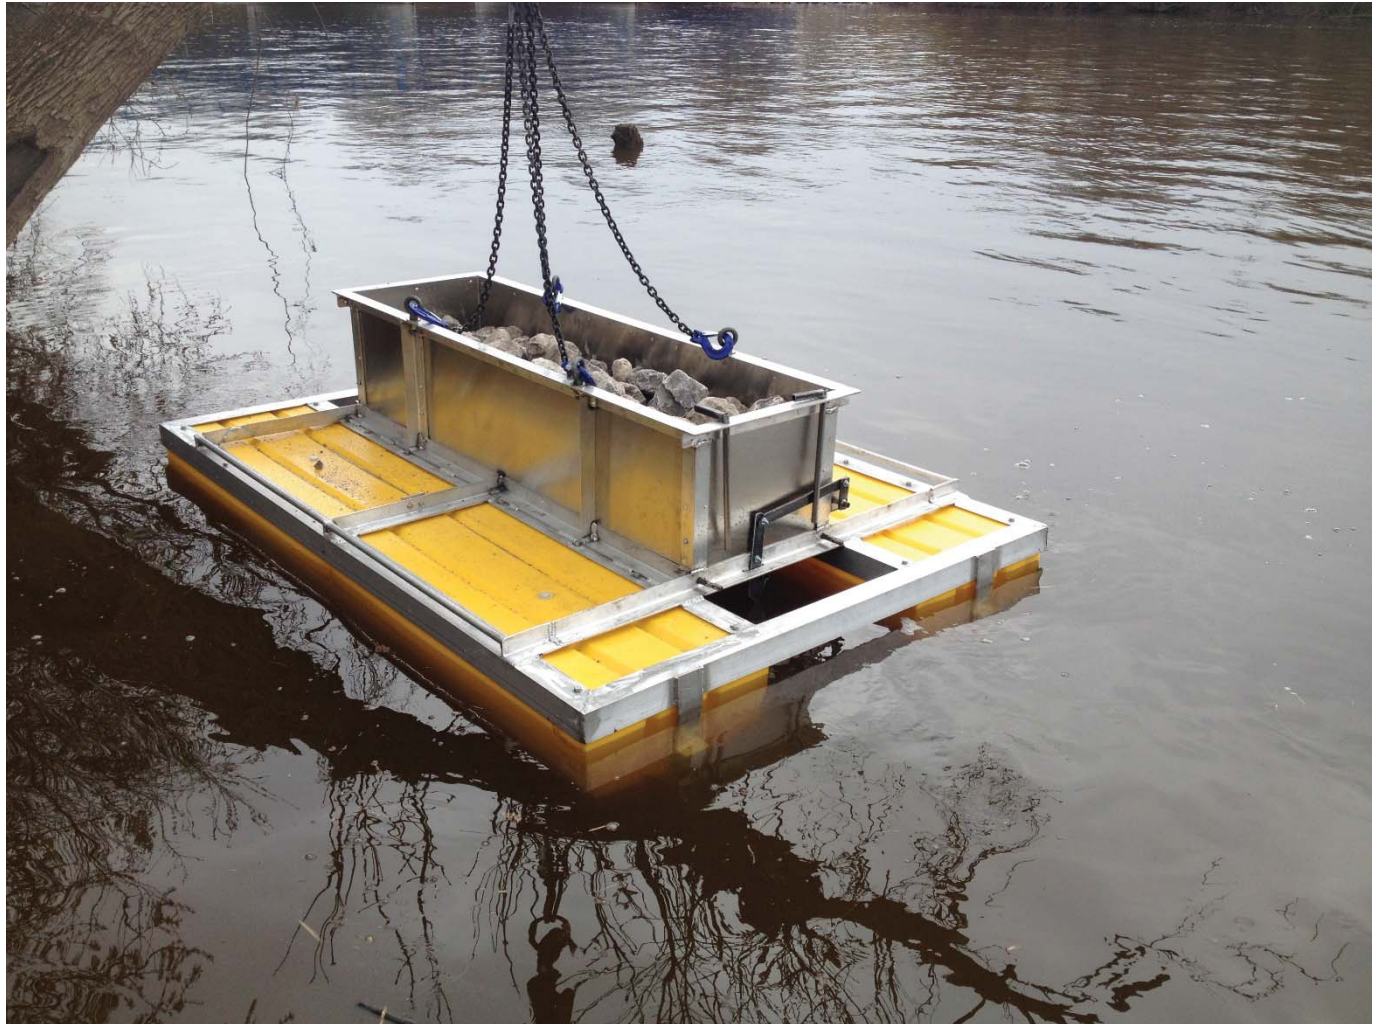
Culverts - Scour

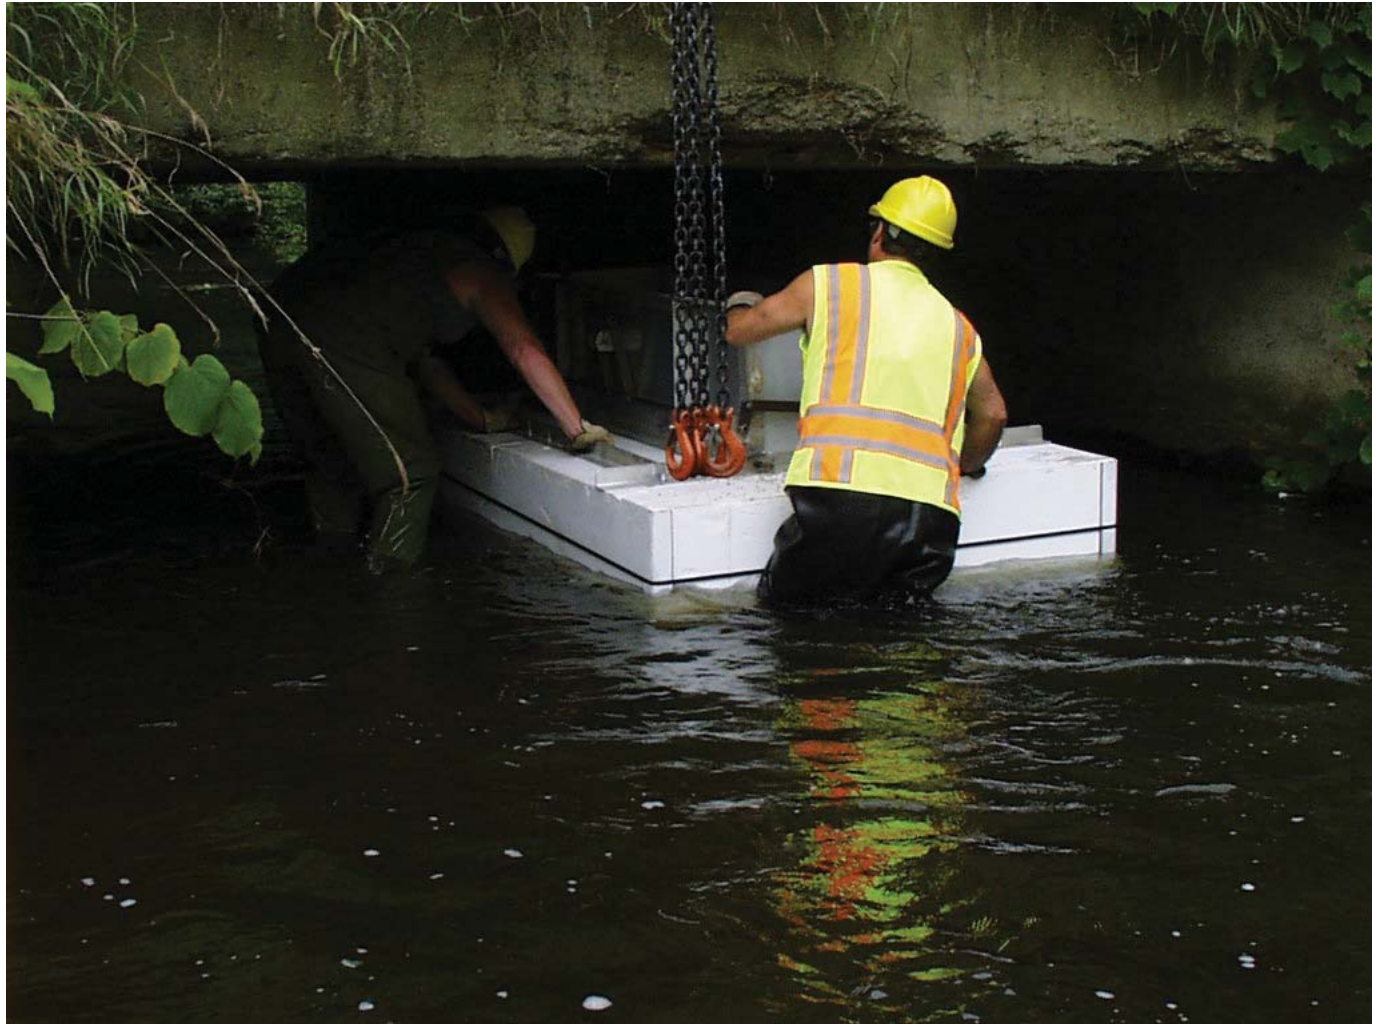
Culverts - Scour

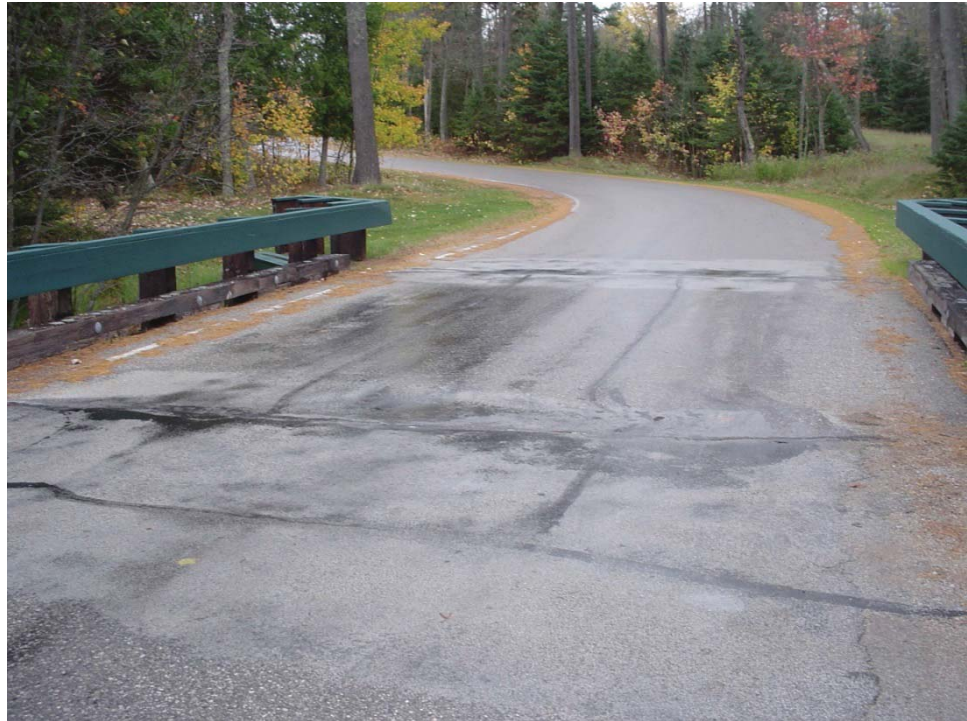
B05 of 49022

- Constructed in 1990
- Timber Superstructure comprised of 2 x 12 timbers spanning 24 feet nailed together.

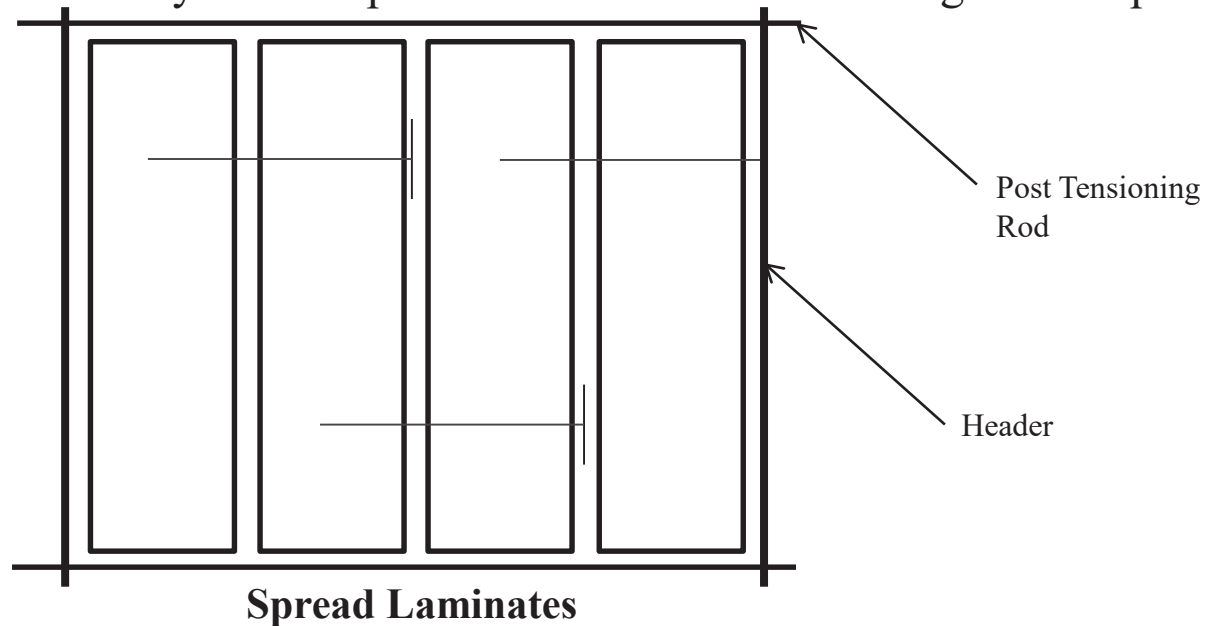
Report 1: Transverse Post-Tensioning of Longitudinally Laminated Timber Bridge Decks

- Ontario Ministry of Transportation Post Tensioned Bridge to 150 psi

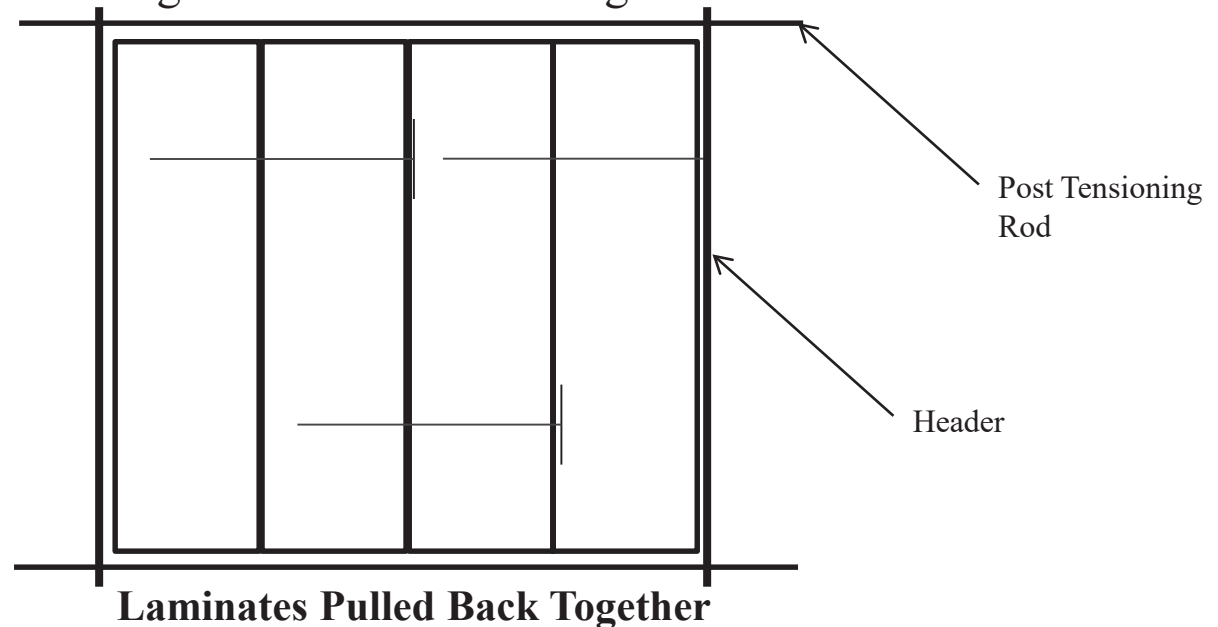
Report 1: Transverse Post-Tensioning of Longitudinally Laminated Timber Bridge Decks

- Post Tensioning Force shrunk the bridge 6 inches

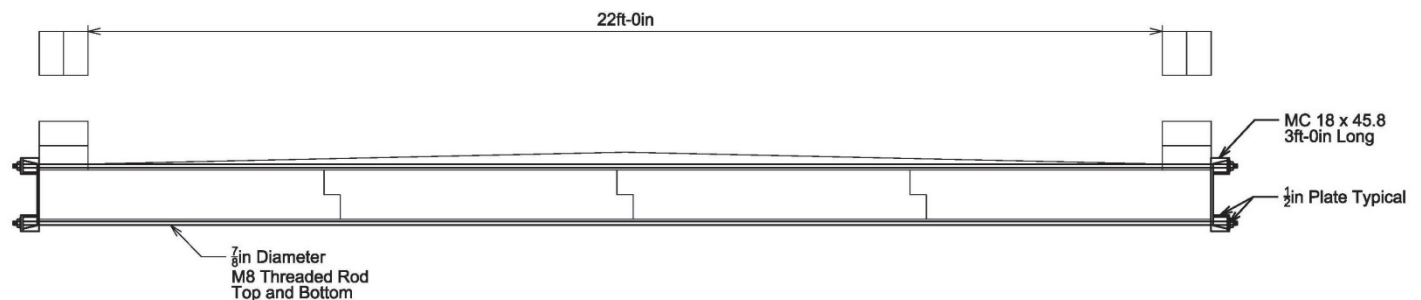
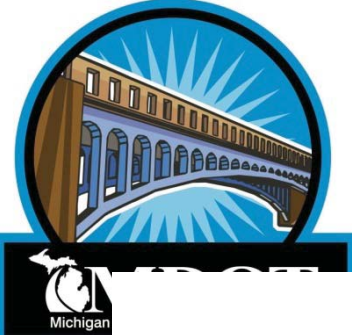
SECTION A-A

- The test bridge shrunk 6 inches when post tensioned to 150 psi
- B05 of 49022 Measured 24'-2" Wide (Only 2" wider than As-Built)
- Report 1 determined only 40 psi between timbers needed for composite action.

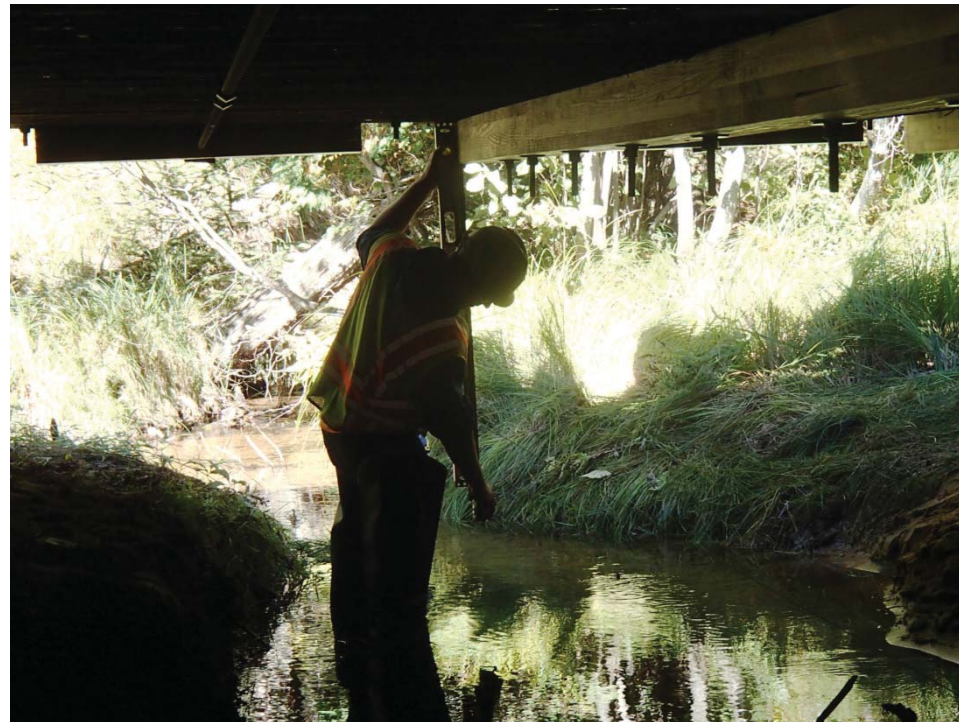
- $\frac{3}{4}$ inch deflection before
- $\frac{1}{4}$ inch deflection after
