Michigan DOT Best Practices

Identifying Maintenance Needs & Properly Addressing

2017 CTT Michigan Bridge Workshop

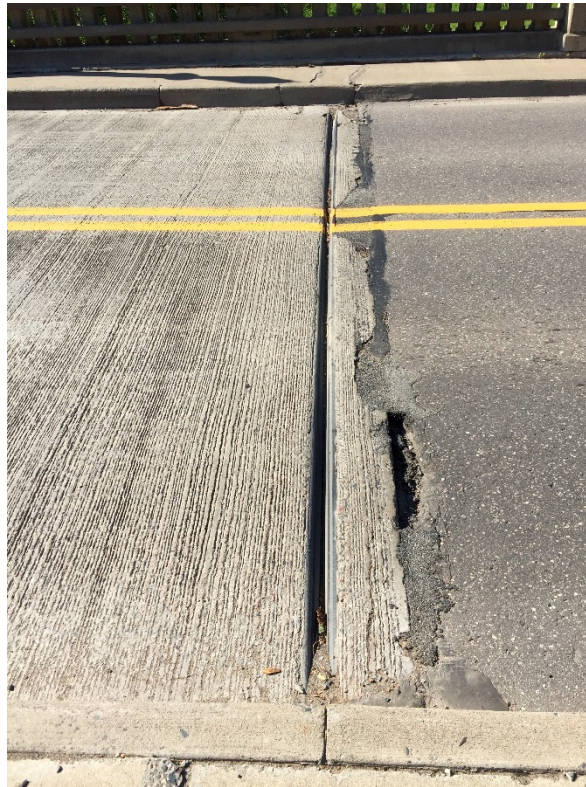
Bad Joint Details

- 2" Expansion Joint
 - Off Bridge and On Sleeper Slab
 - Deck Slides over Back Wall
 - 0" Gap Between Deck Fascia and Return Wall

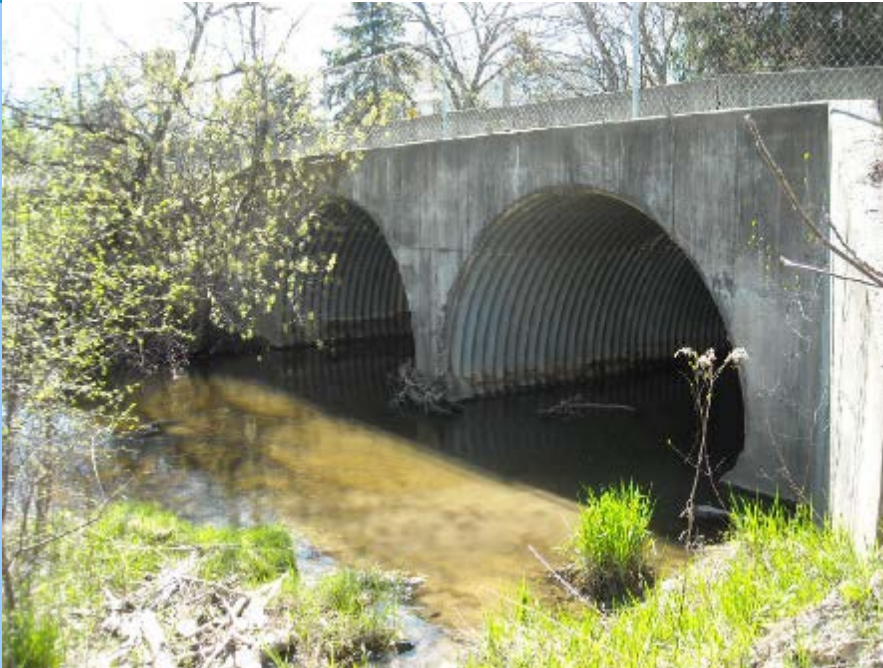
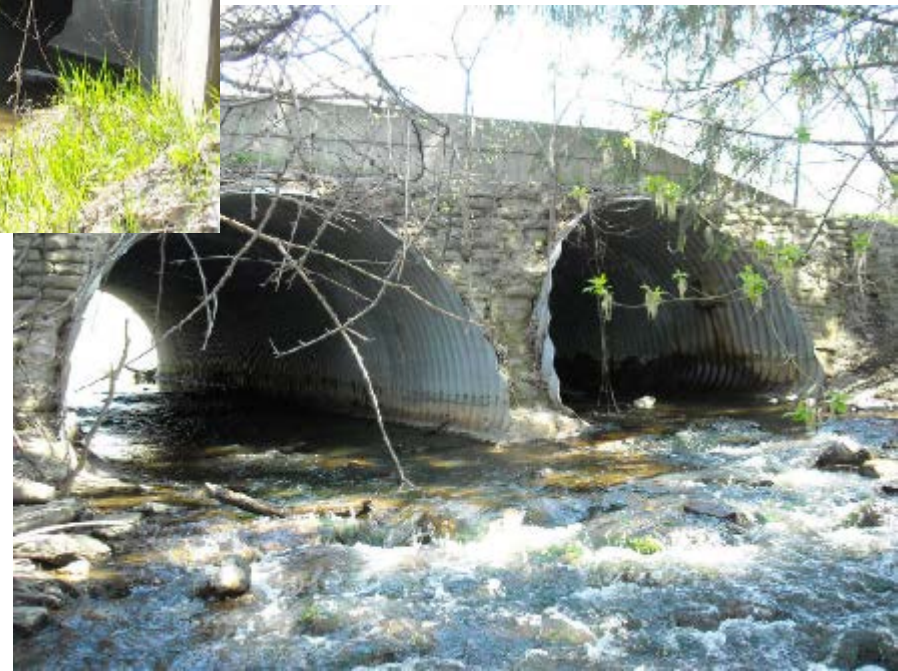
- Twin Multi-Plate Pipe Arch
- Originally Constructed in 1967 and extended in 1983
- Severe Corrosion at Invert and Haunch
- 170 Linear Feet of CMP
- 12 ft 10 inches Wide
- 8 ft 4 inches Tall
- 2.5 Inch Thick Geospray Mortar
- 3 Weeks

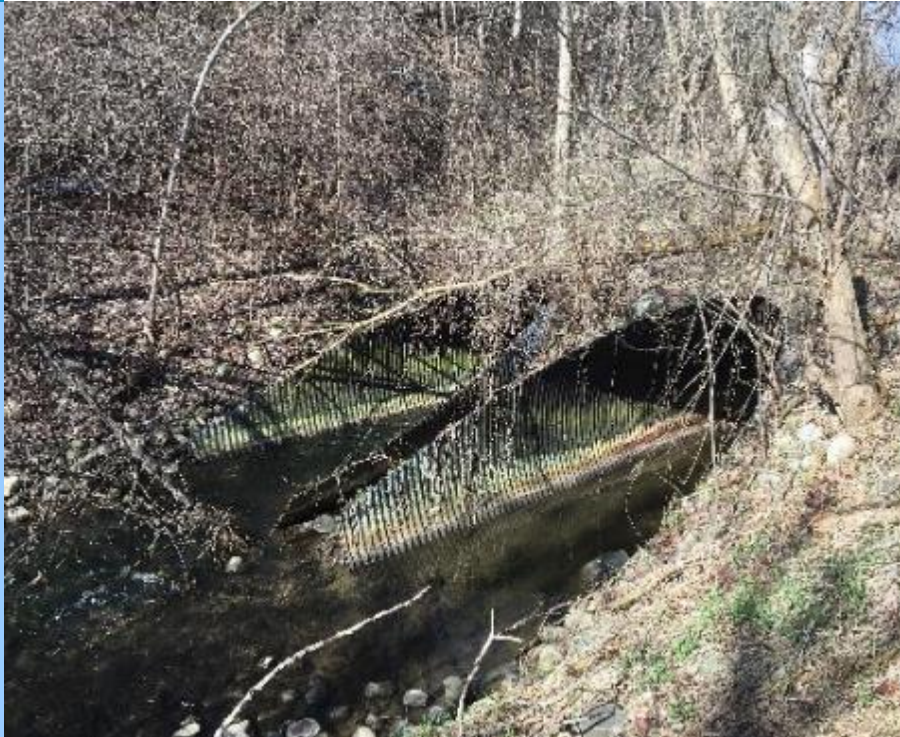
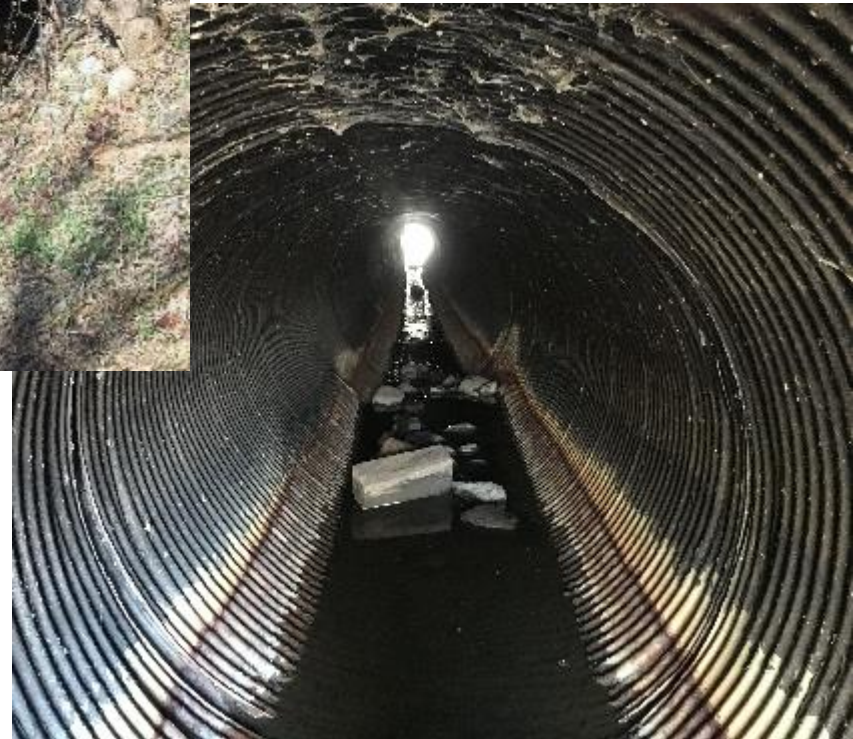
- Corroded Twin Structural Plate Culverts under 13 Mile Road in Farmington Hills, MI
- Culverts originally constructed in 1987
- 78" Diameter
- 200 linear Ft each
- 1.5 Inch Thick Geospray Mortar
- 2 Weeks

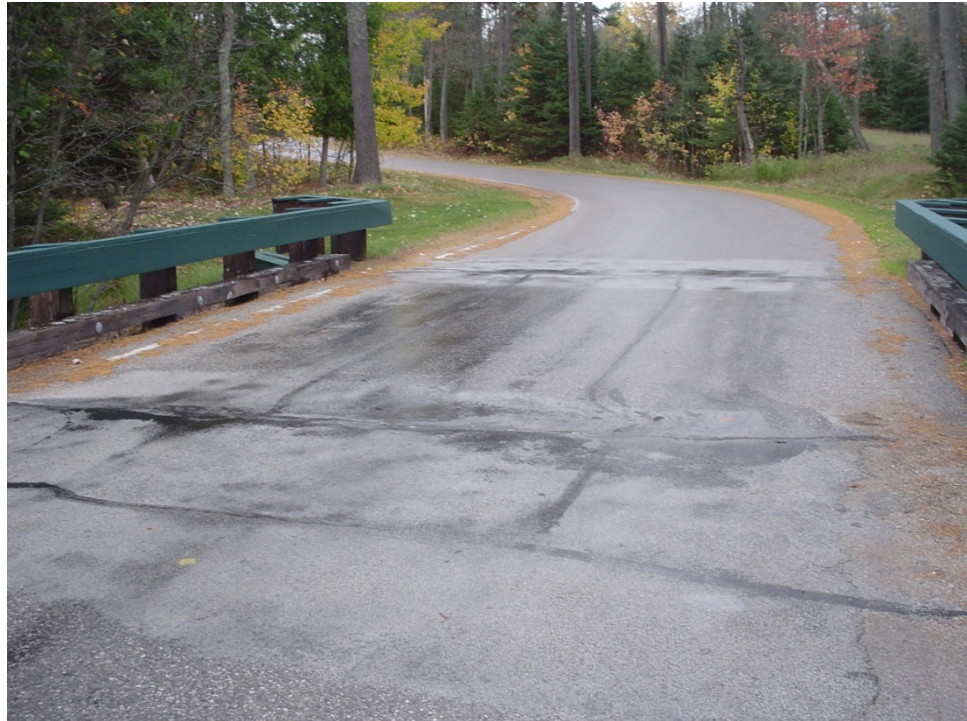
B05 of 49022

- Constructed in 1990
- Timber Superstructure comprised of 2 x 12 timbers spanning 24 feet nailed together.

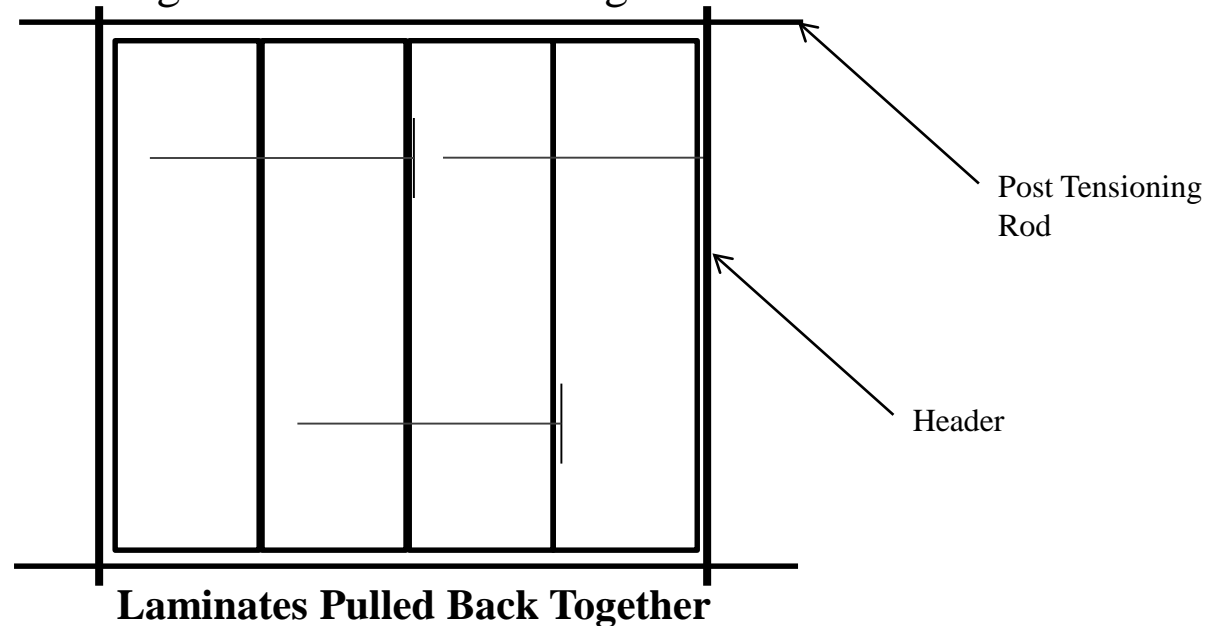
Report 1: Transverse Post-Tensioning of Longitudinally Laminated Timber Bridge Decks

- Post Tensioning Force shrunk the bridge 6 inches

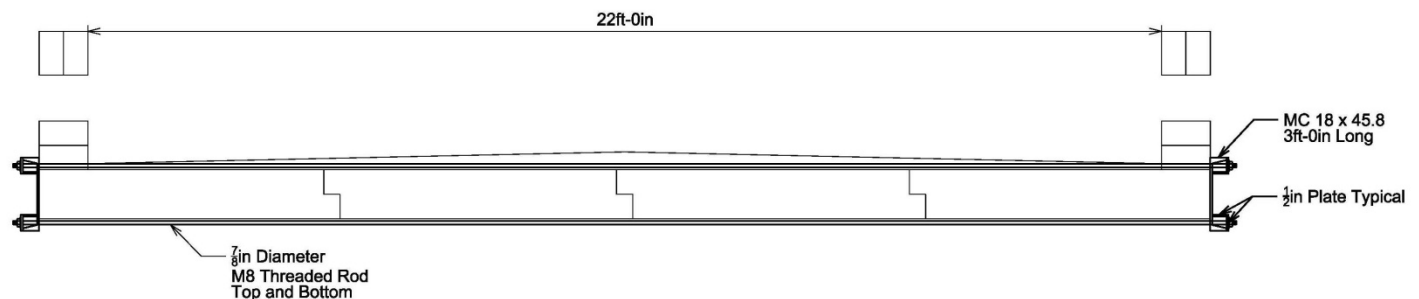
SECTION A-A

Section at
MC 18x45.8 and
M8 Threaded Rod

- The test bridge shrunk 6 inches when post tensioned to 150 psi
- B05 of 49022 Measured 24'-2" Wide (Only 2" wider than As-Built)
- Report 1 determined only 40 psi between timbers needed for composite action.

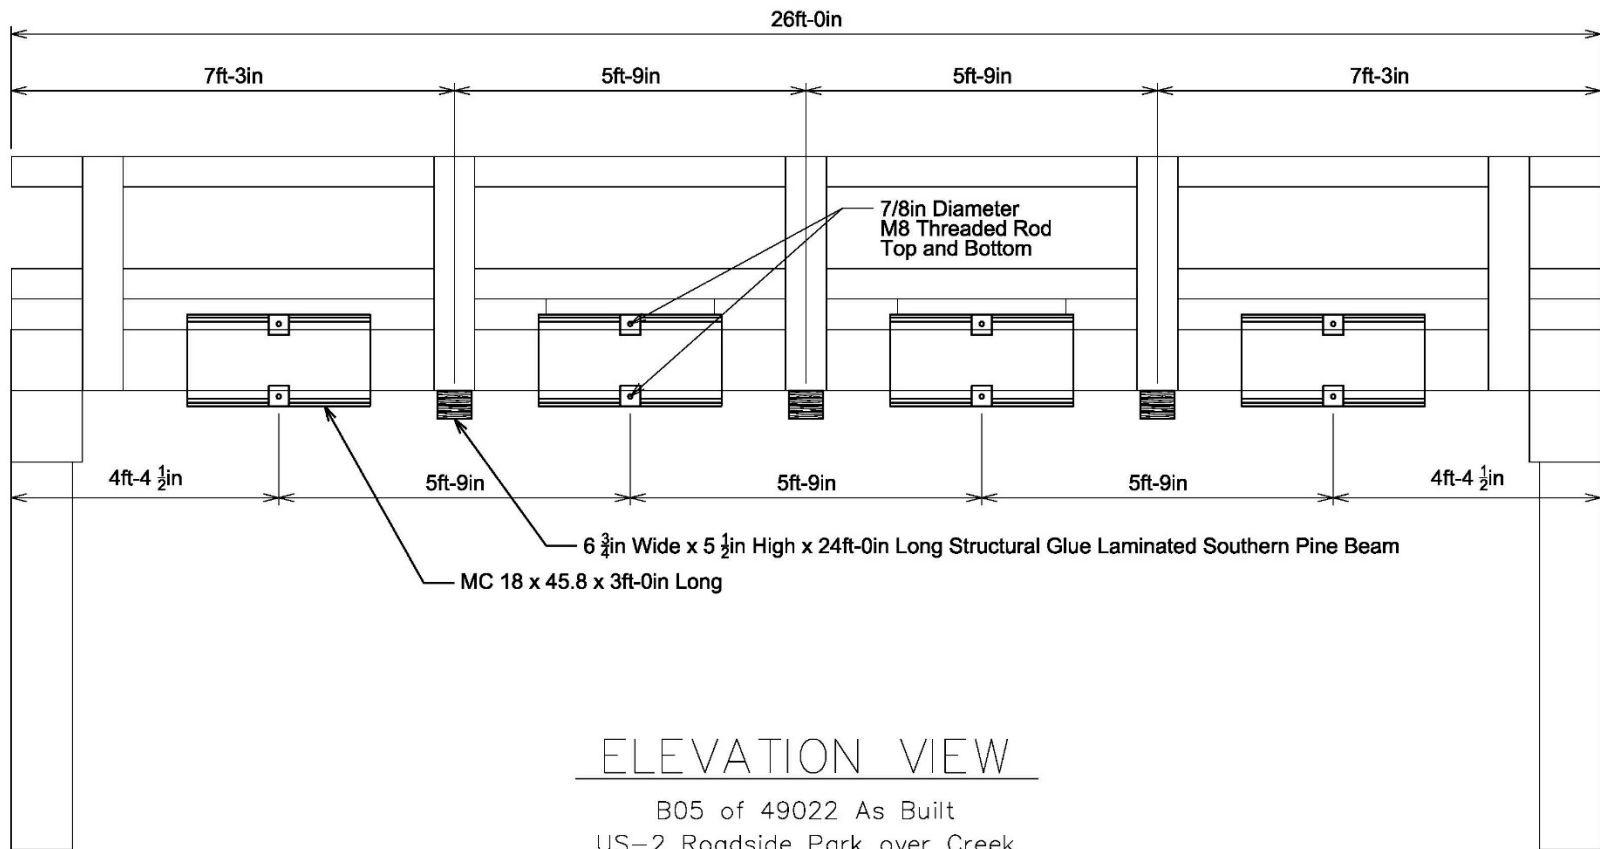
ELEVATION VIEW

B05 of 49022 As Built
US-2 Roadside Park over Creek
2.6 Miles East of Naubinway

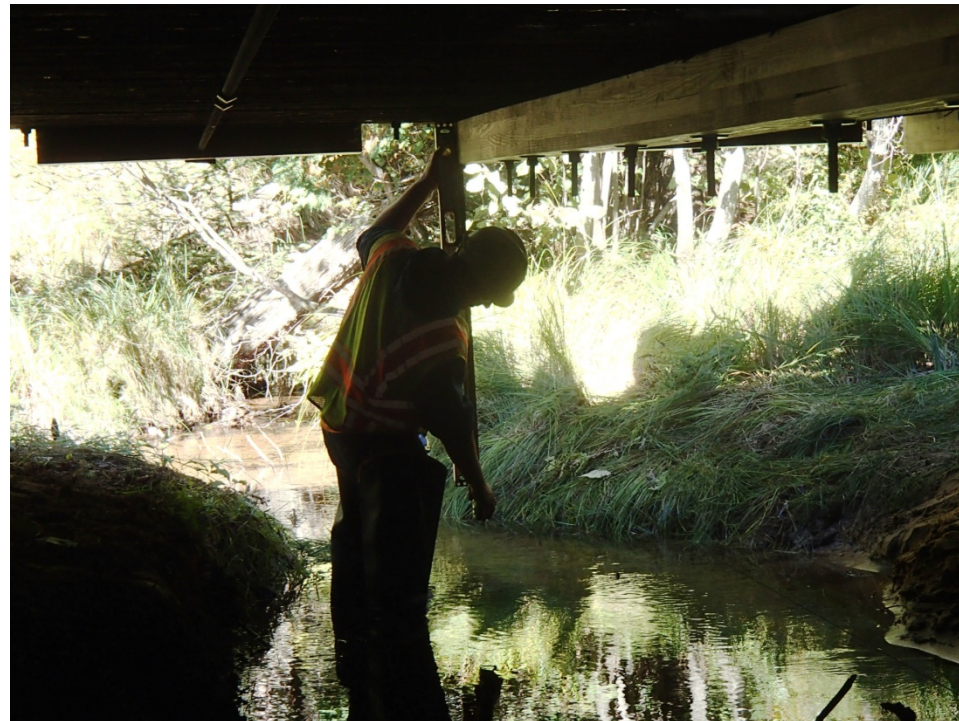
- $\frac{3}{4}$ inch deflection before
- $\frac{1}{4}$ inch deflection after
