# MDOT ANCILLARY STRUCTURES – MANAGING AGING CULVERTS

NICHOLAS GREEN, HNTB

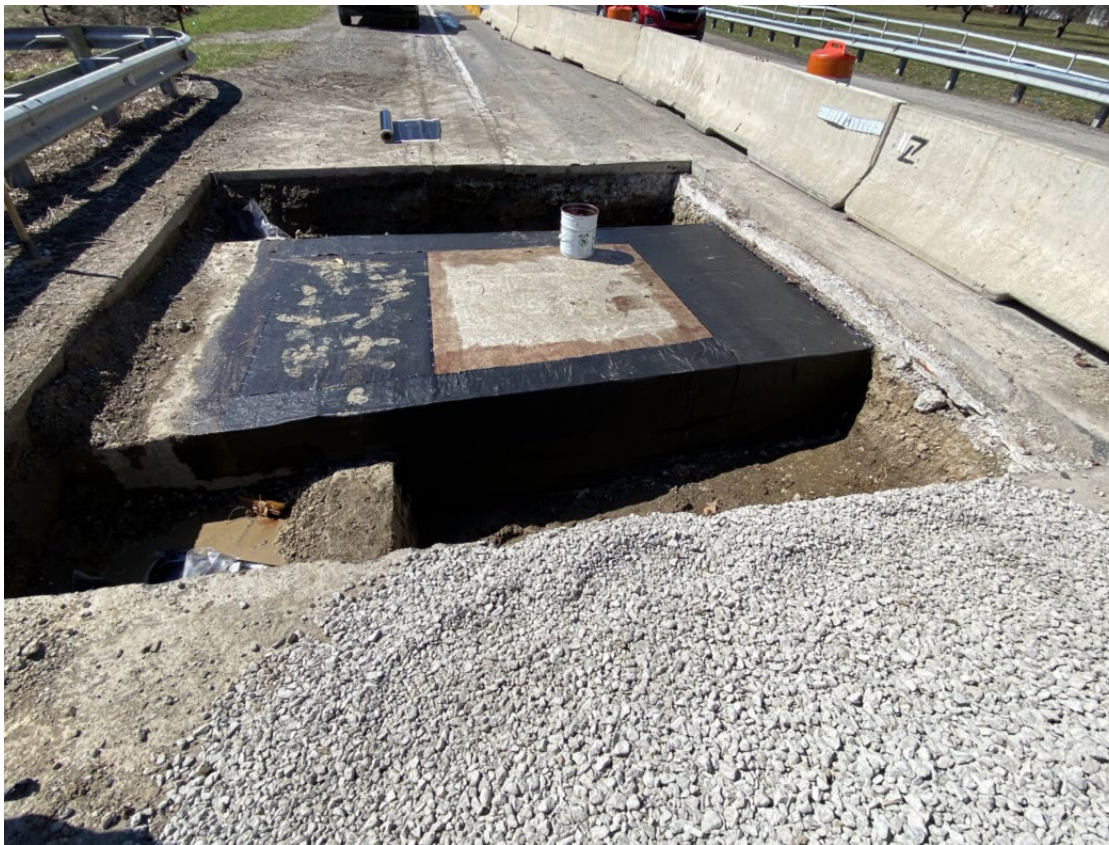
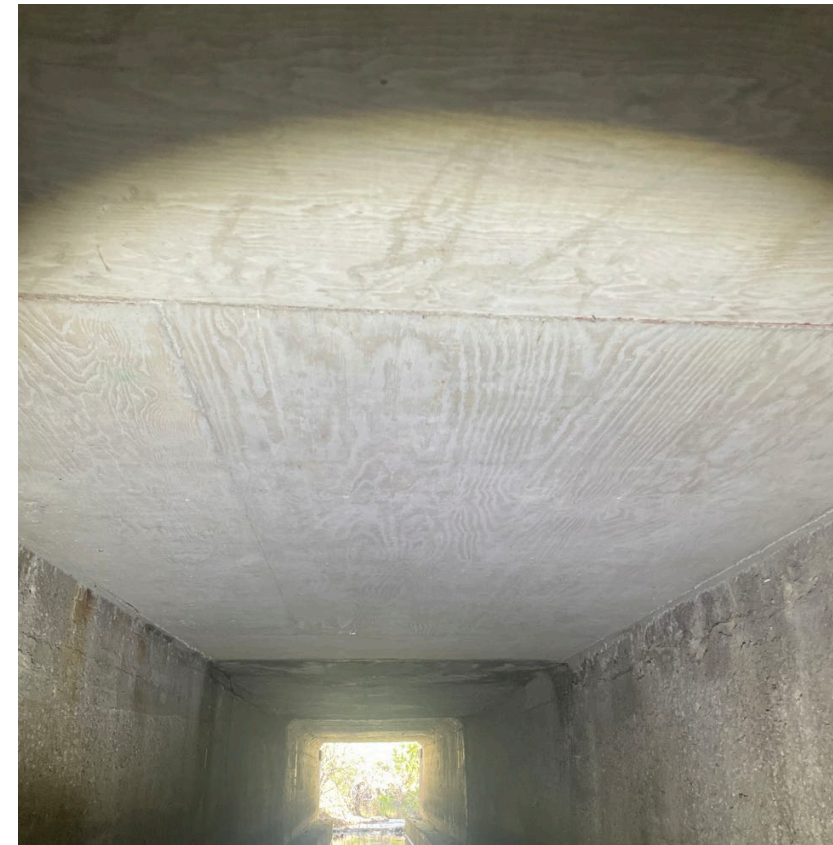
# M-125 OVER PIKE SWALE – SOFFIT REPAIR

- 48" x 72" Three-Sided Concrete Culvert
- Constructed in 1930s
- Asset defects include:
  - Structural cracking
  - Deterioration of concrete footings
  - Spalling of culvert soffit exposing reinforcement
  - Depression in roadway above soffit deterioration
- Deemed RFA Priority Level 1 in February 2024
