CMP	Structural Deterioration (Corrosion)	Closed Bottom Invert Deterioration	Open Bottom Invert Deterioration	Section Deformation	Joints/ Seams	Condition
10	New condition. Galvanizing intact. No corrosion.	New condition; galvanizing intact; no corrosion.	New condition	Reference CMP Shape Deformation Table	Reference CMP Joints / Seams Table	Excellent
9	Discoloration of surface. Galvanizing partially gone. No layers of rust.	Discoloration of surface. Galvanizing partially gone along invert. No layers of rust.	Good with no invert erosion			Very Good
8	Discoloration of surface. Galvanizing gone along invert but no layers of rust. Minor section loss at ends of pipe not located beneath roadway.	Discoloration of surface. Galvanizing gone along invert but no layers of rust. Minor section loss at ends of pipe not located beneath roadway.	Good with only minor invert erosion			Good
7	Galvanizing gone with layers of rust. Moderate section loss at ends of pipe not located beneath roadway. Moderate section loss: Less than 6 in <sup>2</sup> /ft <sup>2</sup> .	Galvanizing gone along invert with layers of rust. Moderate section loss at ends of pipe not located beneath roadway. Moderate section loss:

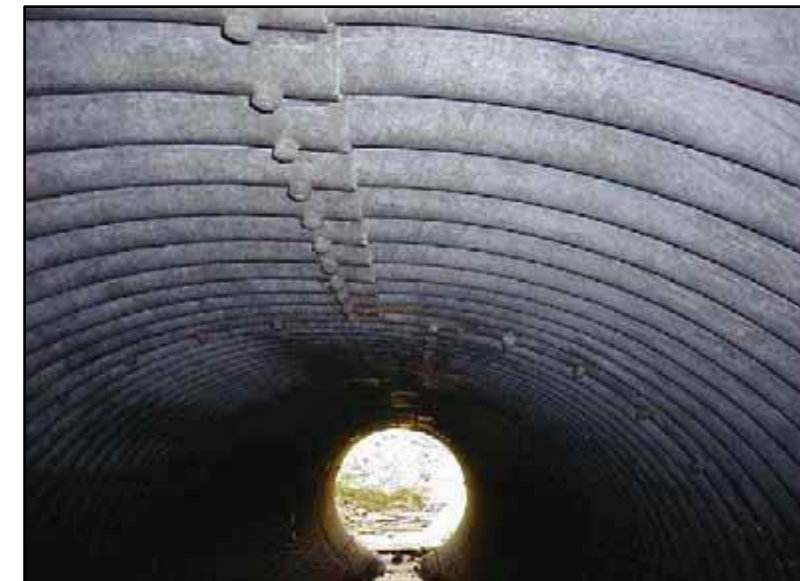
CMP Joints & Seams	Pipe Joints or Seams	Multi-plate Joints or Seams	Condition
10	Straight line between sections.	Minor amounts of efflorescence or staining	Excellent
9	No settlement or misalignment. Tight with no defects apparent.	Light surface rust on bolts due to loss of galvanizing. Efflorescence staining.	Very Good
8	Minor misalignment at joints. Minor settlement. Distress to pipe material adjacent to joint.	Metal has cracking on each side of a bolt hole: Less than 3 in a seam section. Minor seam openings that are less than 1/8 inch. Potential for backfill infiltration. More than 2 missing bolts in a row. Rust scale around bolts.	Good
7	Misalignment of joints but no infiltration. Settlement. Dislocated end section. Extensive areas of shallow deterioration.	Evidence of backfill infiltration through seams.	Satisfactory
6	Joint open and allowing backfill to infiltrate. Significant cracking or buckling of pipe material. Joint offset less than 3 inches. End sections dislocated and about to drop off from main portion of the structure. Infiltration staining apparent.	Moderate cracking at bolt holes along a seam in one section. Backfill being lost through seam causing slight deflection. Less than 6 missing bolts in a row or 20% along the total seam.	Fair
