2019 Michigan Bridge Conference Workshop

# METRIC 18

## INSPECTION PROCEDURES – SCOUR

# MDOT Scour Program

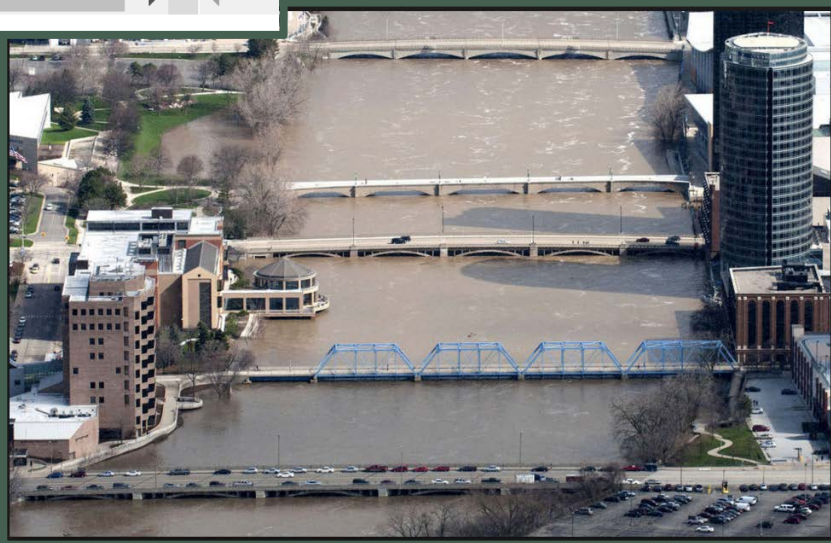
# Scour Action Plan – High Flow

- High Flow Event Field Review
  - *As-Needed until Scour Inspection*
- High Flow Event Report
  - *Storm Duration*
  - *High Water Distance from Chord*
  - *Estimated Total Rainfall*
  - *Estimated Flow Discharge*
  - *Whirlpools*
  - *Debris*
  - *Actions Taken/Closure*

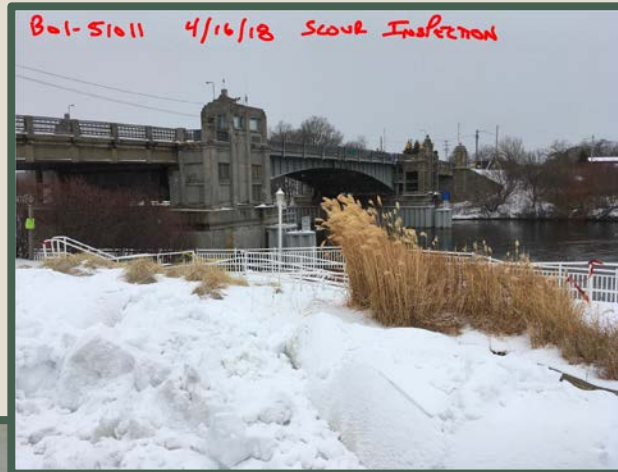
# Scour Action Plan – Scour Inspection

- Scour Inspection Field Review
  - Probe substructure units
- Scour Inspection Report
  - Observed Scour
  - Inspection Methods/Location
  - Recommendations
  - Supporting Documents and Photos

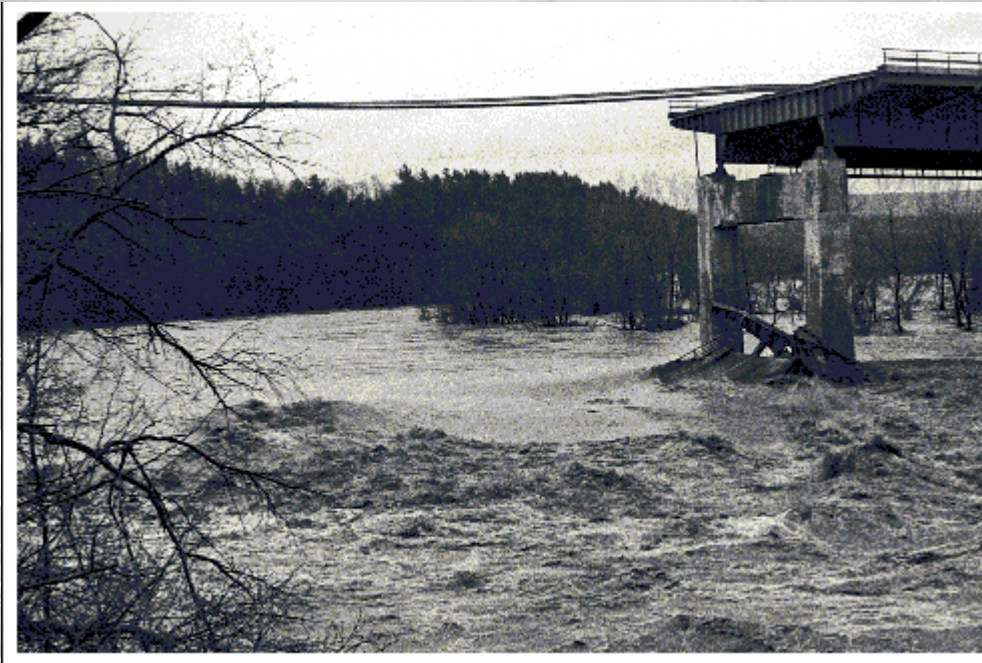
- On April 5, 1987, the New York State Thruway Bridge over Schoharie Creek collapsed due to scour killing ten people.
- The bridge was built in 1953 on piers with spread footings and no piles.
- National scour evaluation program was established in 1988 by Technical Advisory T 5140.20, which was superseded in 1991 by T 5140.23, "Evaluating Scour at Bridges."

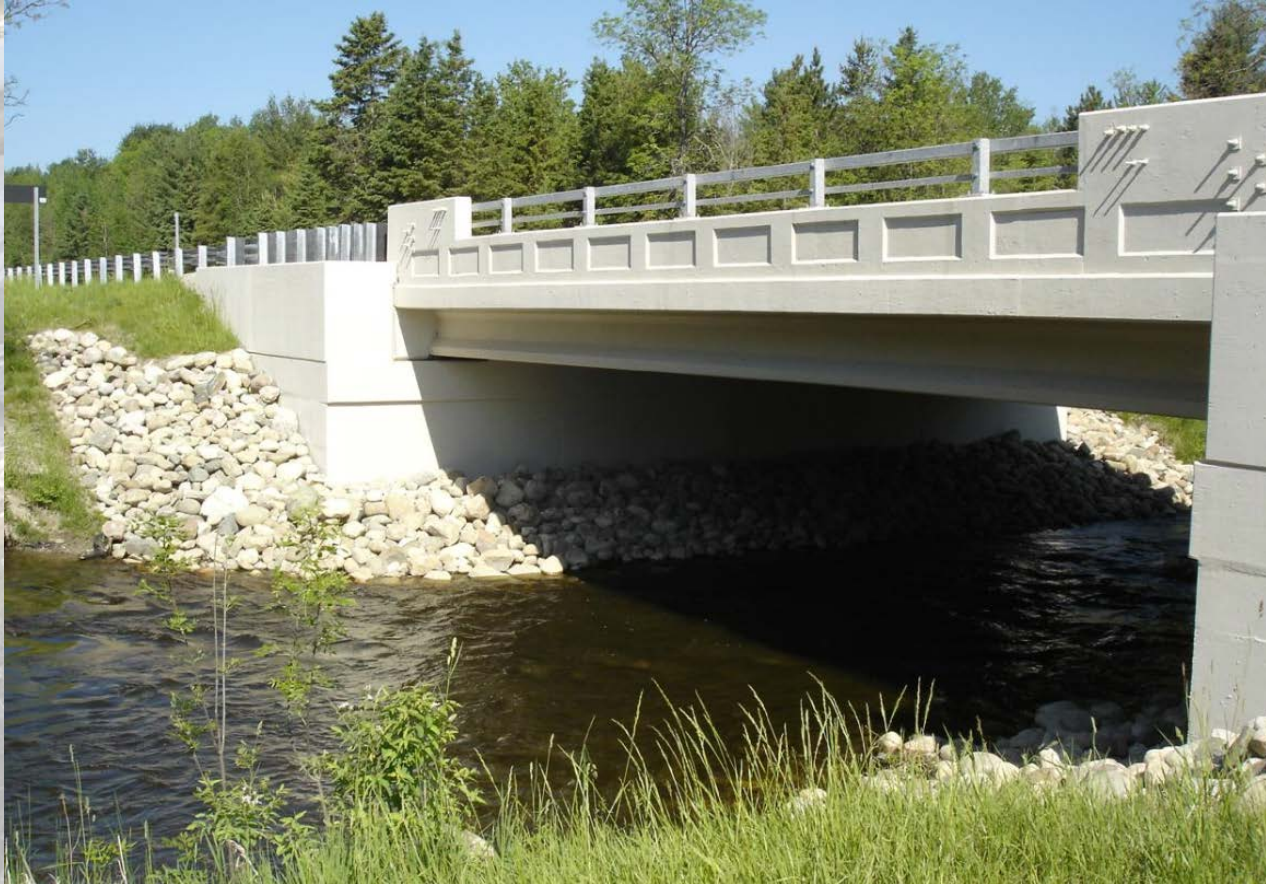
- Substructure elements on deep foundations or bedrock?
- Sufficient Riprap?
- Low risk for scour?

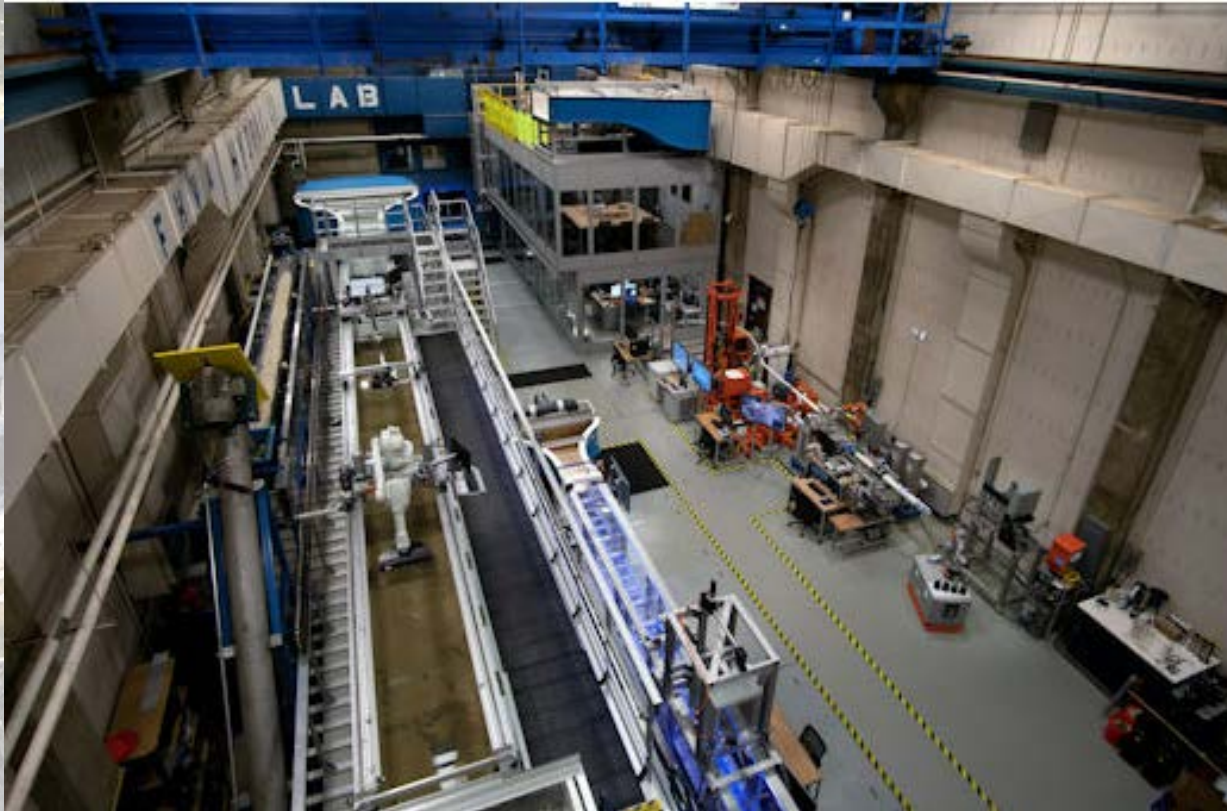
- Physical modeling in a lab environment.
- Has not been done on any MDOT structures.
- FHWA's J. Sterling Jones Hydraulics Research Lab at Turner-Fairbanks
