# Michigan Non-NBI Culvert Structure Inspection Guide

Michigan  
Transportation Asset  
Management Council

September 2022

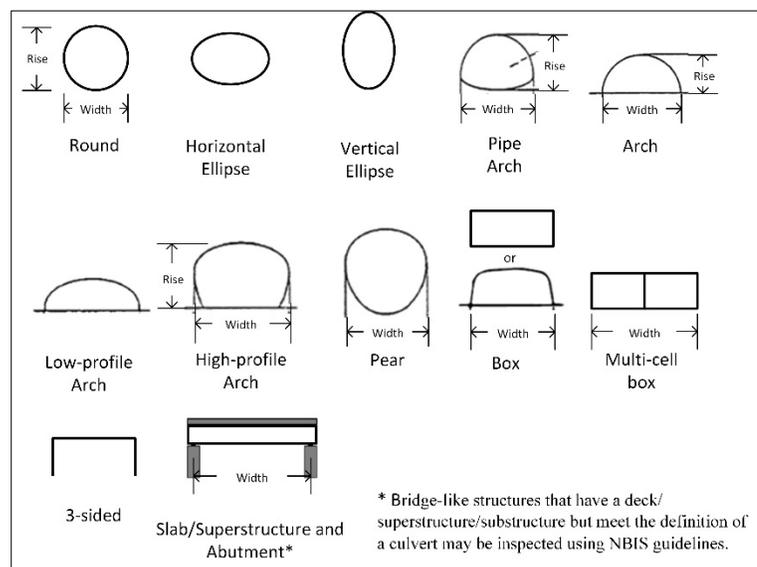
Figure 1 Culvert shapes

- **Shape (see Figure 1)**  
Shape of the culvert classified according to the following descriptions. Custom shapes may be defined as sub-types under "Other"

- Round
- Horizontal ellipse
- Vertical ellipse
- Pipe arch
- Arch
- Low-profile arch
- High-profile arch
- Pear
- Box
- Multi-cell box
- Three-sided

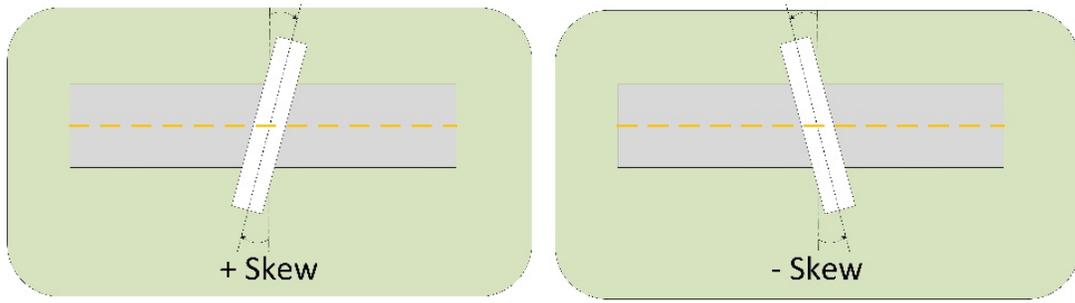
Figure 2 Culvert skew angles

- Slab/superstructure and abutment
- Other
- Skew angle (degrees between -90 and 90; optional only if defining both ends of the culvert) (see Figure 2)
  - Angle that the culvert is skewed away from a line perpendicular to the roadway (zero skew). Based on the acute angle formed by the intersection of road centerline with the culvert centerline, the angle is positive if the end rotation is clockwise and negative if the end rotation is counterclockwise.

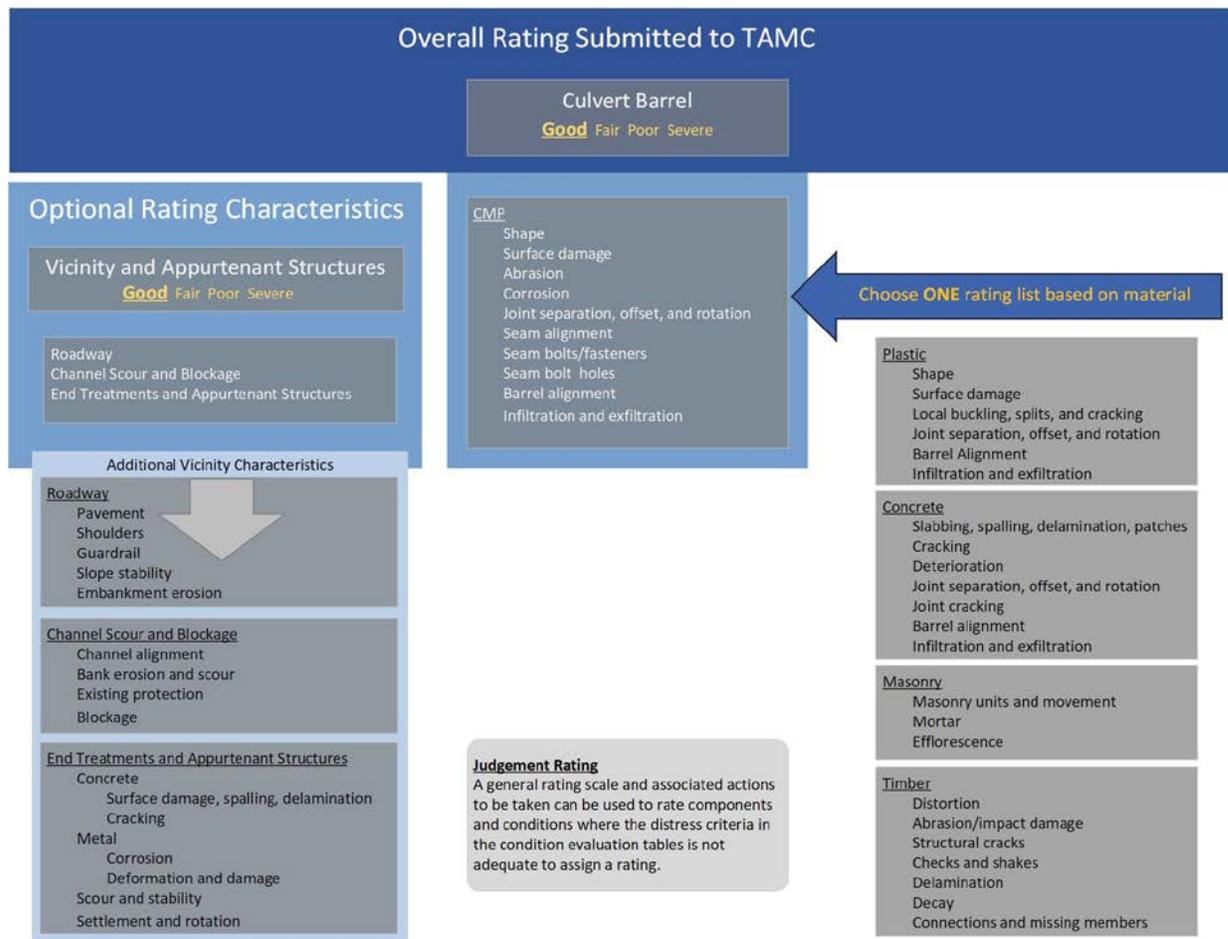
Figure 3 Culvert condition rating component flowchart

Components and characteristics that may be rated using this culvert condition rating system include the vicinity and appurtenant structures component category—roadway, channel scour and blockage, and end treatments and appurtenant structures—and culvert barrel component category—barrel condition, alignment, joints, and seams. Each component category’s rating—that is, the rating of the vicinity and appurtenant structures component category and the culvert barrel component category—is determined by rating the culvert’s components and characteristics and assigning an overall score (see Figure 3). A component-category-level assessment provides agencies with more information for decision-making as compared to a more general condition rating. For example, two culverts may both be rated “poor”, but one might be due to sedimentation and the other due to corrosion; each case would have different solutions and would require different allocation of resources for maintenance efforts.

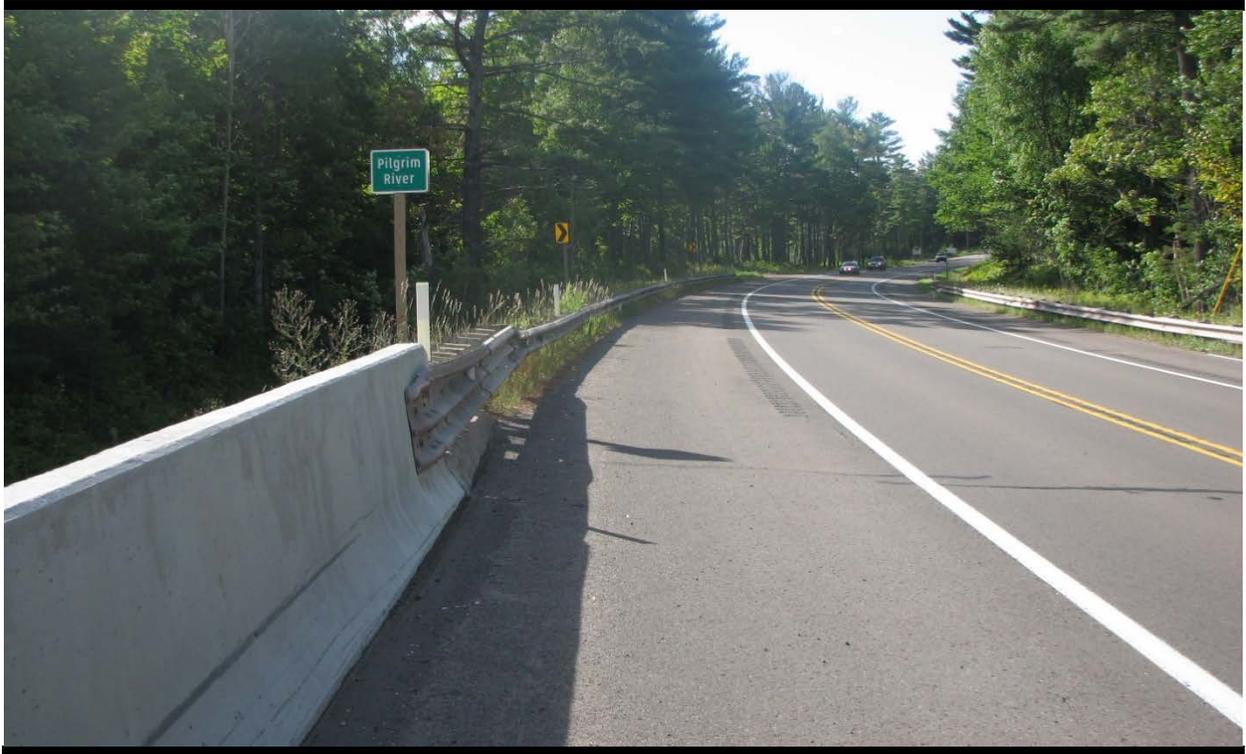
*Figure 4 The condition of the roadway and embankment can help identify distress within a culvert below. Characteristics to inspect include the pavement, guardrail, shoulders, slope stability, and embankment erosion.*

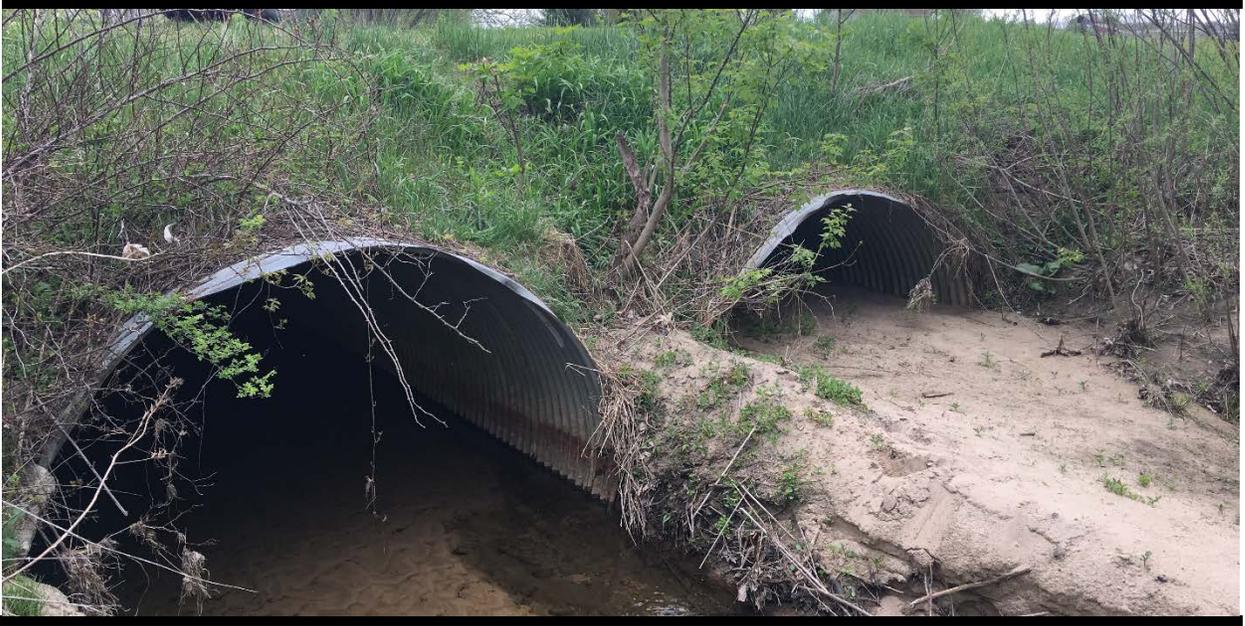
*Figure 5 Culvert placement can cause damage to the area around the culvert due to scour or ineffectiveness due to blockage. The characteristics to inspect include channel alignment, bank erosion & scour, existing scour protection, and blockage.*

Channel scour and blockage is a single component rated by four characteristics: channel alignment, bank erosion and scour, existing protection, and blockage.

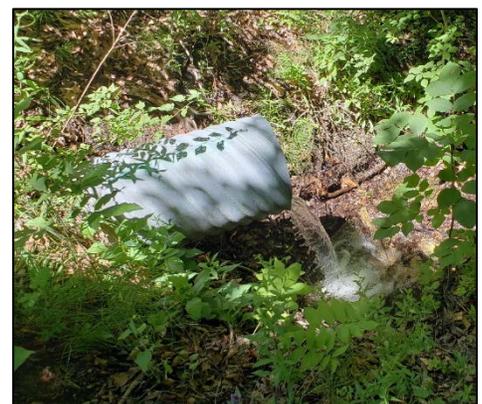
*Figure 6 Erosion can result in a perched culvert barrel where water cascades from the outlet. This falling water can result in further erosion and eventually undermine the culvert barrel to the point that it bends or rotates downward and impedes stream flow.*

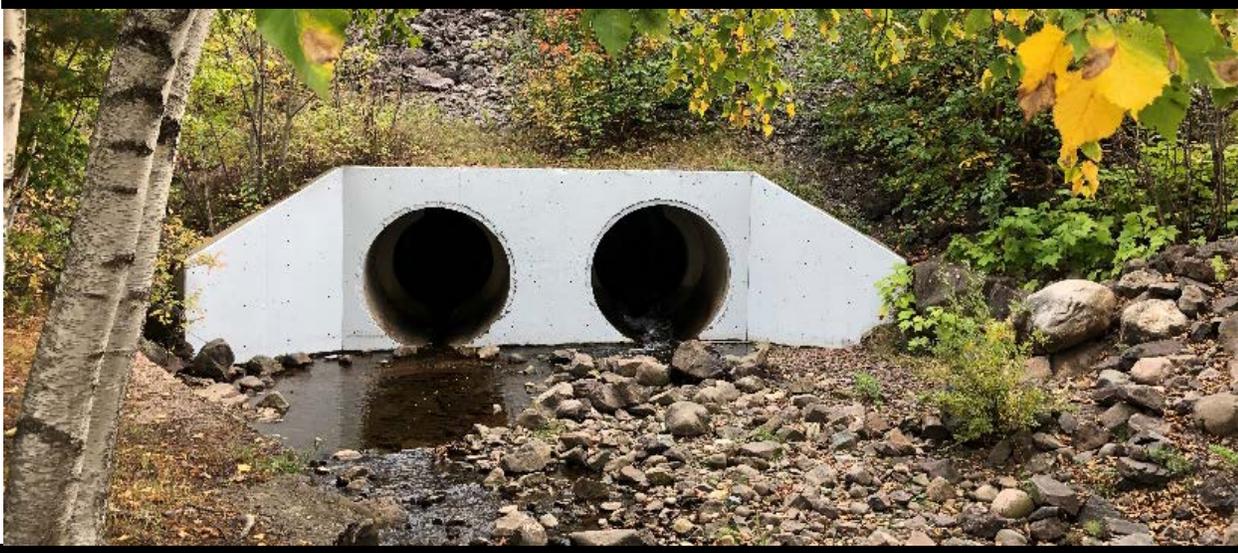
*Figure 7 End treatments should be inspected in relation to the surrounding vicinity. In this photo, the end treatment appears to be in good condition, but there are signs of ponding and movement of stream protection (more riprap in front of one barrel than the other).*

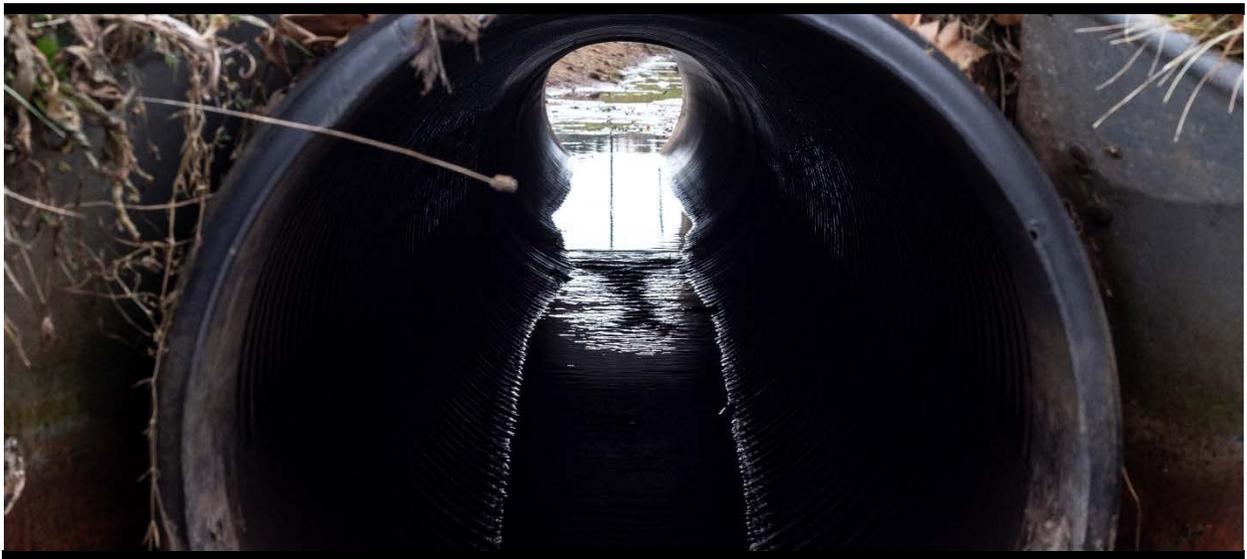
*Figure 8 Plastic barrels may show signs of deformation such as sags, humps, or changes to the barrel's cross section. These changes can sometimes be observed by looking for irregularities in the way that water is flowing through the culvert.*

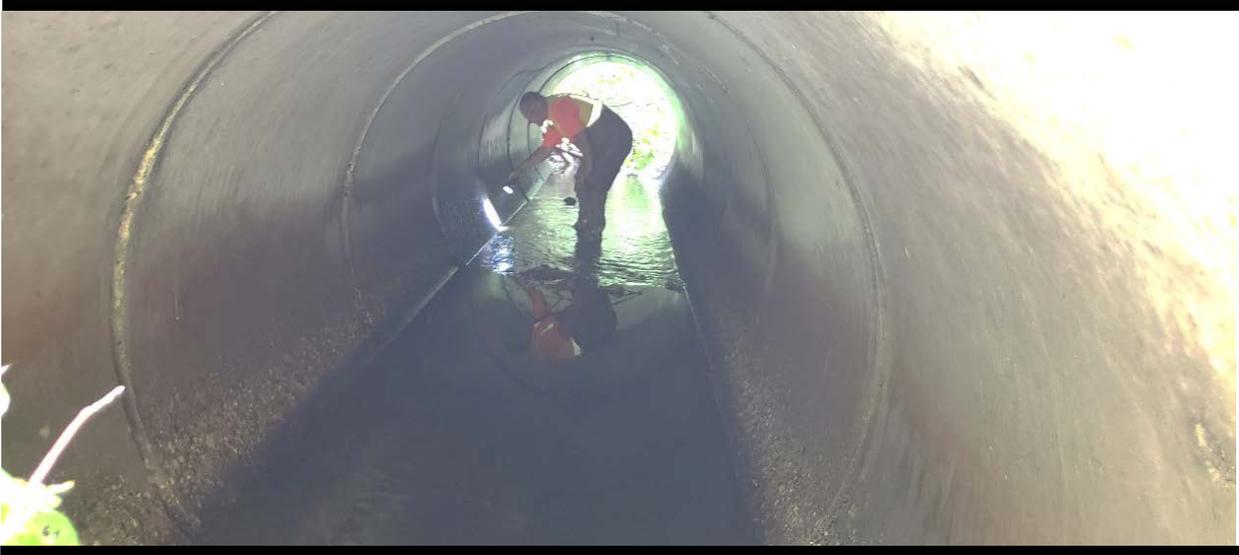
*Figure 9 Concrete barrels should be checked for abrasion along the waterline as well as for signs of infiltration or exfiltration around joints. Performing visual inspections and checking for hollow sounds near joints can help to identify voids that may form as soil around the culvert is carried away. (Photo: Lake County Road Commission)*

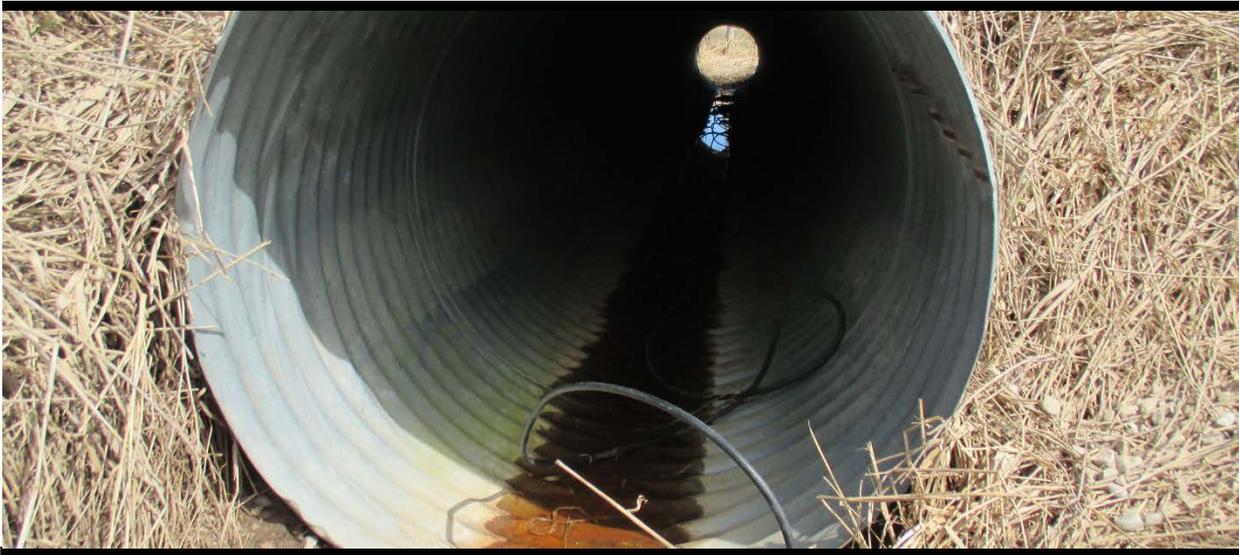
*Figure 10 Corrugated metal barrels distresses like abrasion or corrosion may only apply to a small portion of the culvert's surface area. However, if even a few inches of a culvert's bottom along the entire length of the culvert barrel has been completely abraded or corroded, that abrasion or corrosion can lead to a culvert failure. The severity, the total area affected, and the location of the distress should be considered during culvert assessment.*

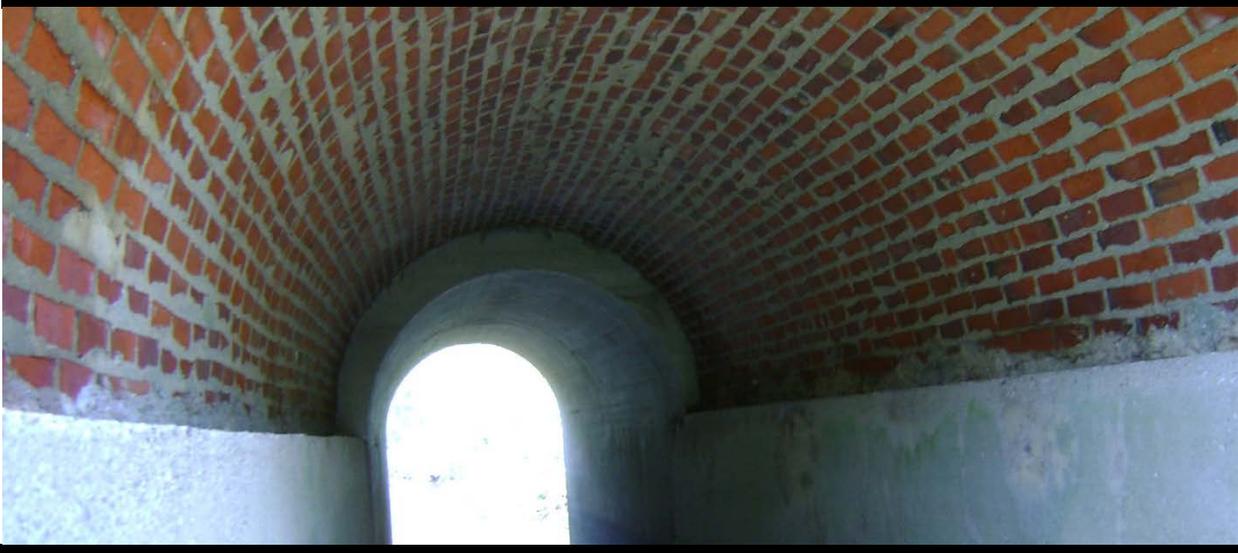
*Figure 11 Masonry barrels are checked for movement of masonry units, mortar, and efflorescence. Note that new mortar or repairs may appear different from original construction. (Photo: St. Clair County Road Commission)*

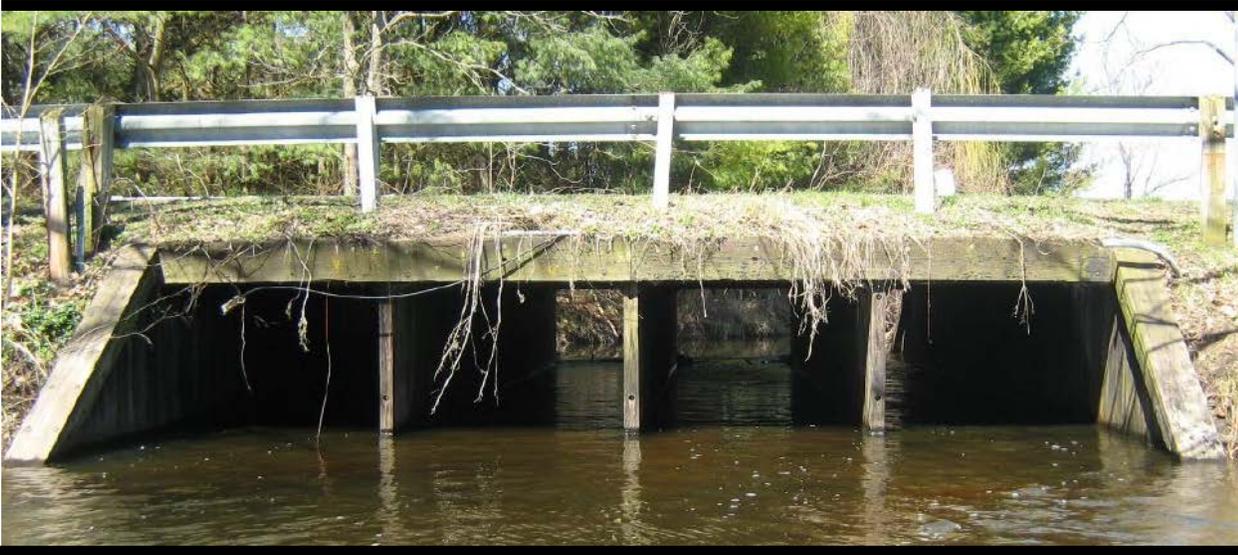
Figure 12 Timber barrel culverts are often in the form of a multi-cell culvert. The width of each cell can be recorded in addition to the total span of the culvert. (Photo: Fleis & Vandenbrink Engineering)
