Outline

GREAT LAKES ENGINEERING GROUP

County Culvert Inspections

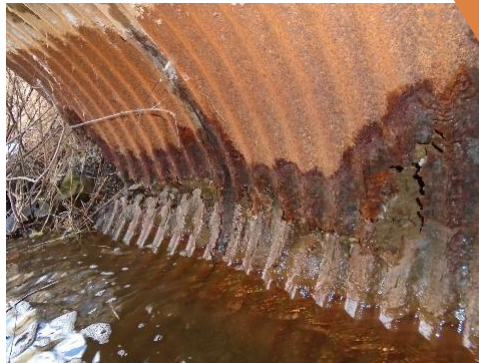
- Culvert reporting process
 - Any significant changes or safety concerns are handled with an email/call to the county
 - All posting changes were included in a summary spreadsheet that was sent to the county at the end of all the inspections

Facility	Feature	Structure Number	Township	Date	Culvert Rating	Current Posting	New Posting
N Parker Rd	Unnamed Creek	C0701006	Lima	9/1/2021	2	22/30/55	16/24/37
Warren Rd	Fleming Creek	C0901009	Ann Arbor	11/12/2021	3	23/35/42	20/NN/NN
Bemis Rd	Unnamed Creek	C1433002	Freedom	11/12/2021	3	-	29/44/52
Maple Rd	Unnamed Creek	C1812005	Saline	11/10/2021	4	-	36/55/65
Hartman Rd	Unnamed Creek	C1812006	Saline	11/10/2021	2	-	10/NN/NN

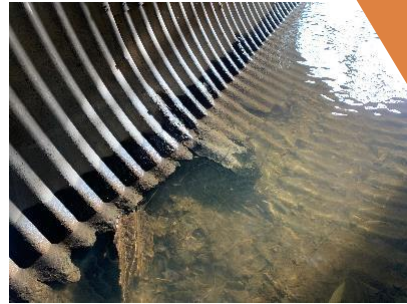
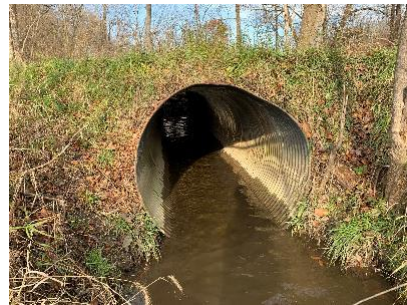
- Culvert naming convention – Example is C0115003
 - Structure number starts with C for culvert
 - Each township has a number assigned
 - For example – Salem Township is #1, Northfield Township is #2, Webster Township is #3, etc.
 - Next number is the Section # within the township
 - Last number is the # of the culvert within that section
 - Culvert is also noted by the Facility (road name) and Feature (drain/creek name if one is provided)
 - Latitude and longitude provided for each culvert

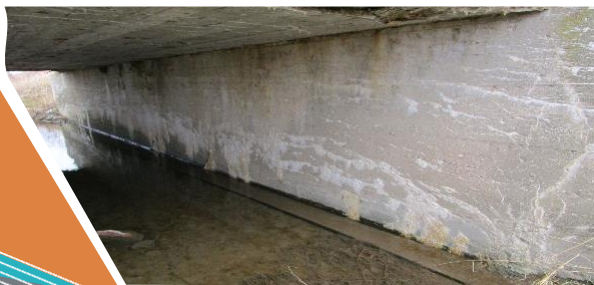
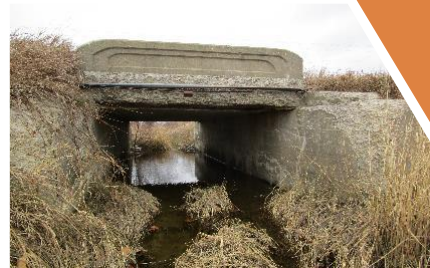
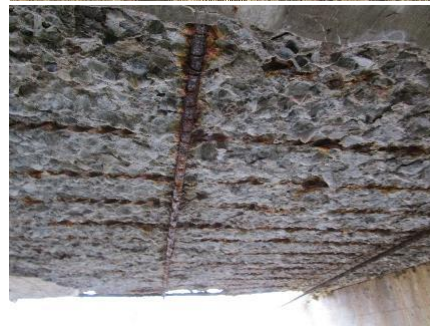
- Inspection process:
 - Culverts and bridges included in the inspection list have a span that ranges from 10' to 20'
 - Culverts and bridges are inspected at a frequency of 5 years maximum depending on their condition
 - Inspection frequency will increase as the condition of the culvert continues to decrease
 - A culvert or bridge in poor condition or worse, the inspection frequency will increase to 12 months or less if necessary

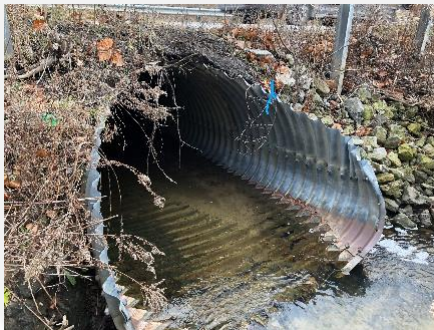
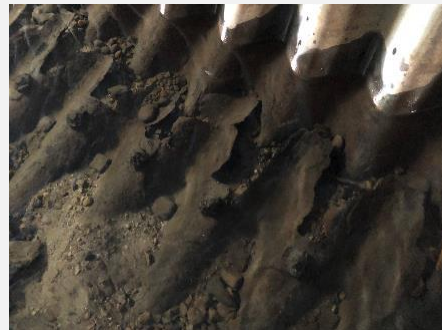
- Culvert reporting process:
 - MiBRIDGE is now used to manage RCOC's culvert inspections
 - Inspection frequencies vary from 48 months down to 6 months, depending on condition

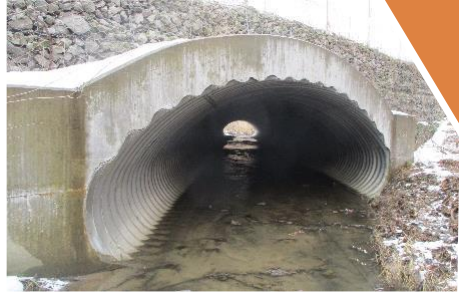
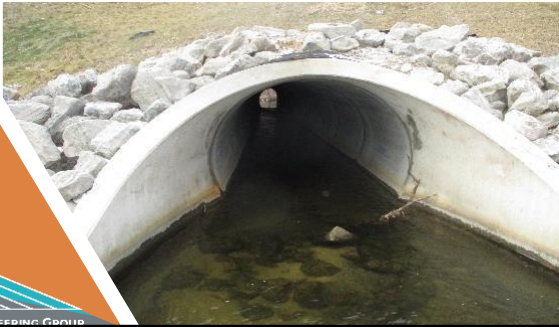
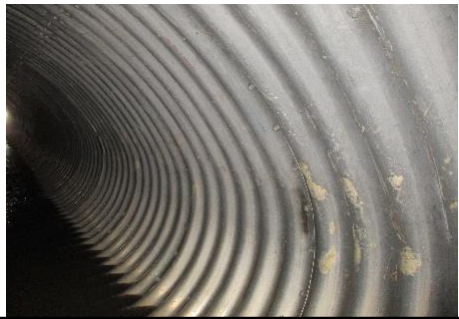
- Culvert replacement process
 - Local route
 - 50/50 split in the cost to replace the culvert between the county and the township.
 - EXCEPTION to this rule is Dead-End Roads. RCOC funds 100% of a culvert replacement on a Dead-End Road (Oakland County has many lakes, and subsequently many Dead-End Roads with large culverts.)

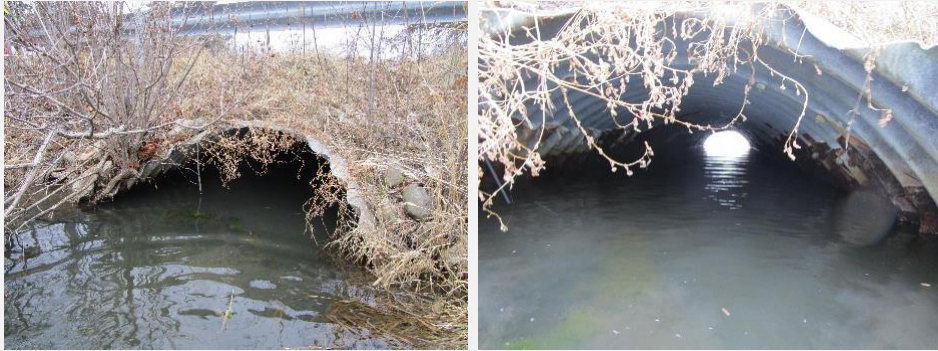
- Conditions vary from one inspection to the next
 - Following two pictures are from previous inspection
 - High water during inspection, minimal amount of deterioration visible

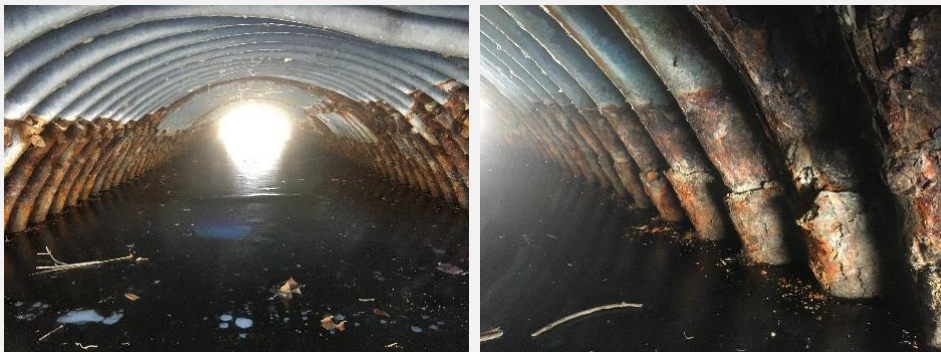
- Conditions vary from one inspection to the next
 - Following two pictures are from current inspection
 - Low water during inspection, numerous holes and buckled portions of the walls
 - Resulted in significant reduction in load posting
