A TALE OF TWO BRIDGES

Au Train Bridge

**PROPOSED AU TRAIN
BRIDGE REHABILITATION**
MDNR - DTMB
ALGER COUNTY, MICHIGAN

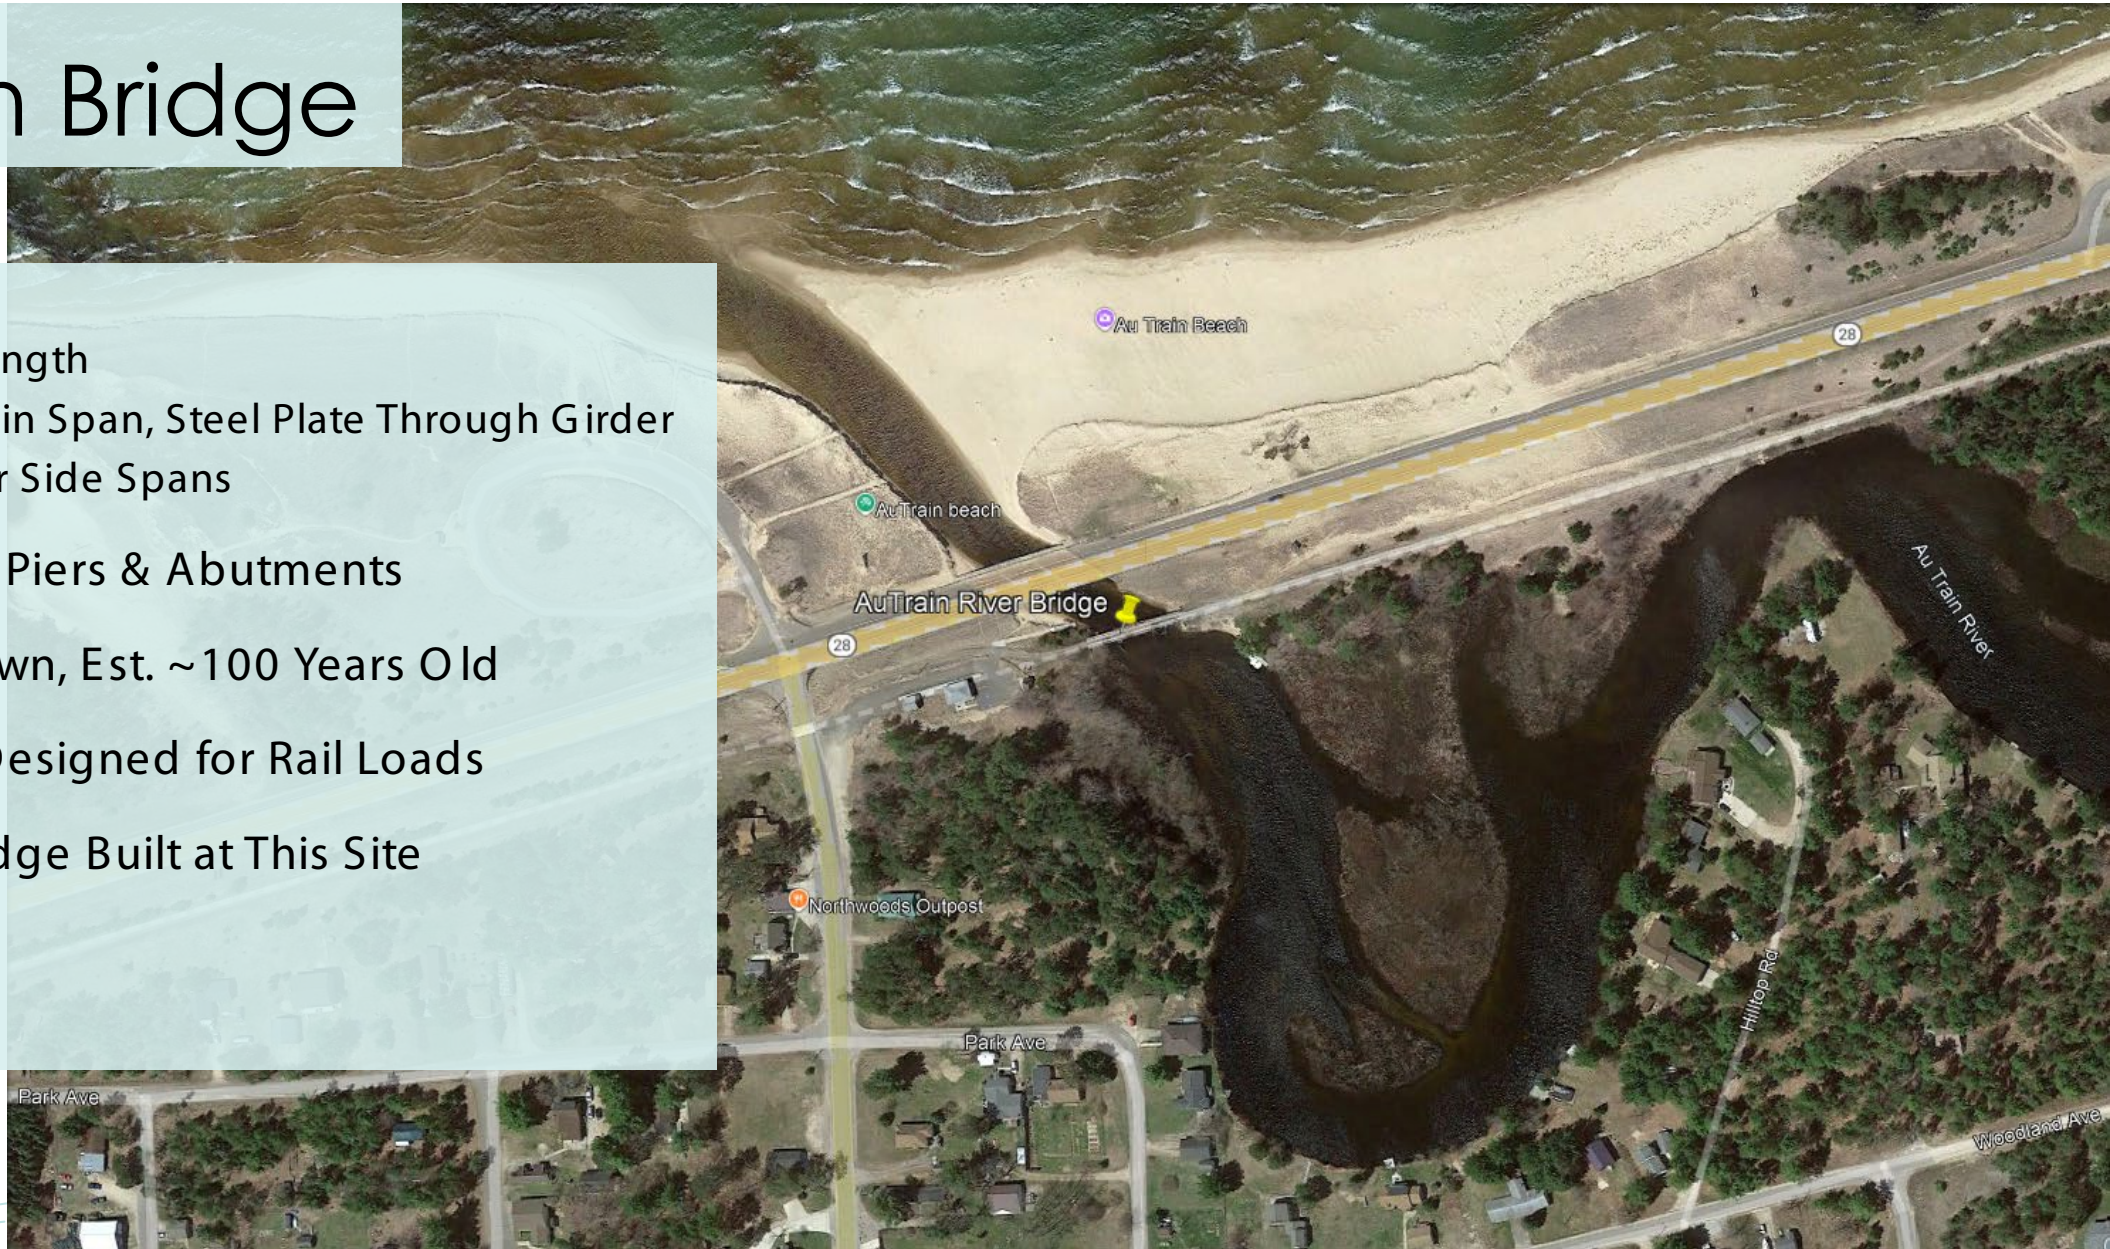
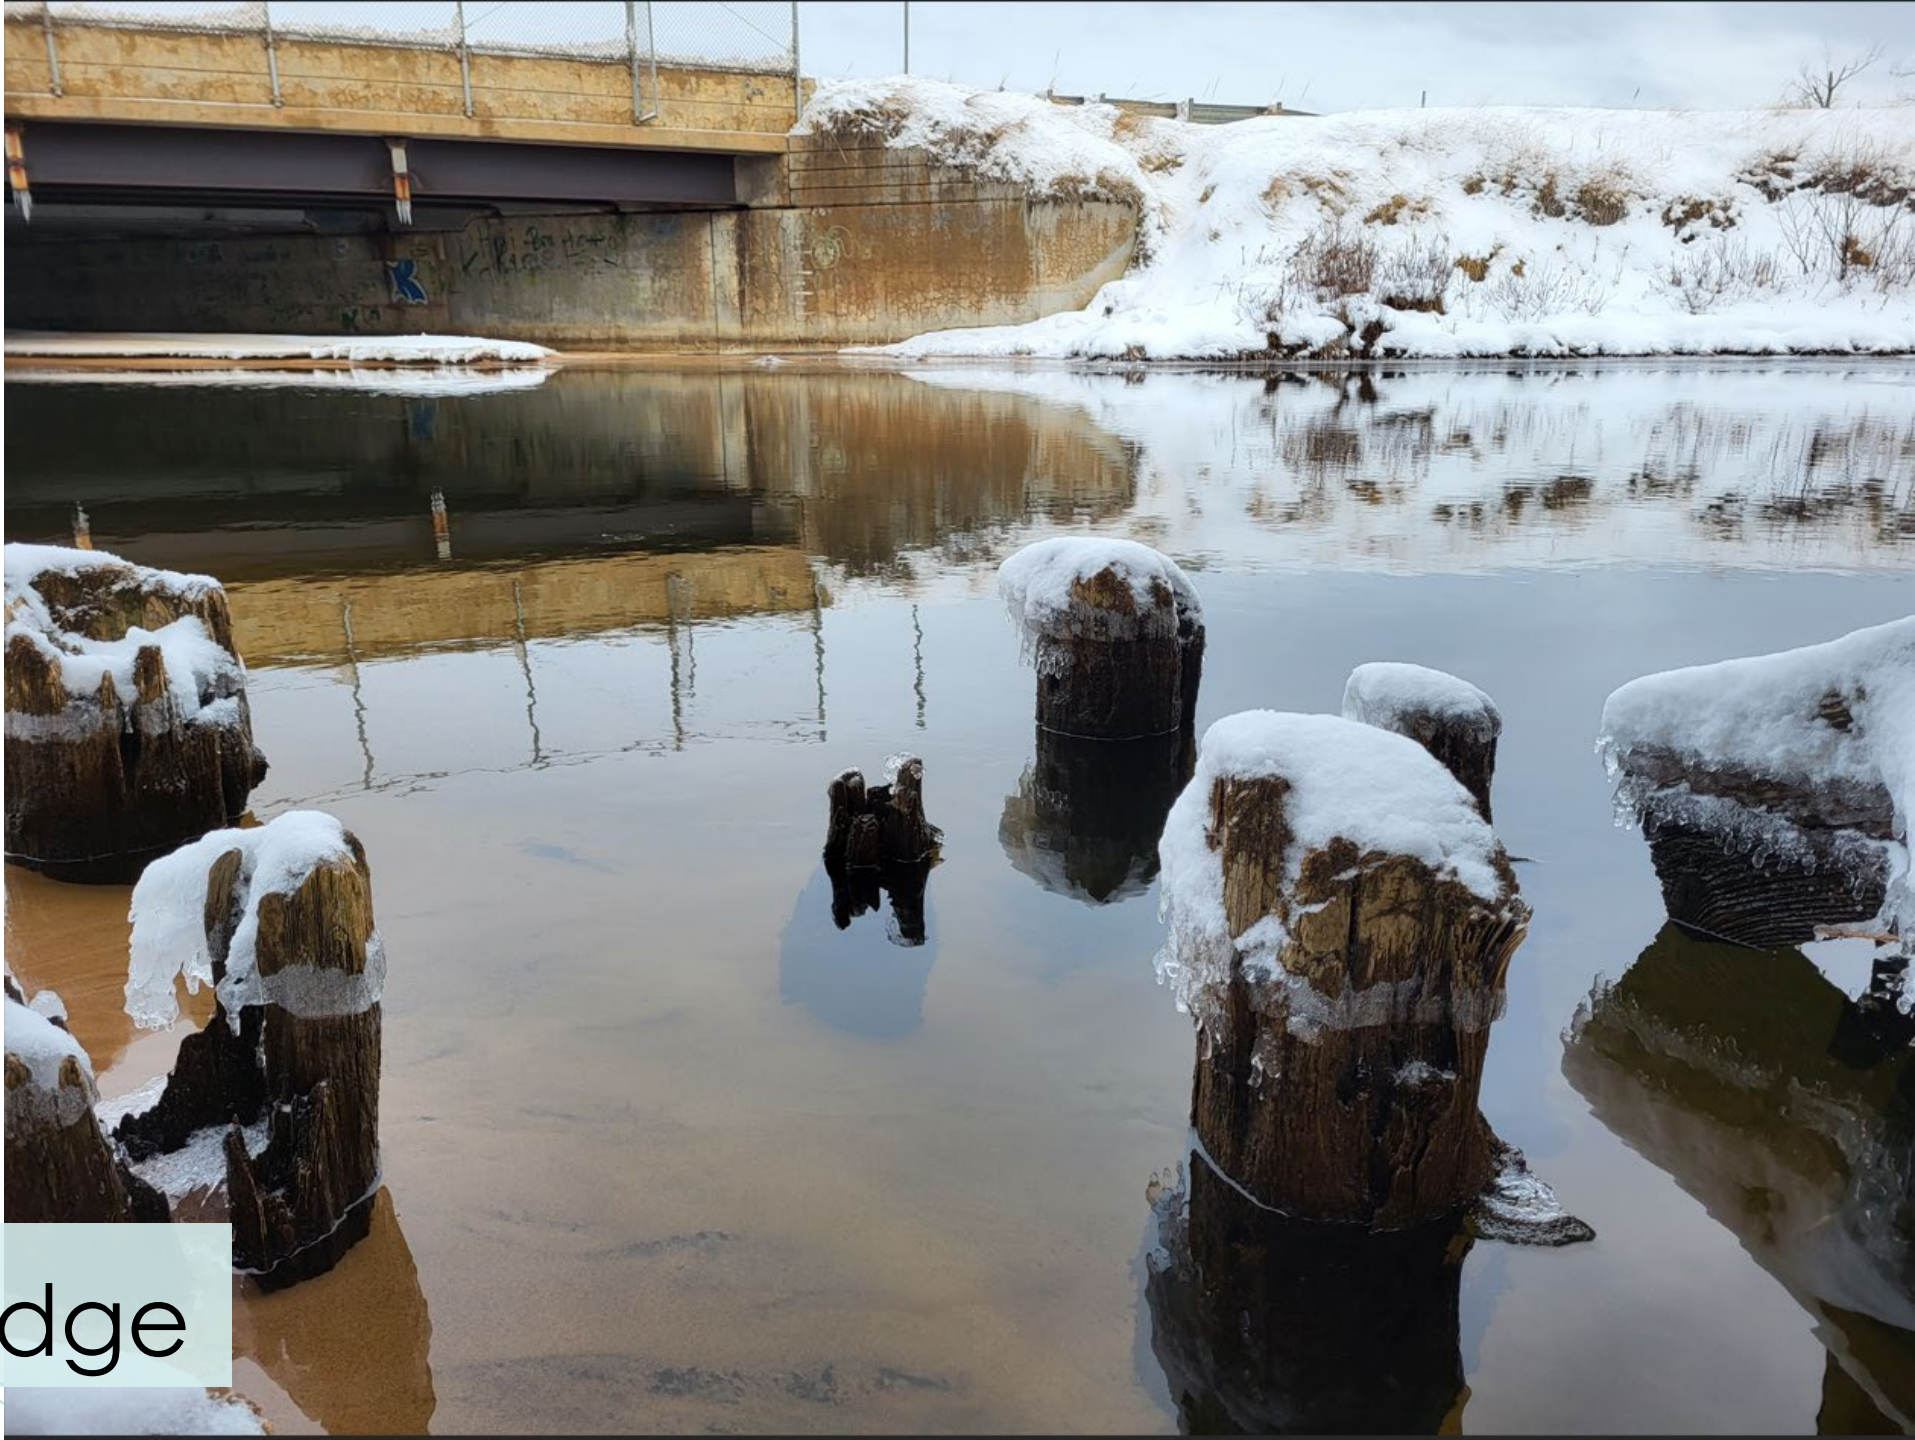
Au Train Bridge

1. Seven Span
 - a. 133' length
 - b. 50' Main Span, Steel Plate Through Girder
 - c. Timber Side Spans
2. Timber Pile Piers & Abutments
3. Age Unknown, Est. ~100 Years Old
4. Originally Designed for Rail Loads
5. Second Bridge Built at This Site

1. Cooper E80 live loads are almost 16x HL-93 loads
2. Dead load weight of center span = 60 Tons

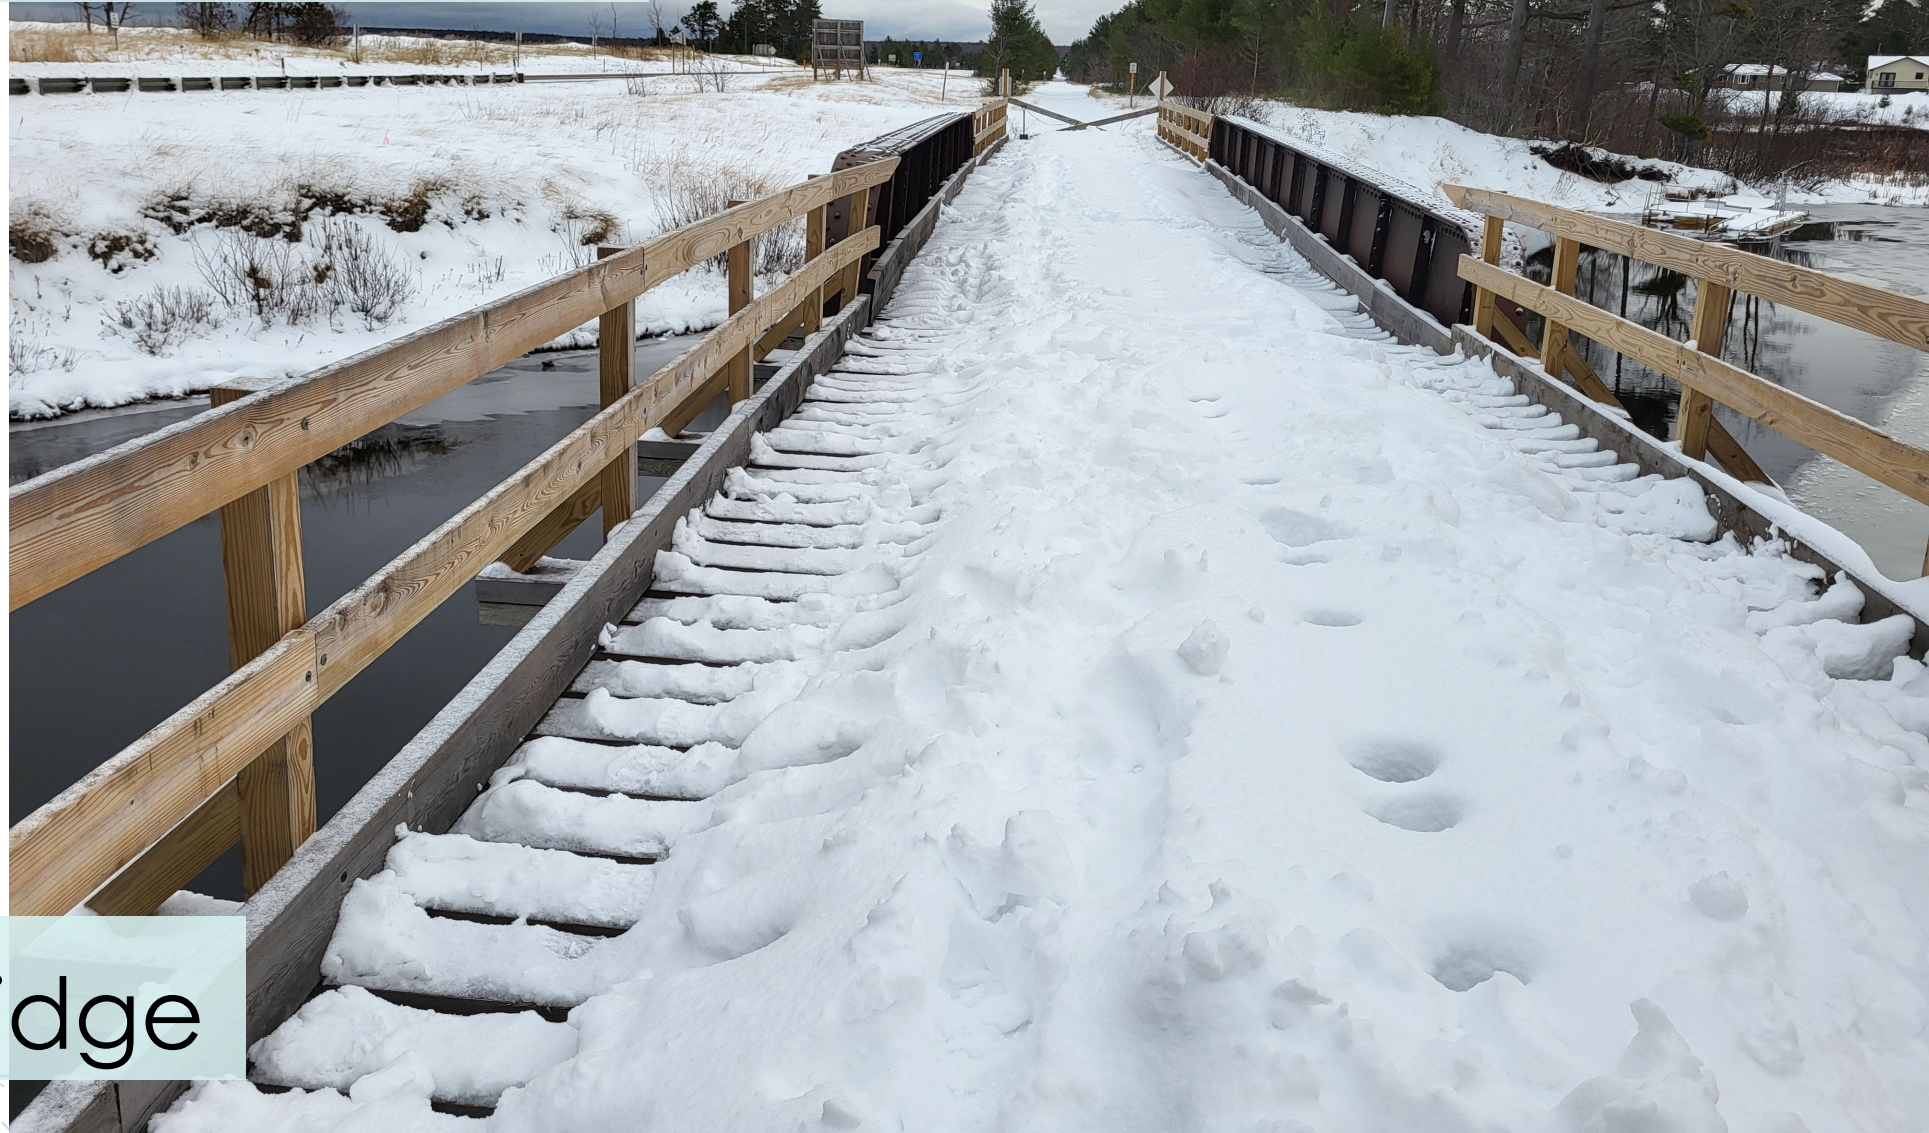
Au Train Bridge

1. August 2024: 8" of settlement
2. December 2024: 12" of settlement

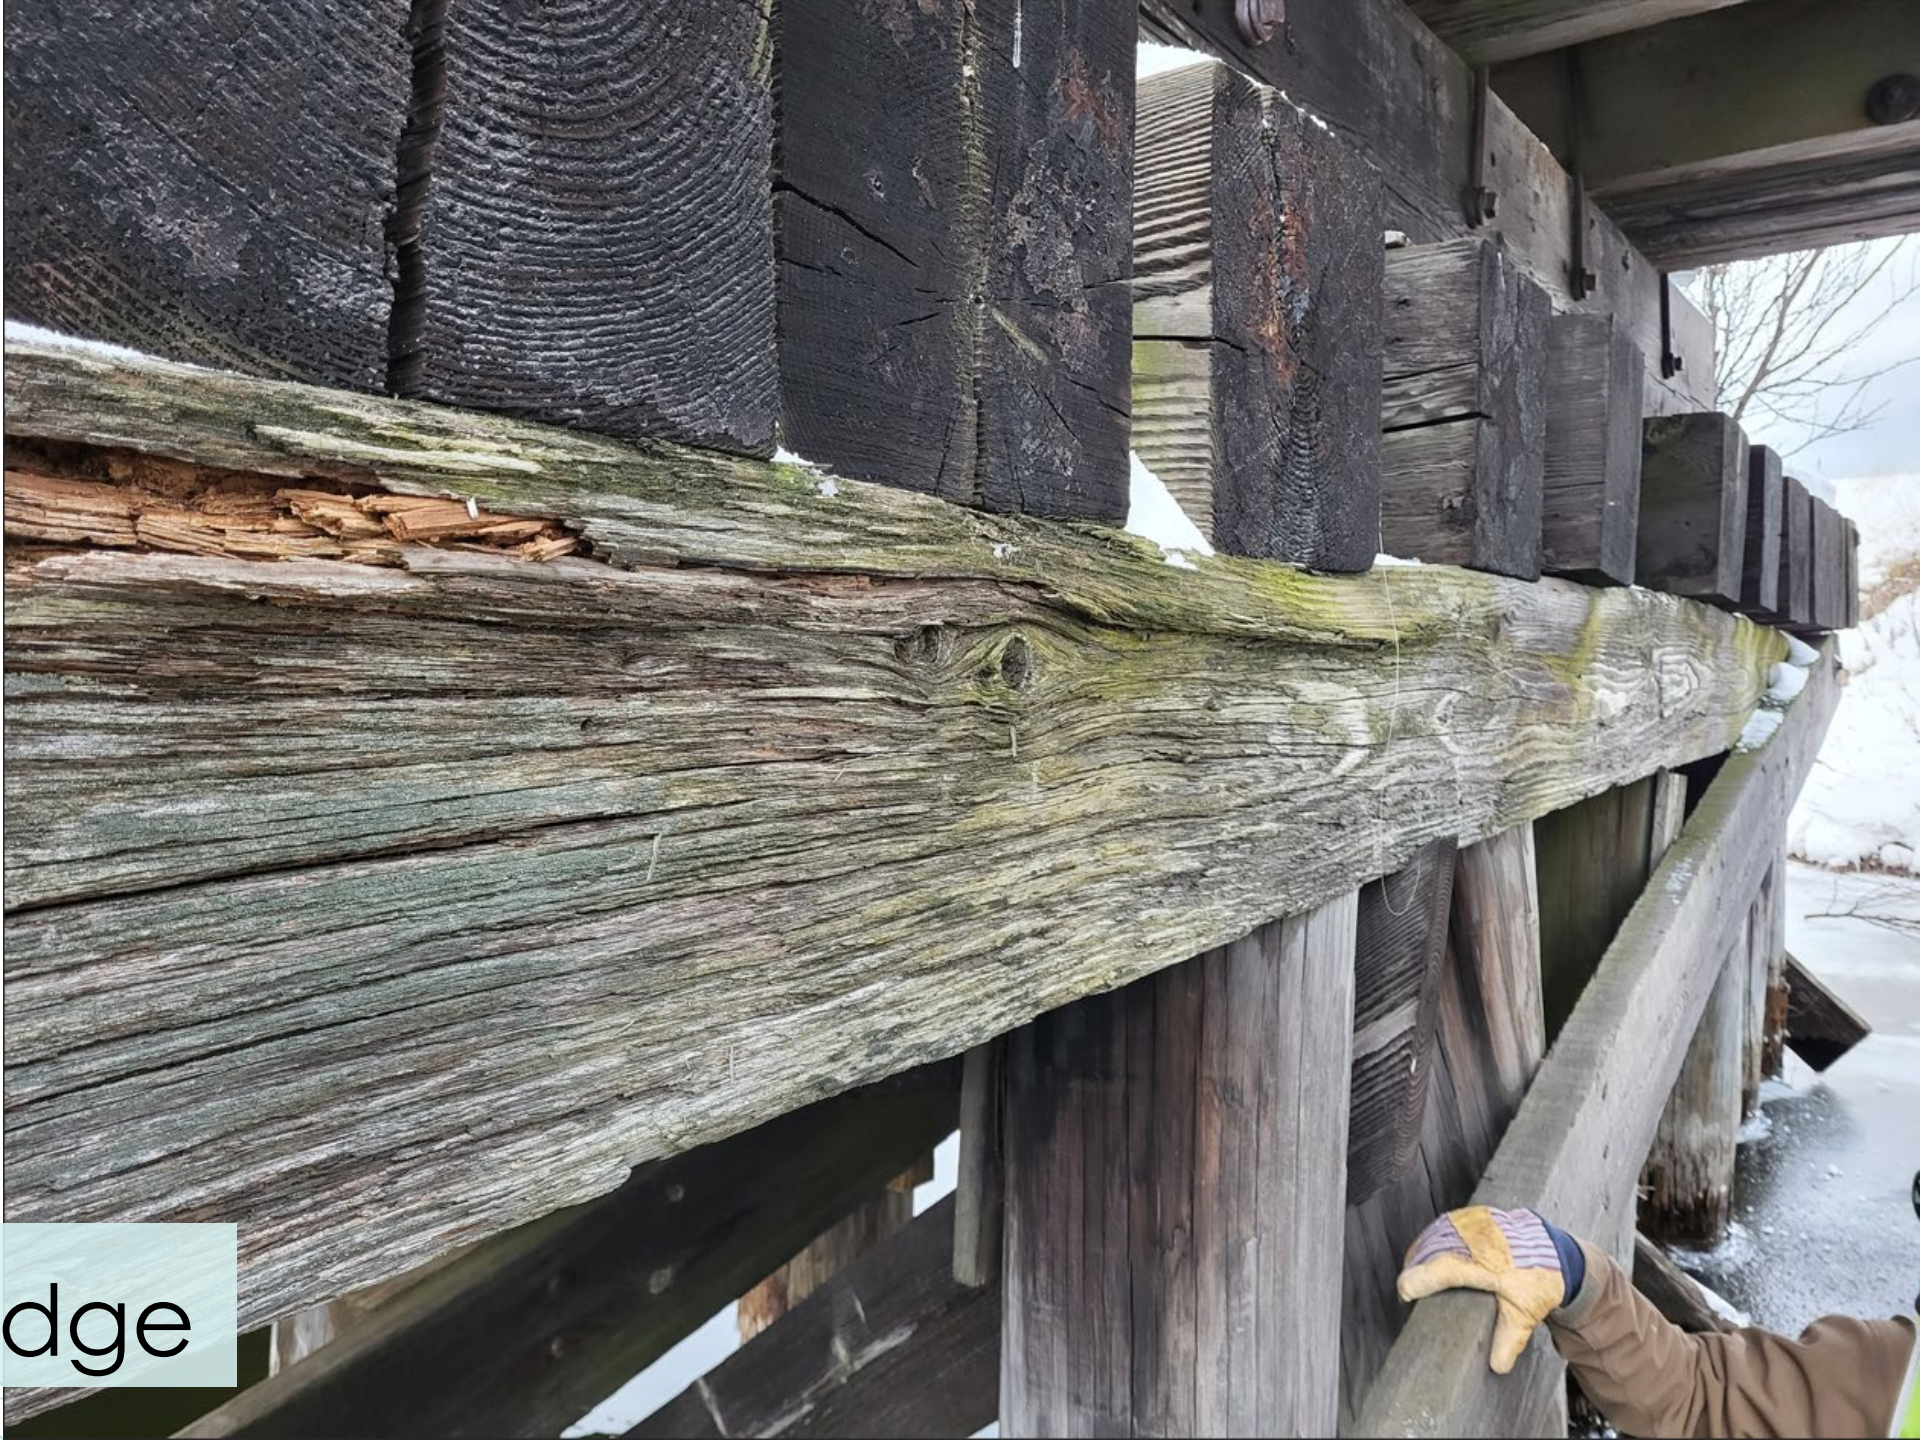
Au Train Bridge

No noticeable distress at the track level up to this point.

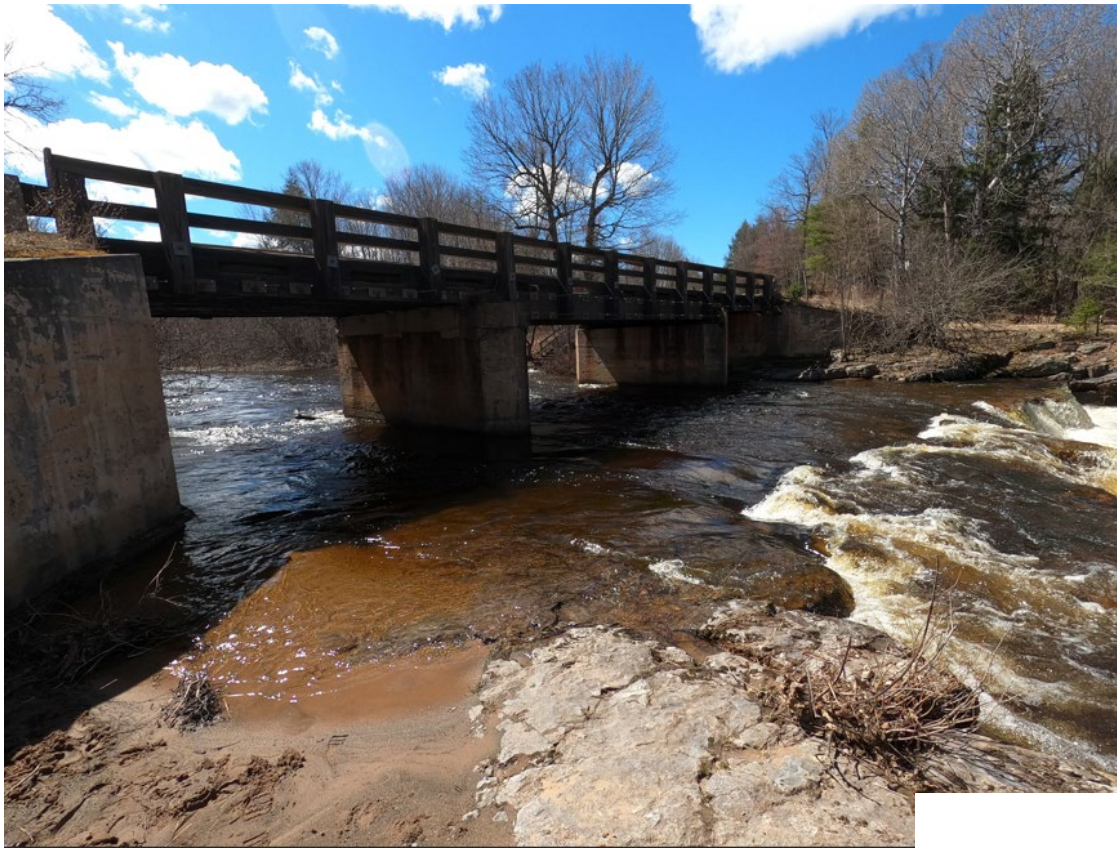
1. Timber box beam superstructures are rare and there are no nationally approved design specifications
2. Flange Lumber Flexing

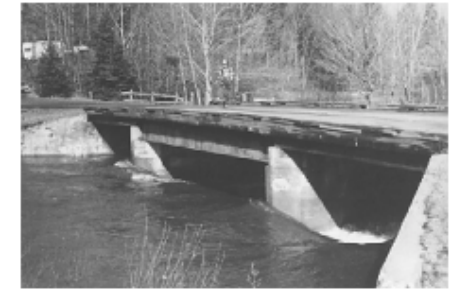
Figure 2—Big Erick's bridge prior to replacement (1980).

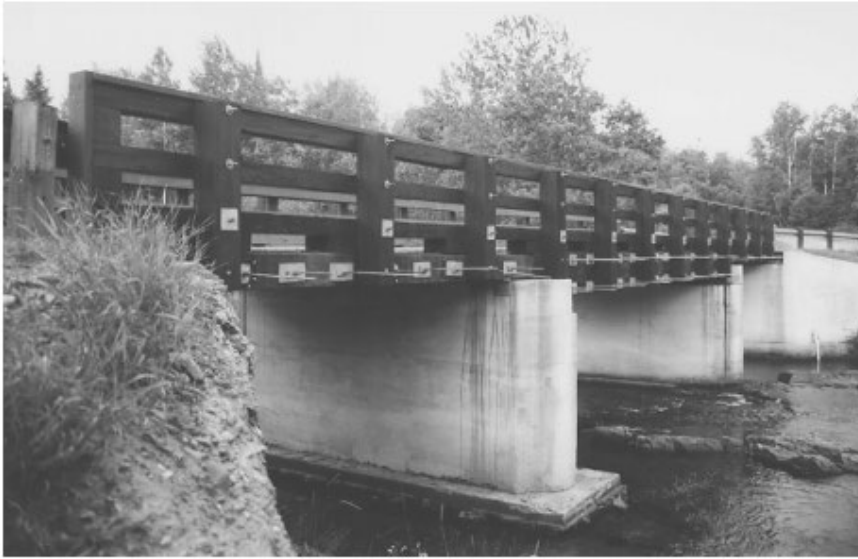
Figure 12—Completed Big Erick's bridge: side view (top), end view (bottom).
